January 31, 2022

Re: Updated Cost Estimate for Granite Falls Hydroelectric Powerhouse Repairs

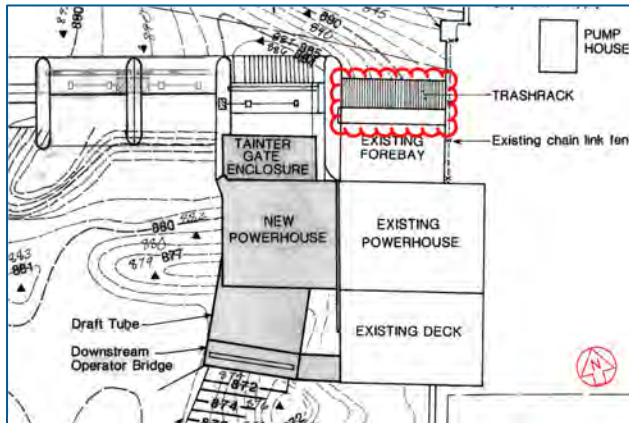
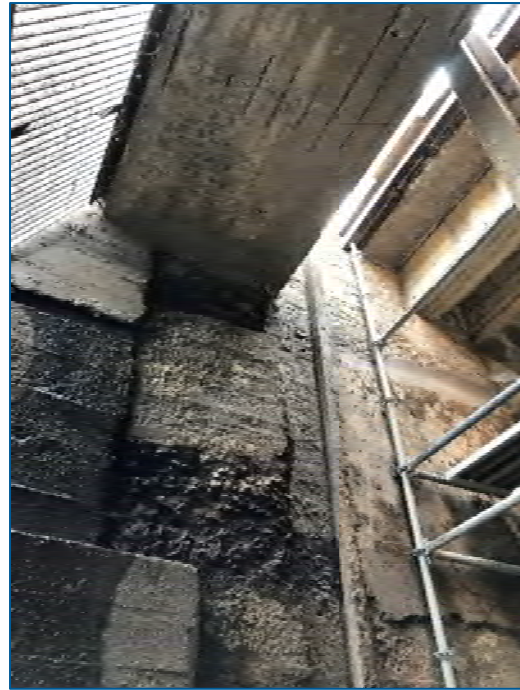
1. Intake Area Concrete Repairs

The concrete surrounding the intake gate slots for unit #1 and #2 and the two steel columns that serve as intermediate supports for the intake gates were observed during the head-pond drawdown completed for the intake gate slot repairs that were constructed as part of the 2021 powerhouse repair project. The intake area concrete is in poor condition and needs repair. The steel columns have severely corroded and

need to be replaced since they will not safely support the hydrostatic load from the intake gates in their current condition.

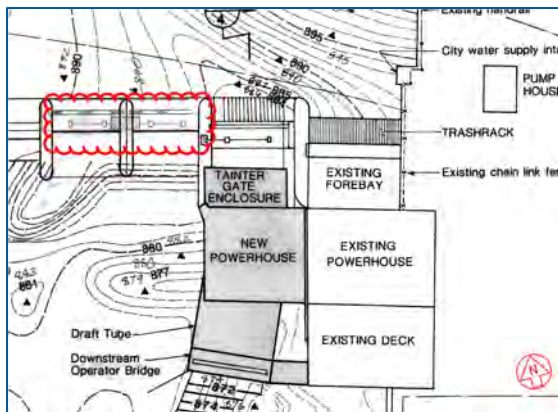
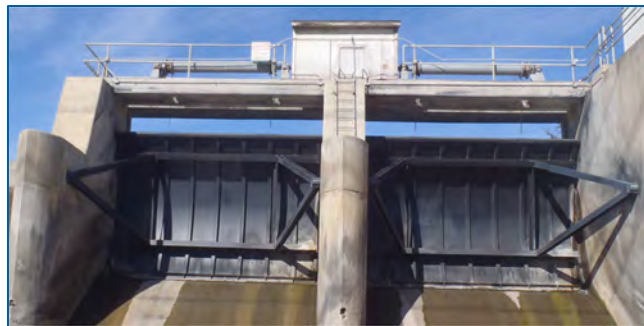
2. Flood Gate Seals

Two radial (tainter) flood gates are located to the right (west) of the powerhouse. Leakage through the gates has become excessive and results in significant ice formation in the winter that prevents gate operation. The seals on these gates need to be replaced. This work would require a partial drawdown of the head-pond and installation of temporary bulkheads to dewater the gate face and install the new seals.

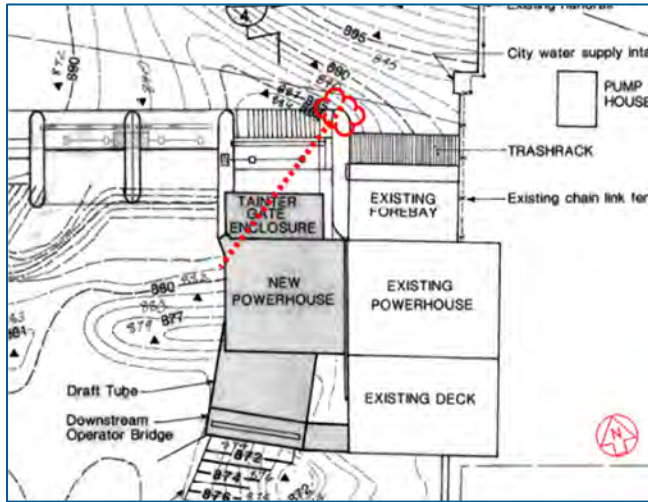
5. Low Level Outlet Valve Replacement

A 12-inch diameter pipe was installed below the unit #3 area of the powerhouse in the mid-1980's to drawdown and pass water during times when the headwater is below the sill elevation of the floodgates. A valve was also included on the upstream end of the pipe so that the pipe could be closed when not in use. The valve is no longer functional and water flows through the pipe uncontrolled, thus it needs to be

replaced. Replacing the valve will enable more flow to pass through the turbines thereby improving the plant's efficiency and improve dam safety by preventing uncontrolled flow through the pipe.

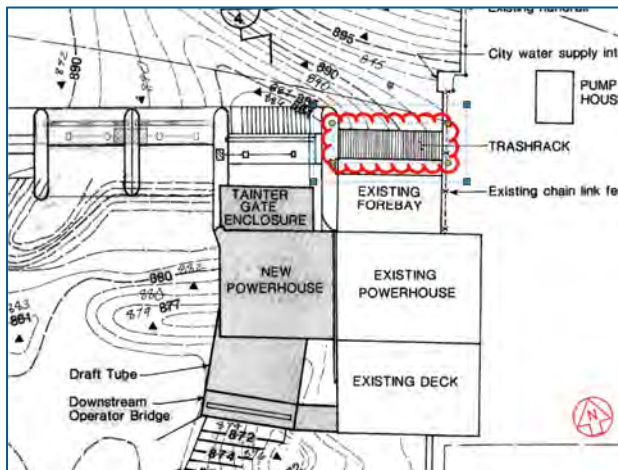
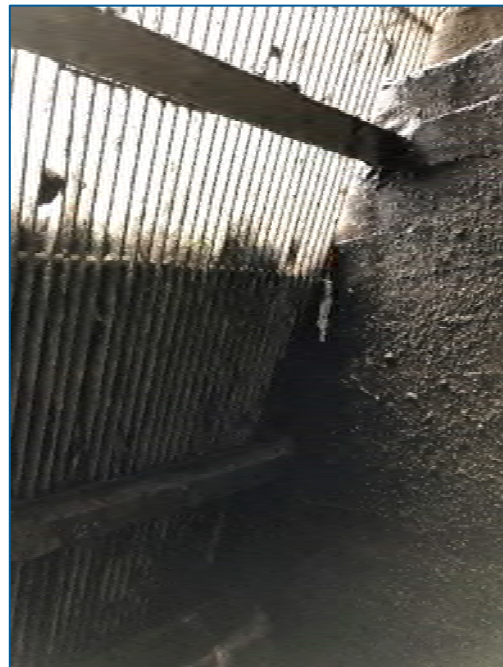
6. Trash Rack Support Steel Replacement

Trash racks are located upstream of the intakes. The steel supporting the trash racks for unit #1 and #2 was observed during the head-pond drawdown done for the intake gate slot repairs in 2021. The steel supporting the trash racks is in poor condition and should be replaced or repaired.

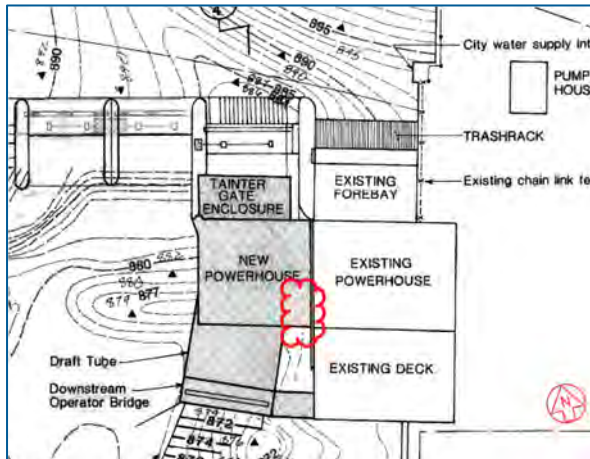
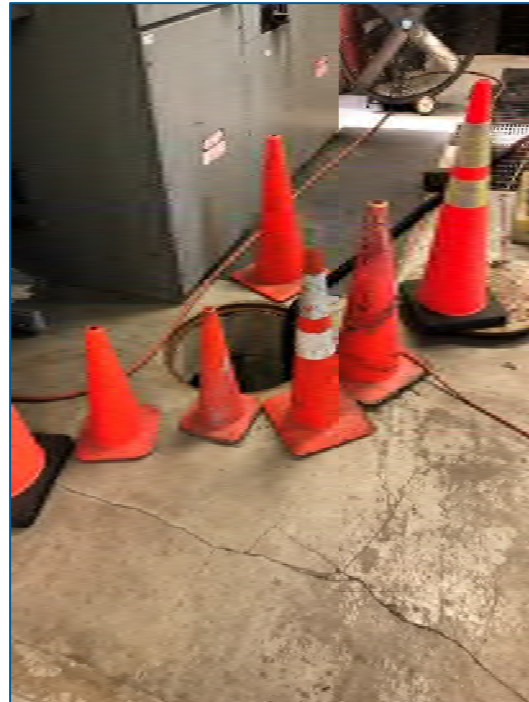
7. Vault Access and Secondary Overflow Valve Installation

Overflow water from the unit #2 turbine pit flows into a large cavity (vault) located in between unit #2 and #3. Personnel access into this area is considered to be unsafe and requires a fixed ladder and

supplementary access platform for access to maintain the overflow valve. A secondary overflow valve is also needed. Protection from freezing for the existing and new valves is also needed.

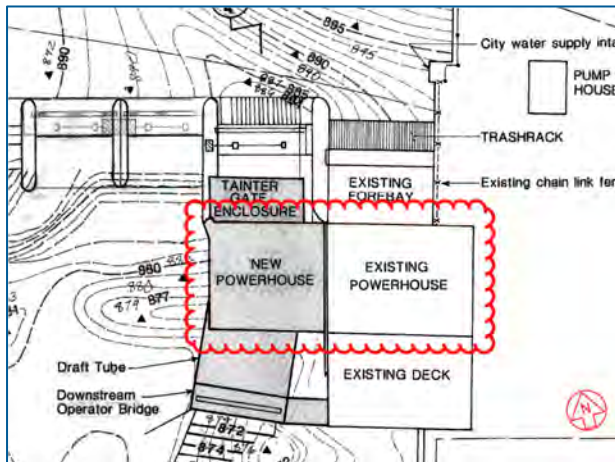
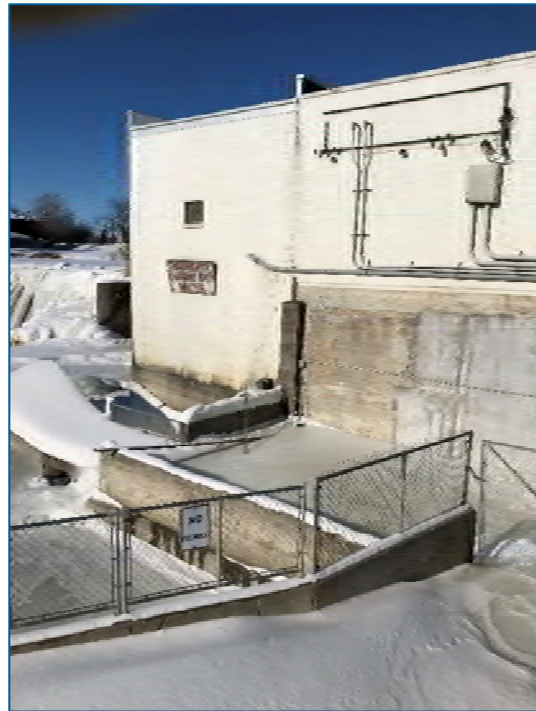
8. Recoating Powerhouse Exterior and Warning Sign Replacement

The exterior coating of the powerhouse has exceeded its life expectancy and needs recoating. Most of the building requires cleaning and painting. The area where concrete repairs were performed require reapplication of the swirl/parge coating to blend with the balance of the adjacent exterior prior to

repainting. As a part of this work scope, a public safety warning sign on the downstream face of the powerhouse needs replacement.

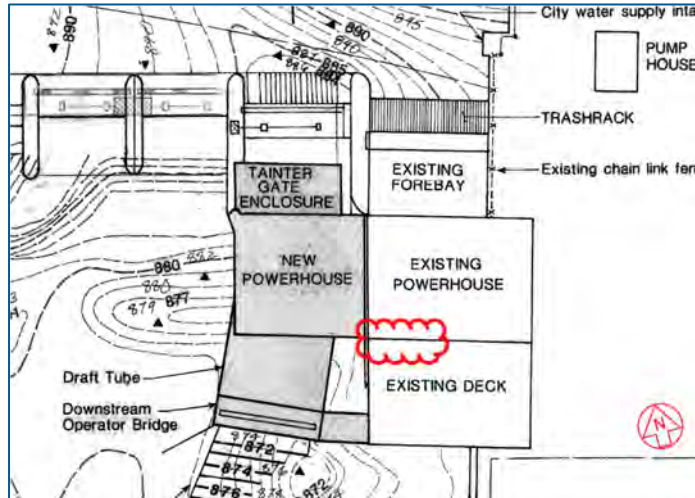
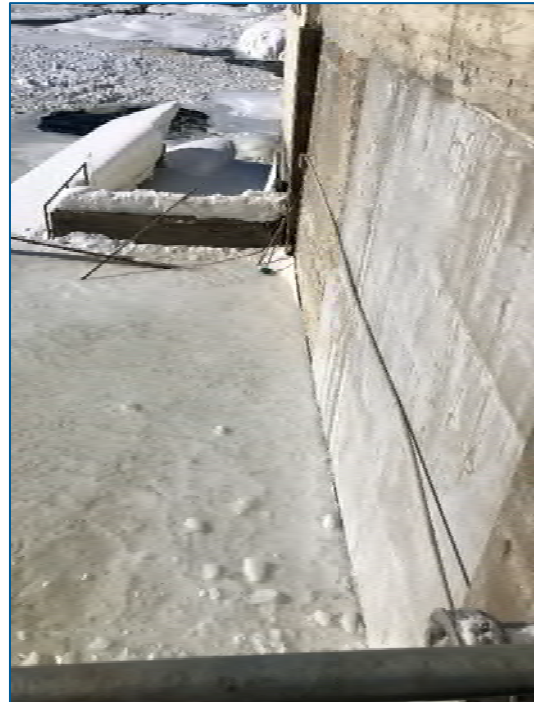
9. Downstream Powerhouse Wall Concrete Repairs

Concrete repairs performed in 2021 were scoped based upon two defined areas that were visibly deteriorated. As a part of the project, the swirl/parge coating that had been applied over the walls was

removed in its entirety over a large portion of the downstream wall which revealed additional deteriorated concrete that was not included in the 2021 repairs.

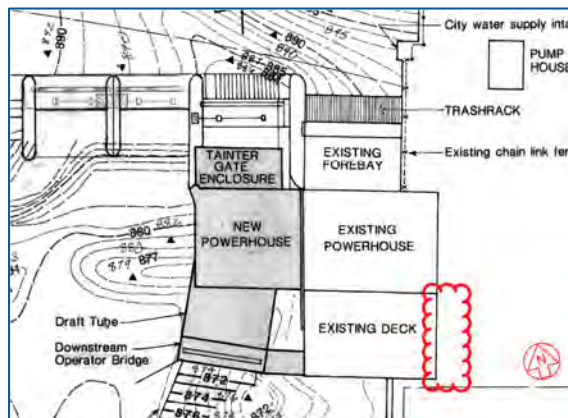
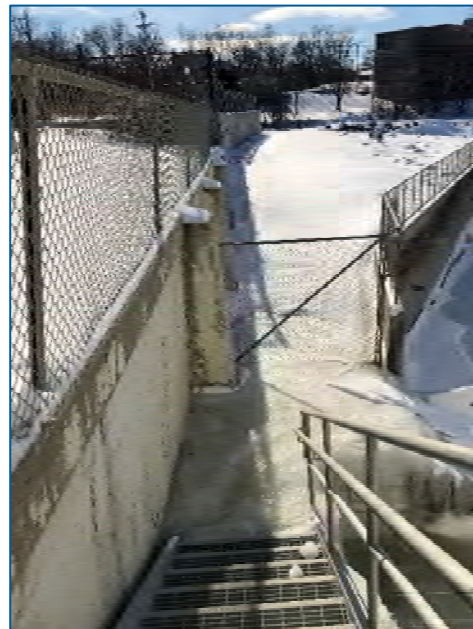
10. Retaining Wall Repair/Replacement

The concrete retaining wall on the downstream/left side of the powerhouse is deteriorated and needs repair and/or replacement. The repair would also incorporate drainage to alleviate seepage originating from the parking lot or old water plant area.

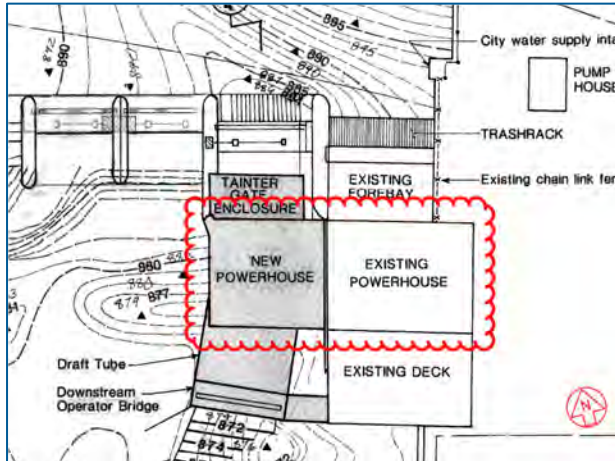
11. Temperature Control in Powerhouse

Excessive summer heat in combination with heat from the generators in the powerhouse have caused the units to trip offline and has caused melting of equipment within the electrical cabinets. A system of controlling excessive heat in the summer is needed to protect the operating equipment.

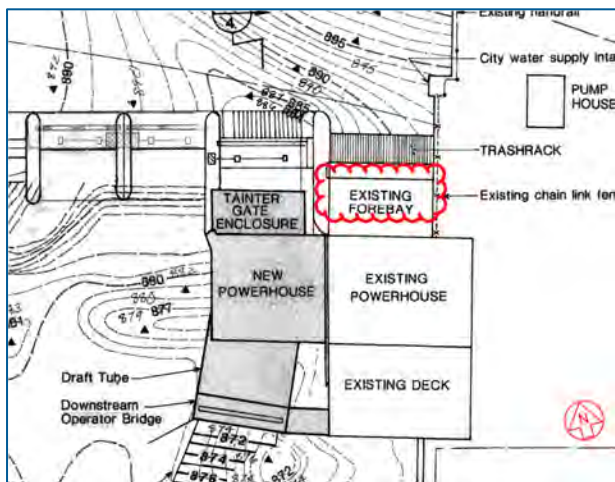
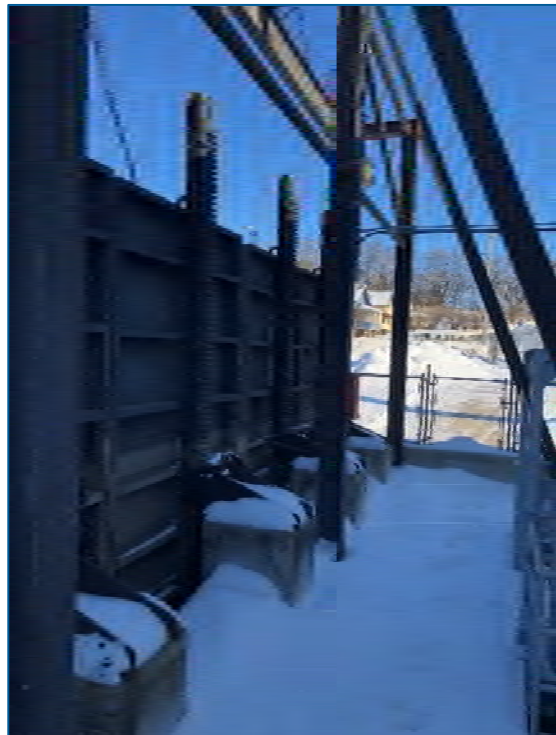
12. Intake Gate Hoist System Repairs

Anchorage of the steel that supports the intake gate hoist has failed and requires supplemental anchorage. The hoist used to lift the gates has exceeded its useful service life and needs replacement.

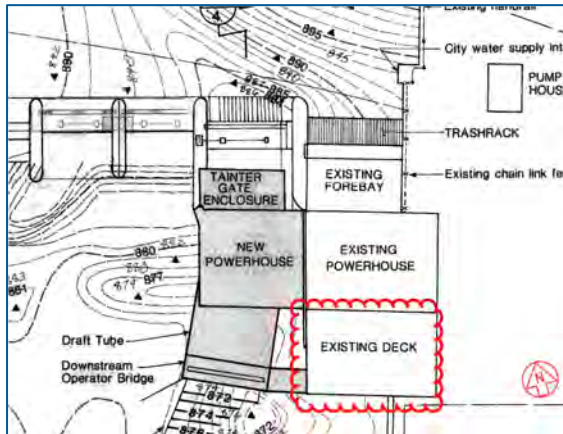
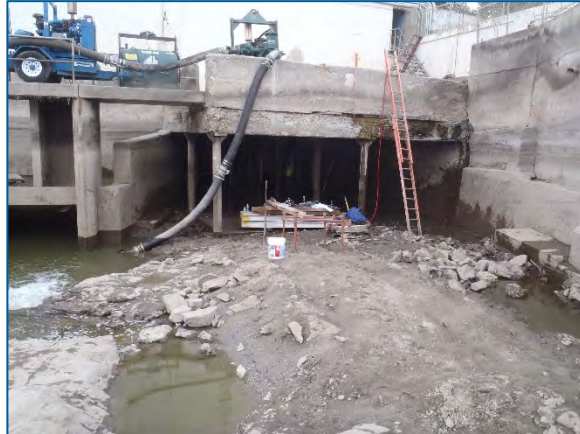
13. Dive Inspection & Misc Concrete Repair in Tailrace Under Units #1 and #2

The tailrace area beneath the unit #1 and #2 turbines was last accessed and repaired during the unit #1 and #2 turbine replacement project that was completed in 2016. It is important that the concrete be assessed on a semi-regular basis so that the integrity of the powerhouse supports is maintained. Access to this area would require divers experienced in concrete assessment and repair.

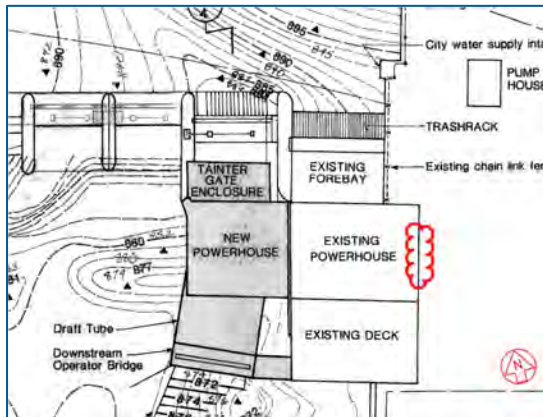
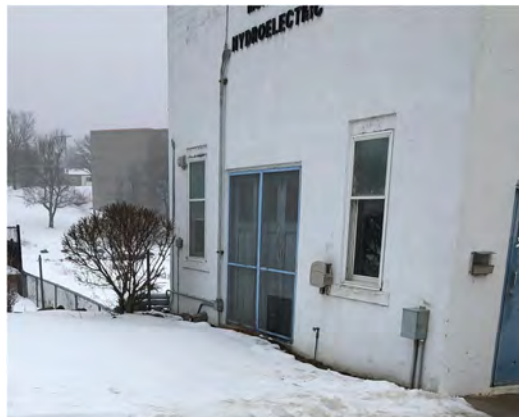
14. Double-Door Replacement

The double-doors used for bringing equipment in and out of the powerhouse have exceeded their useful life and require replacement.
