# Pickwick Mill Dam Project

## Photos 4B & 4C Referenced on Photo Key

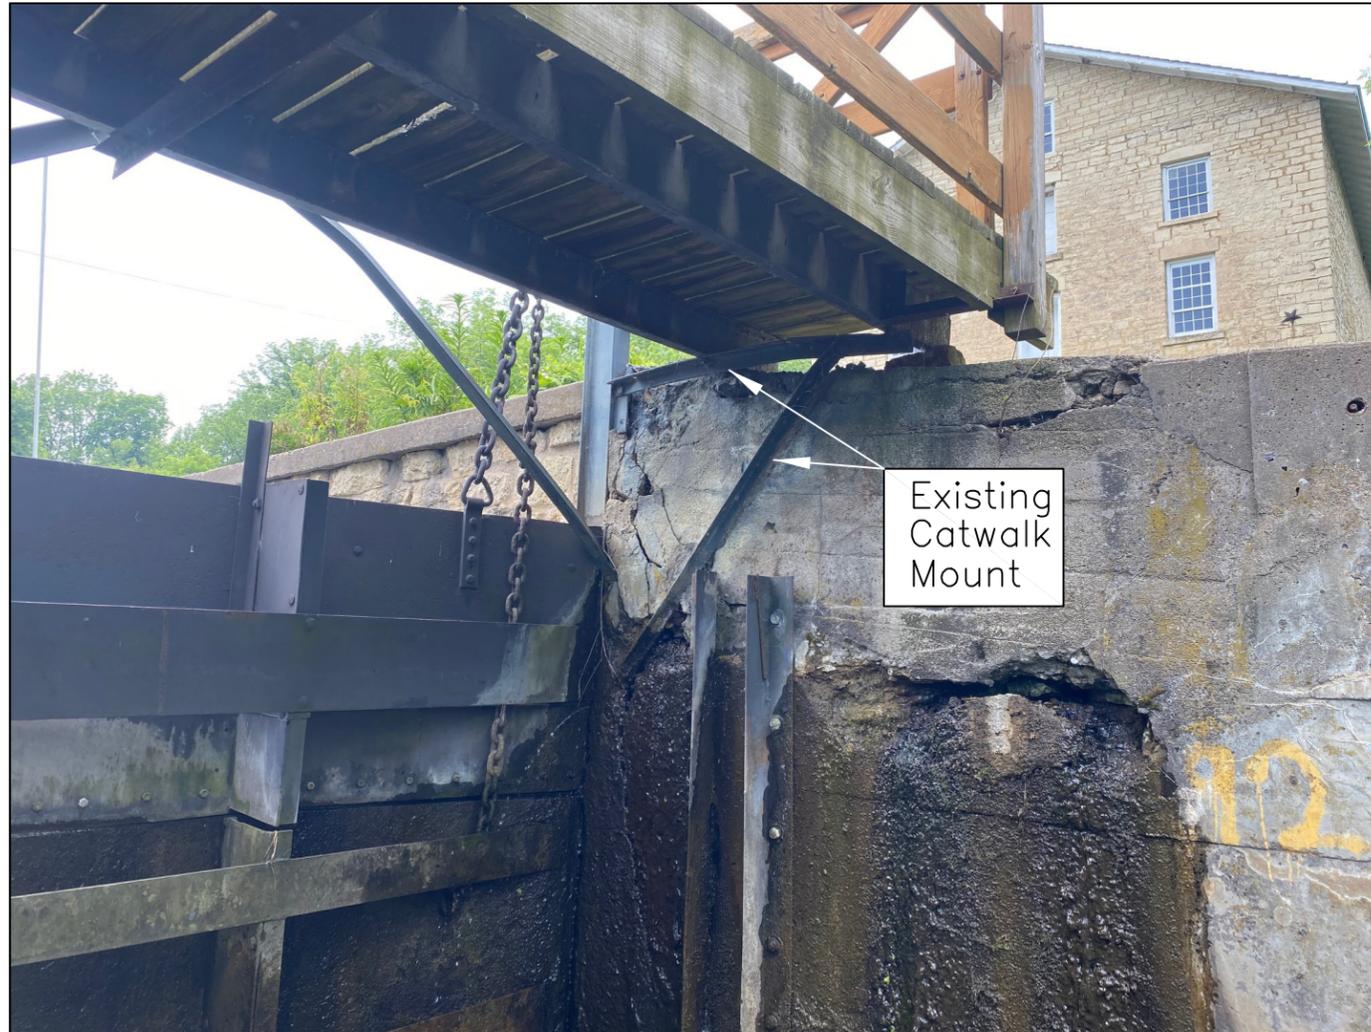
Photo 4B

Existing catwalk mount on the westerly side of Gate 1. View facing westerly.

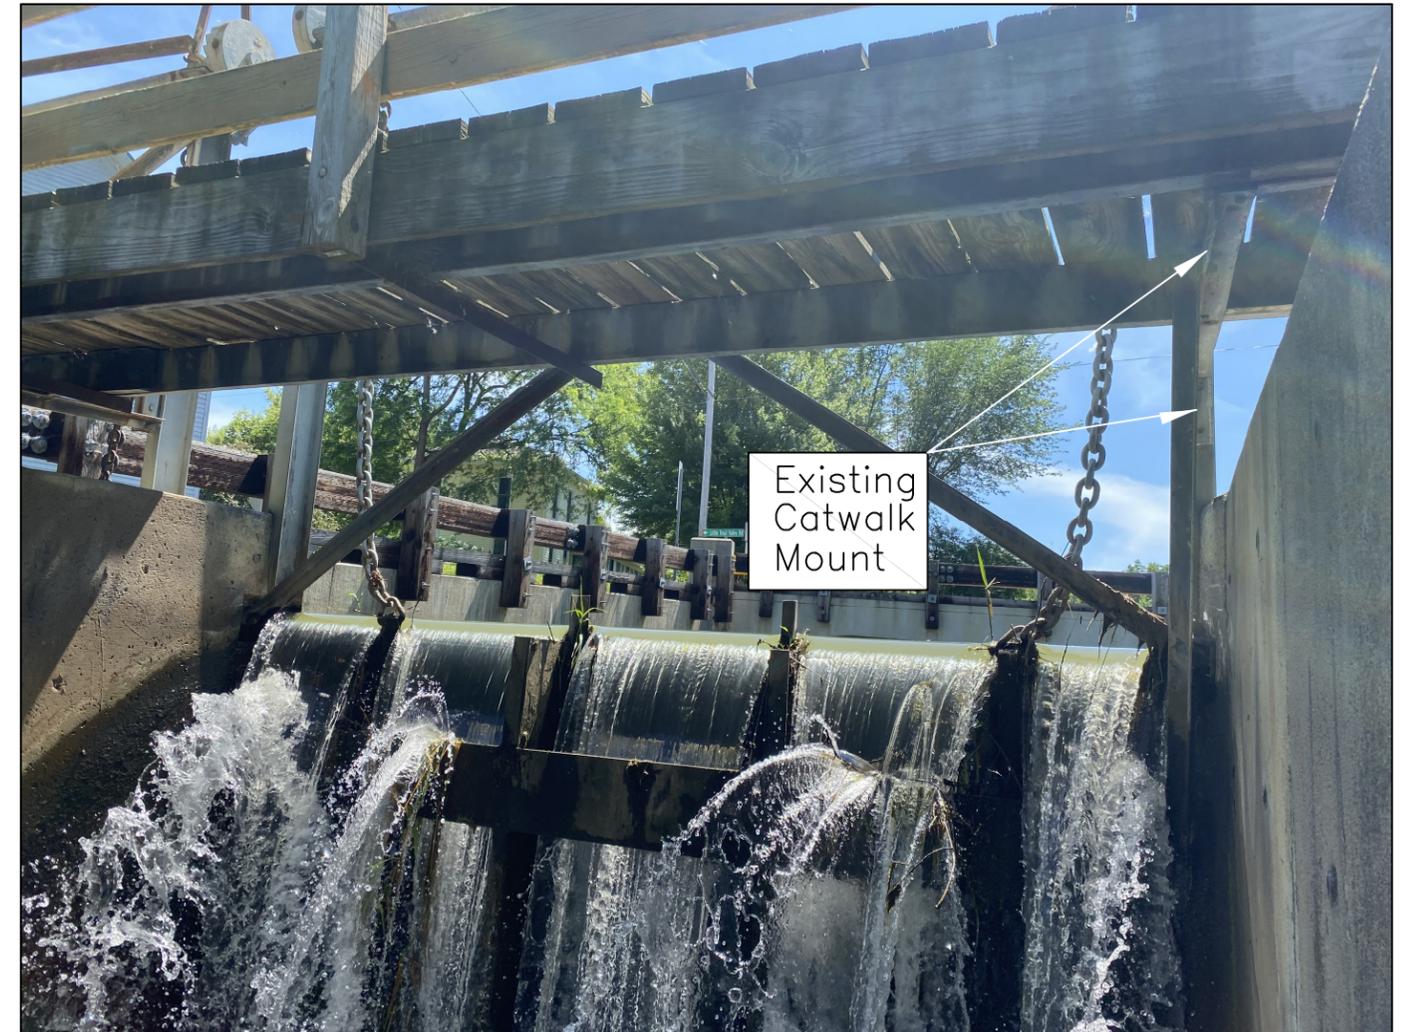
Photo 4C

Existing catwalk mount on the westerly side of Gate 2. View facing southerly.

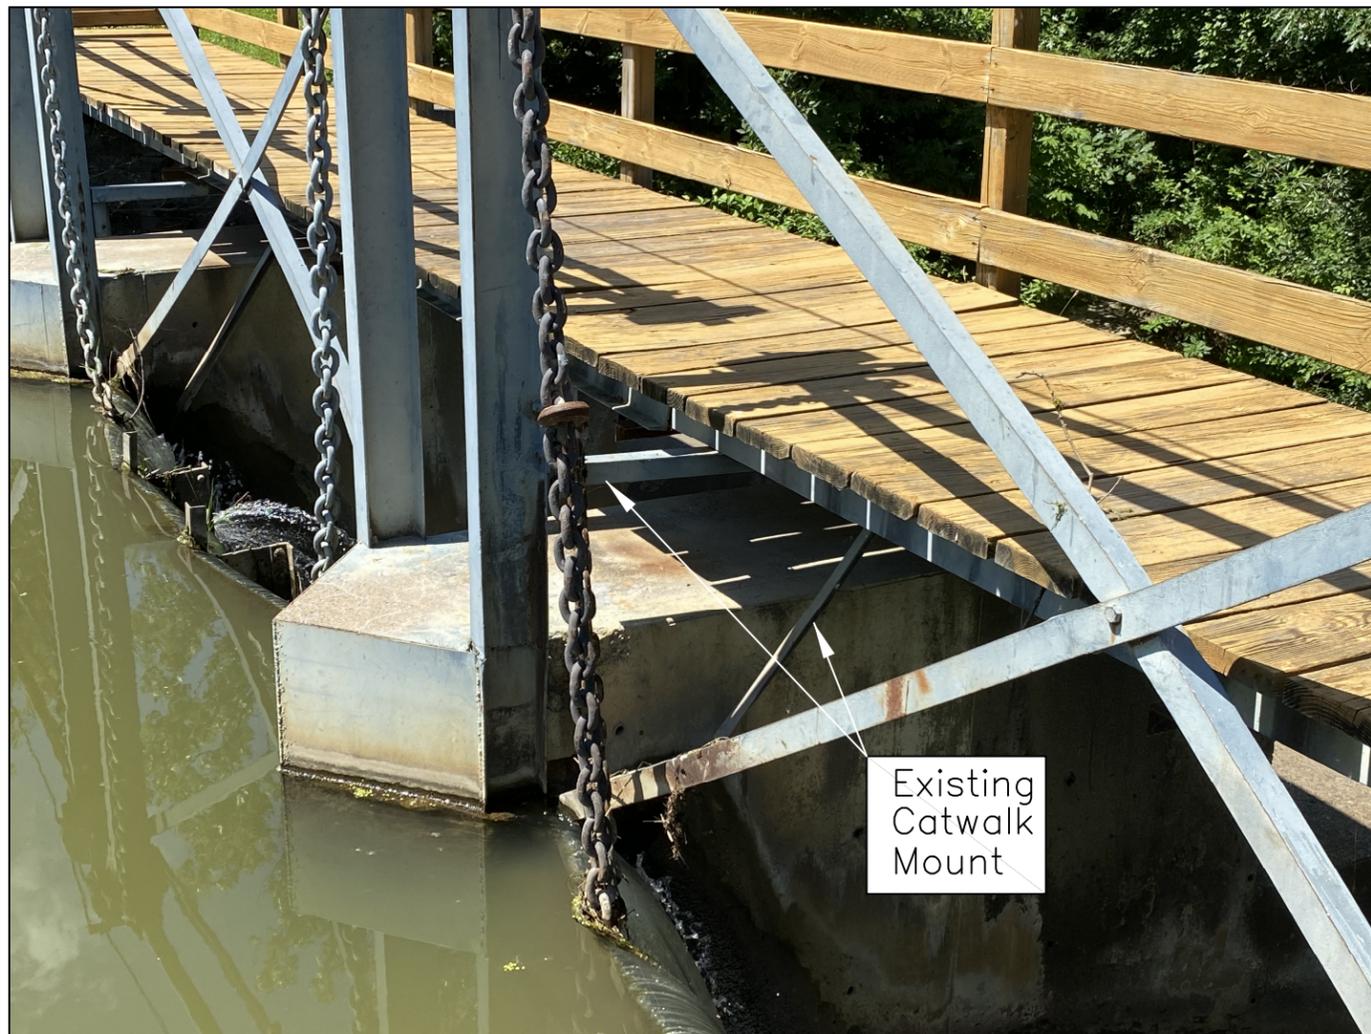
Photo 4D

Existing catwalk mount on the westerly side of Gate 3. View facing Northwesterly.

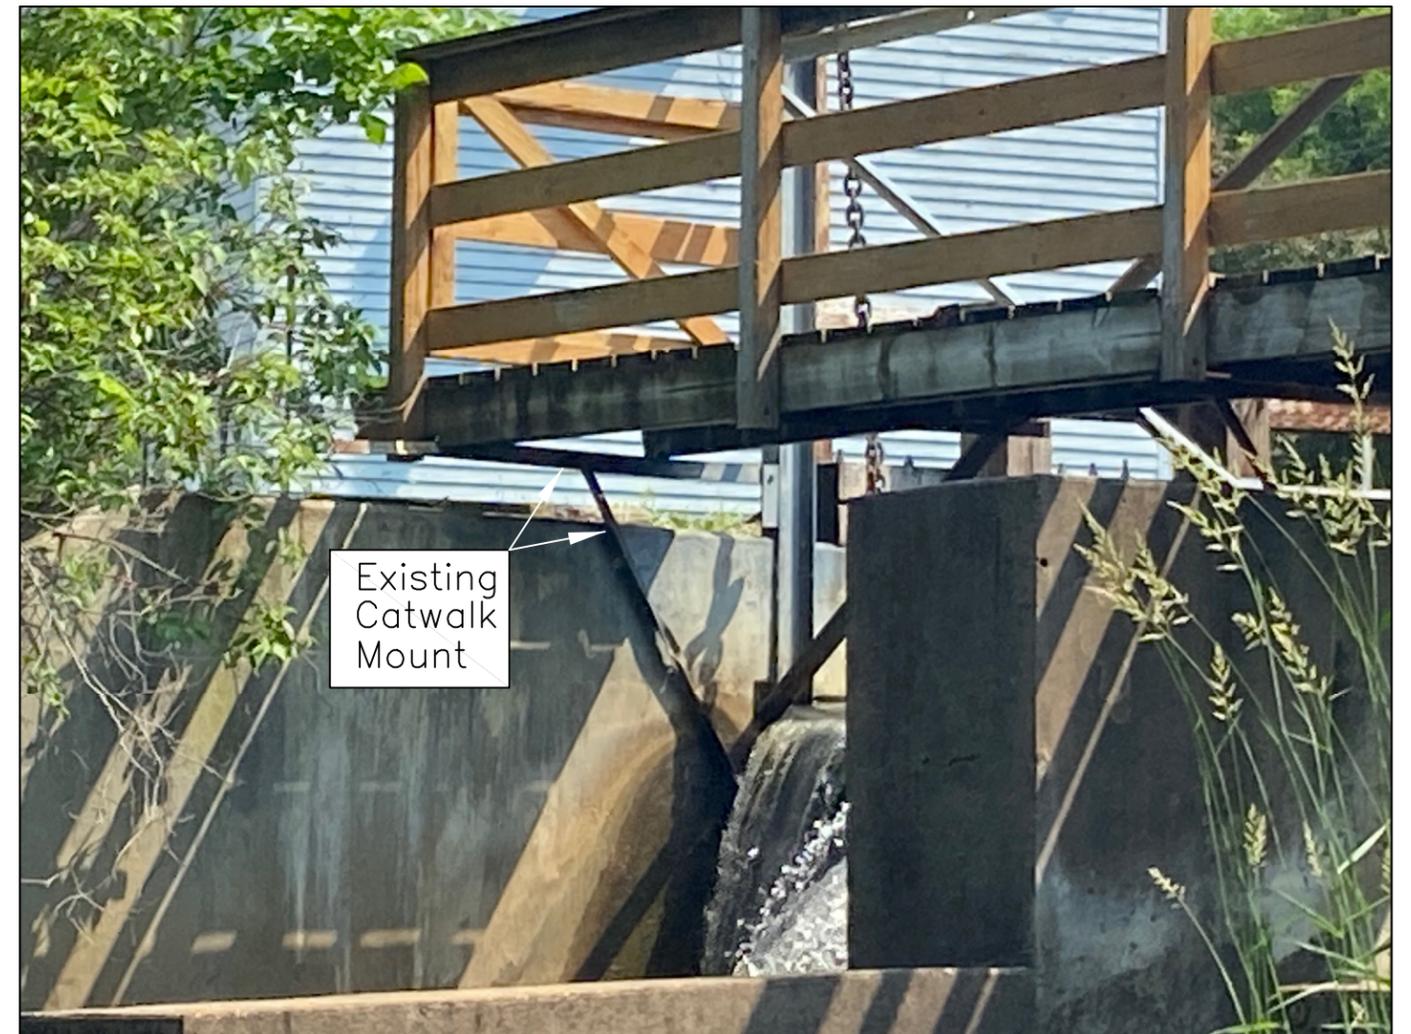
Photo 4E

Existing catwalk mount on the easterly side of Gate 3. View facing Southeasterly.

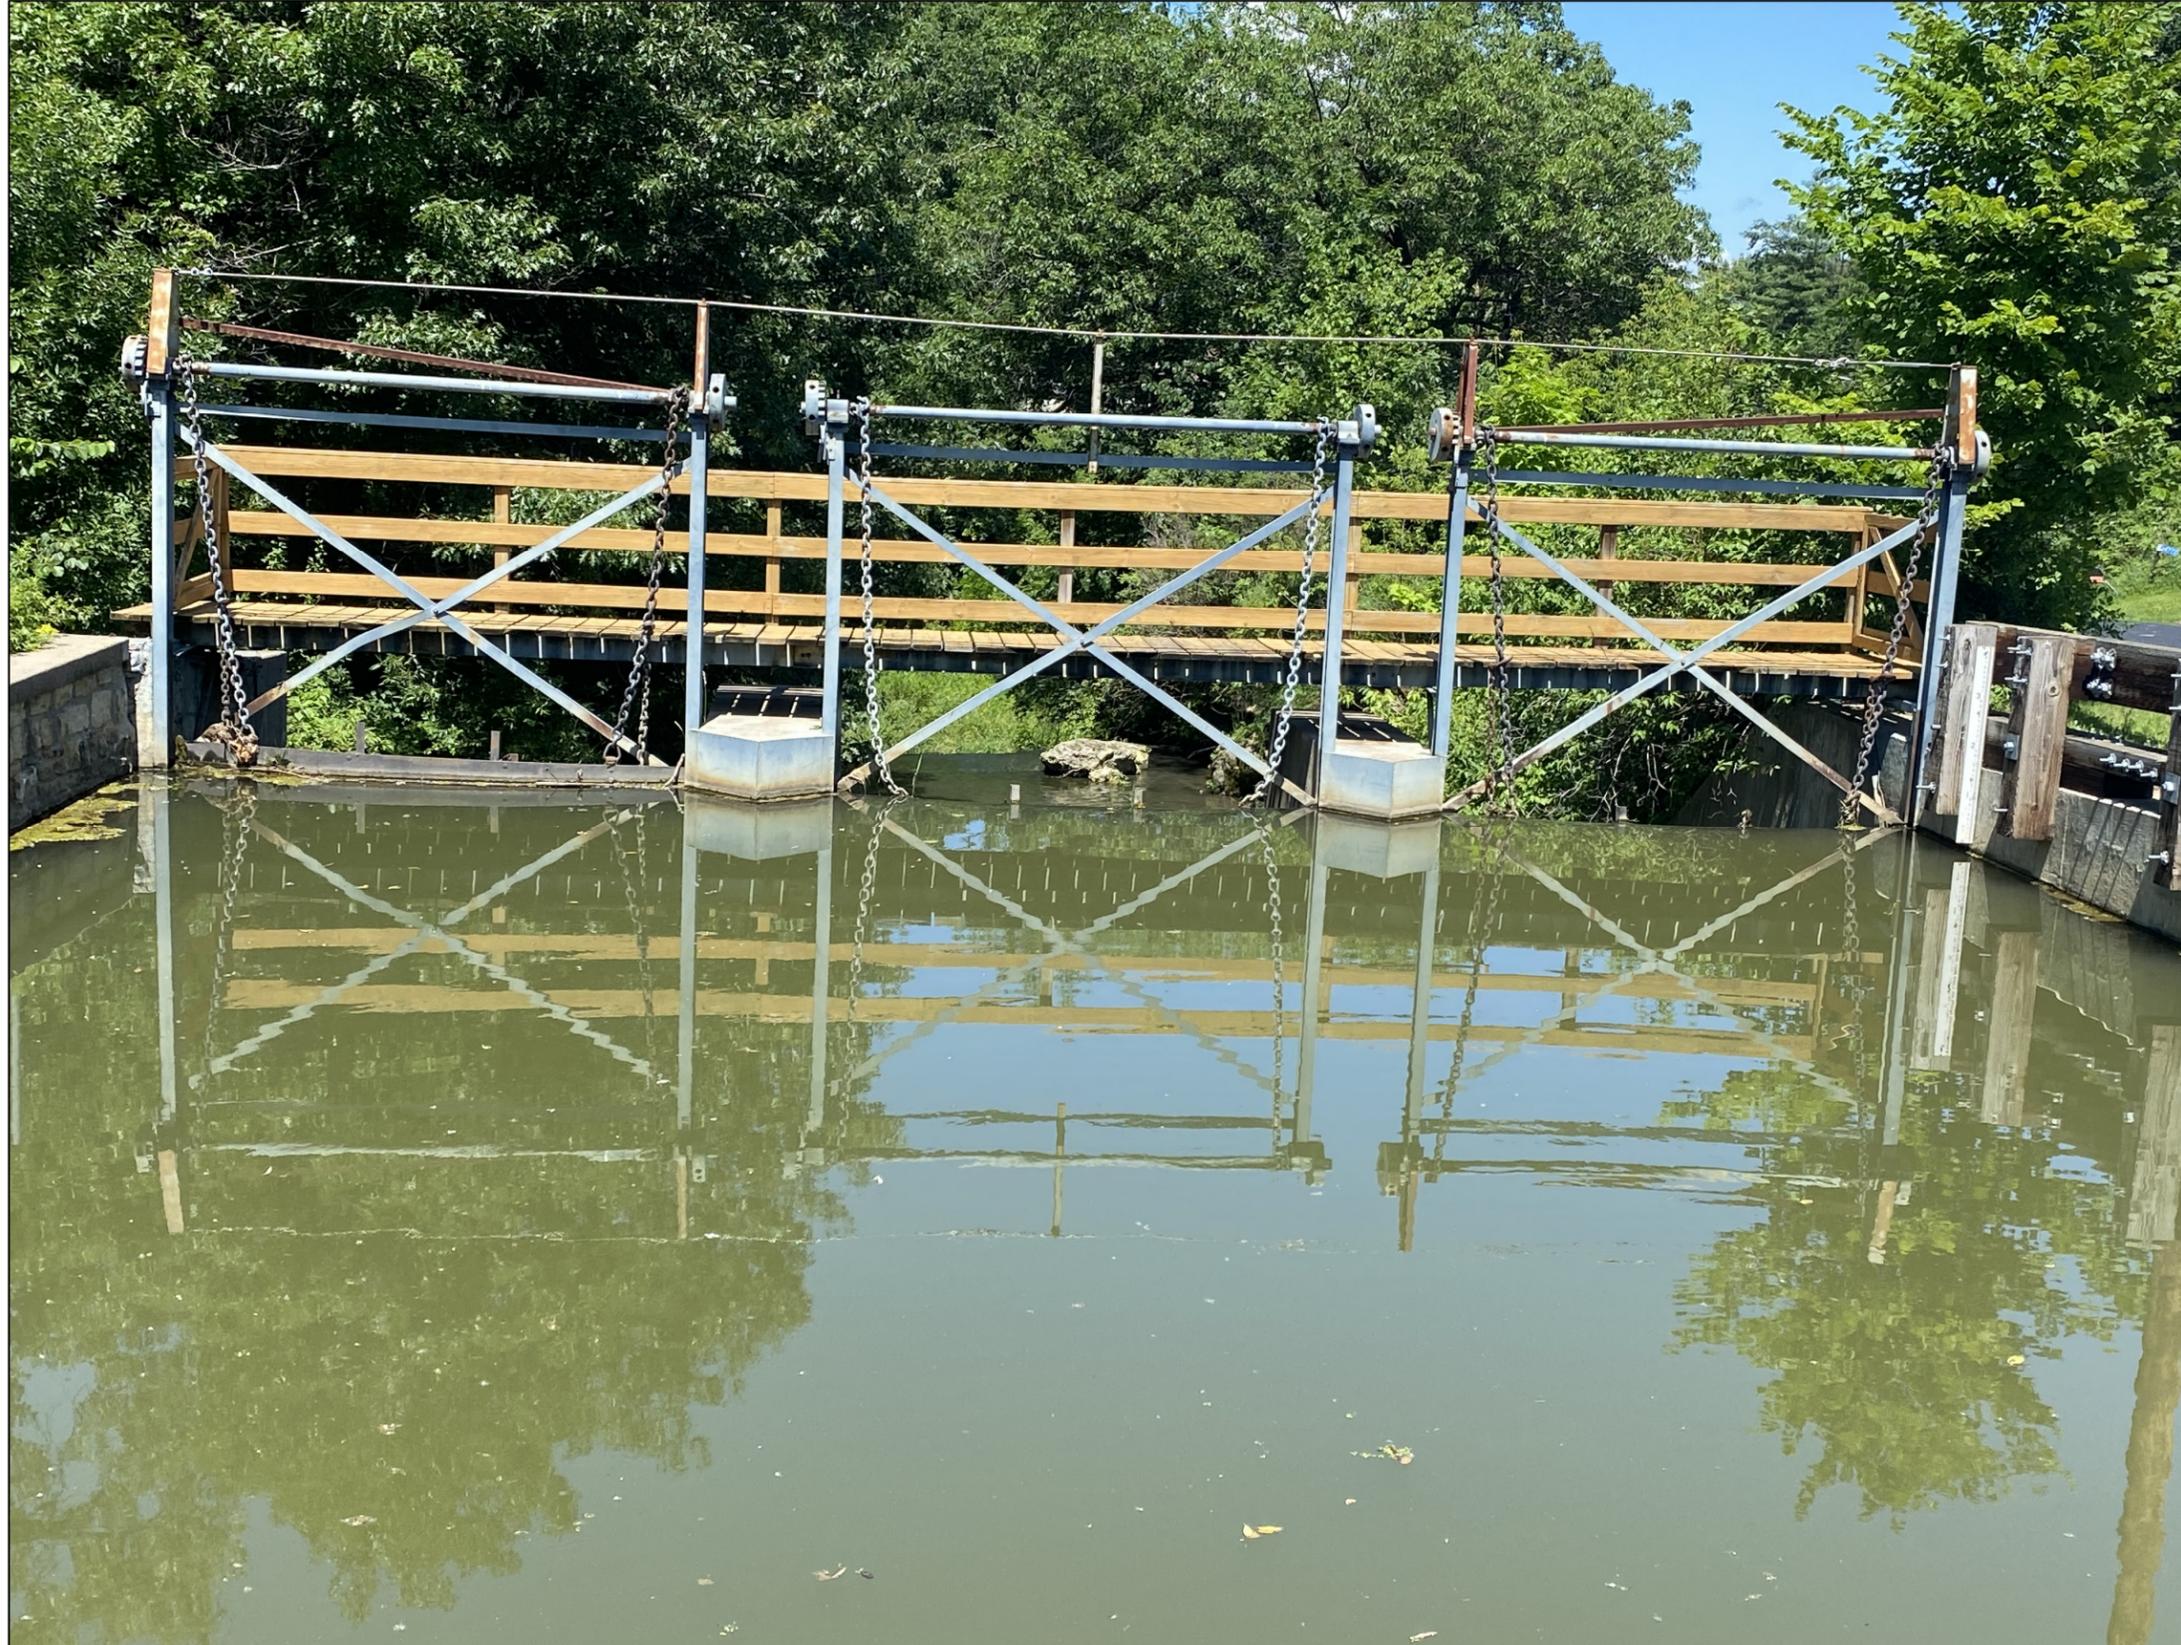
### Photo 5A

Steel dam gates and  
superstructure view from  
southwest facing northeast

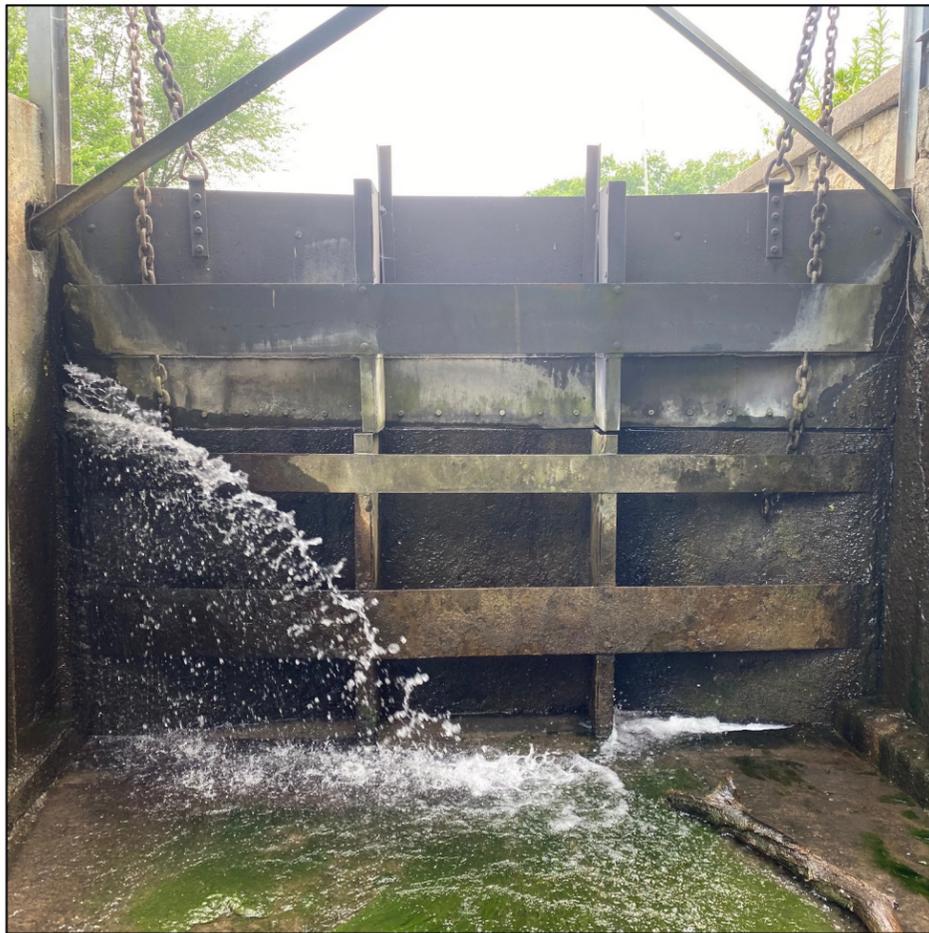
Photo 5B

Downstream side of the left (west) Gate 1.  
View facing southerly.

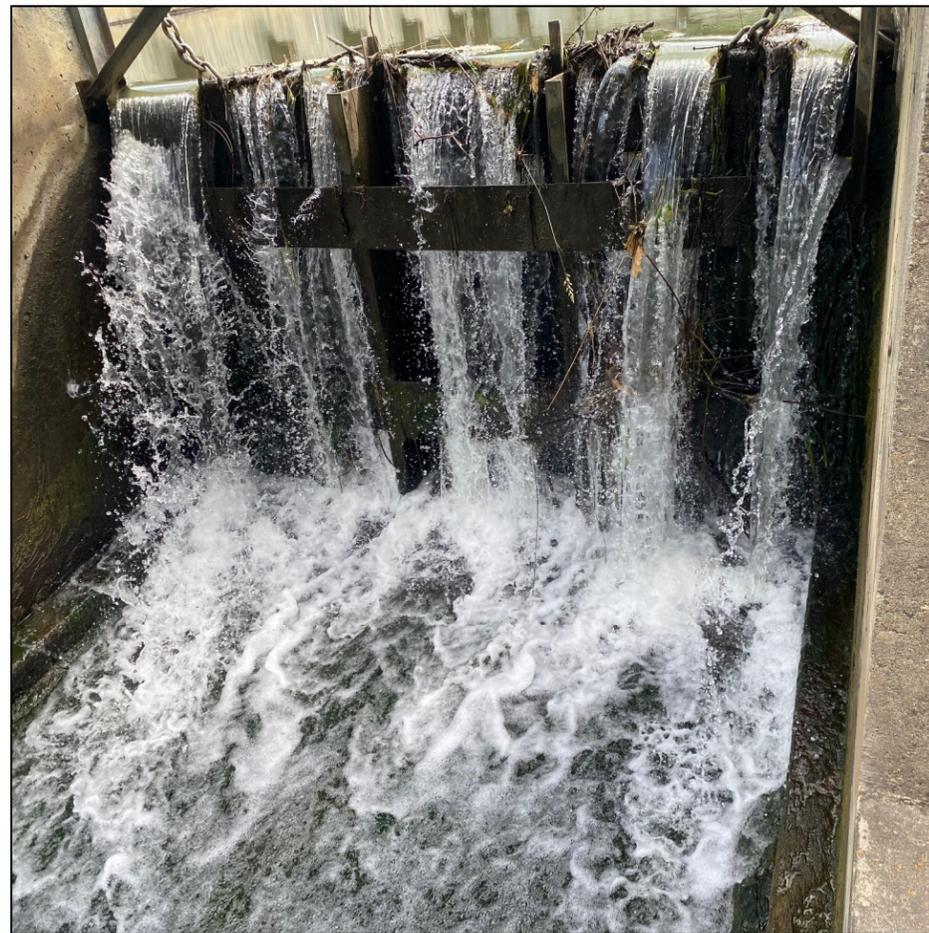
Photo 5C

Downstream side of the (center) Gate 2.  
View facing southerly.

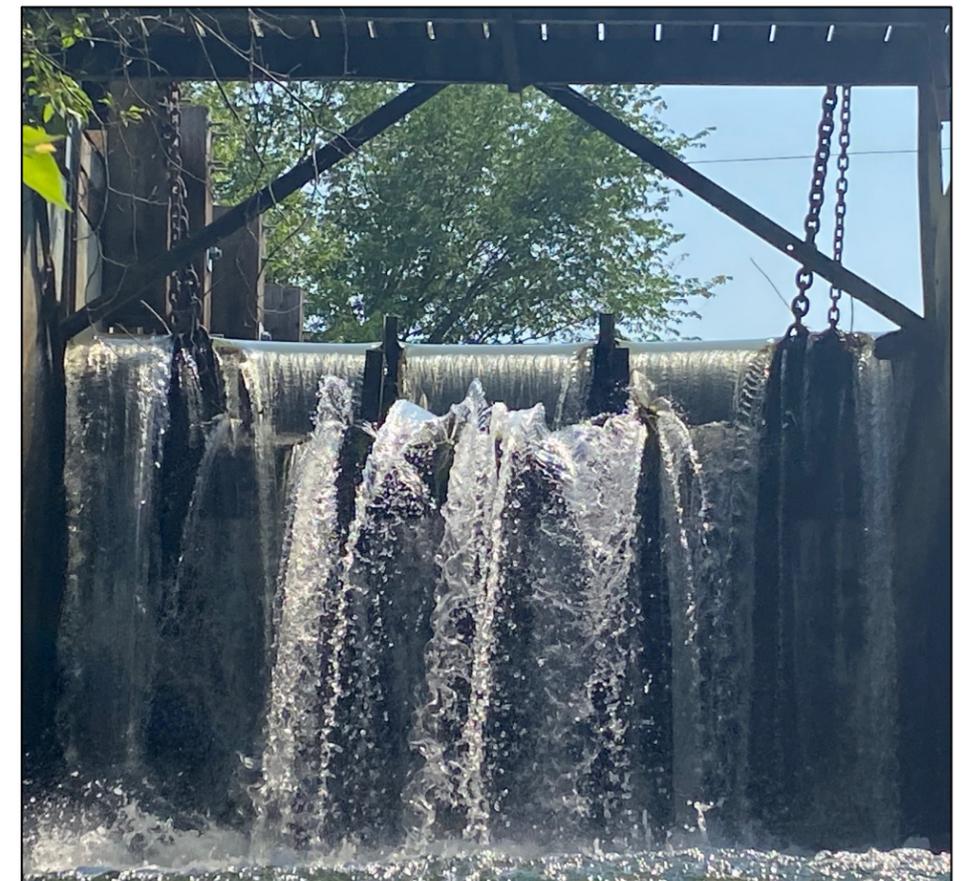
Photo 5D

Downstream side of the right (east) Gate 3.  
View facing southerly.

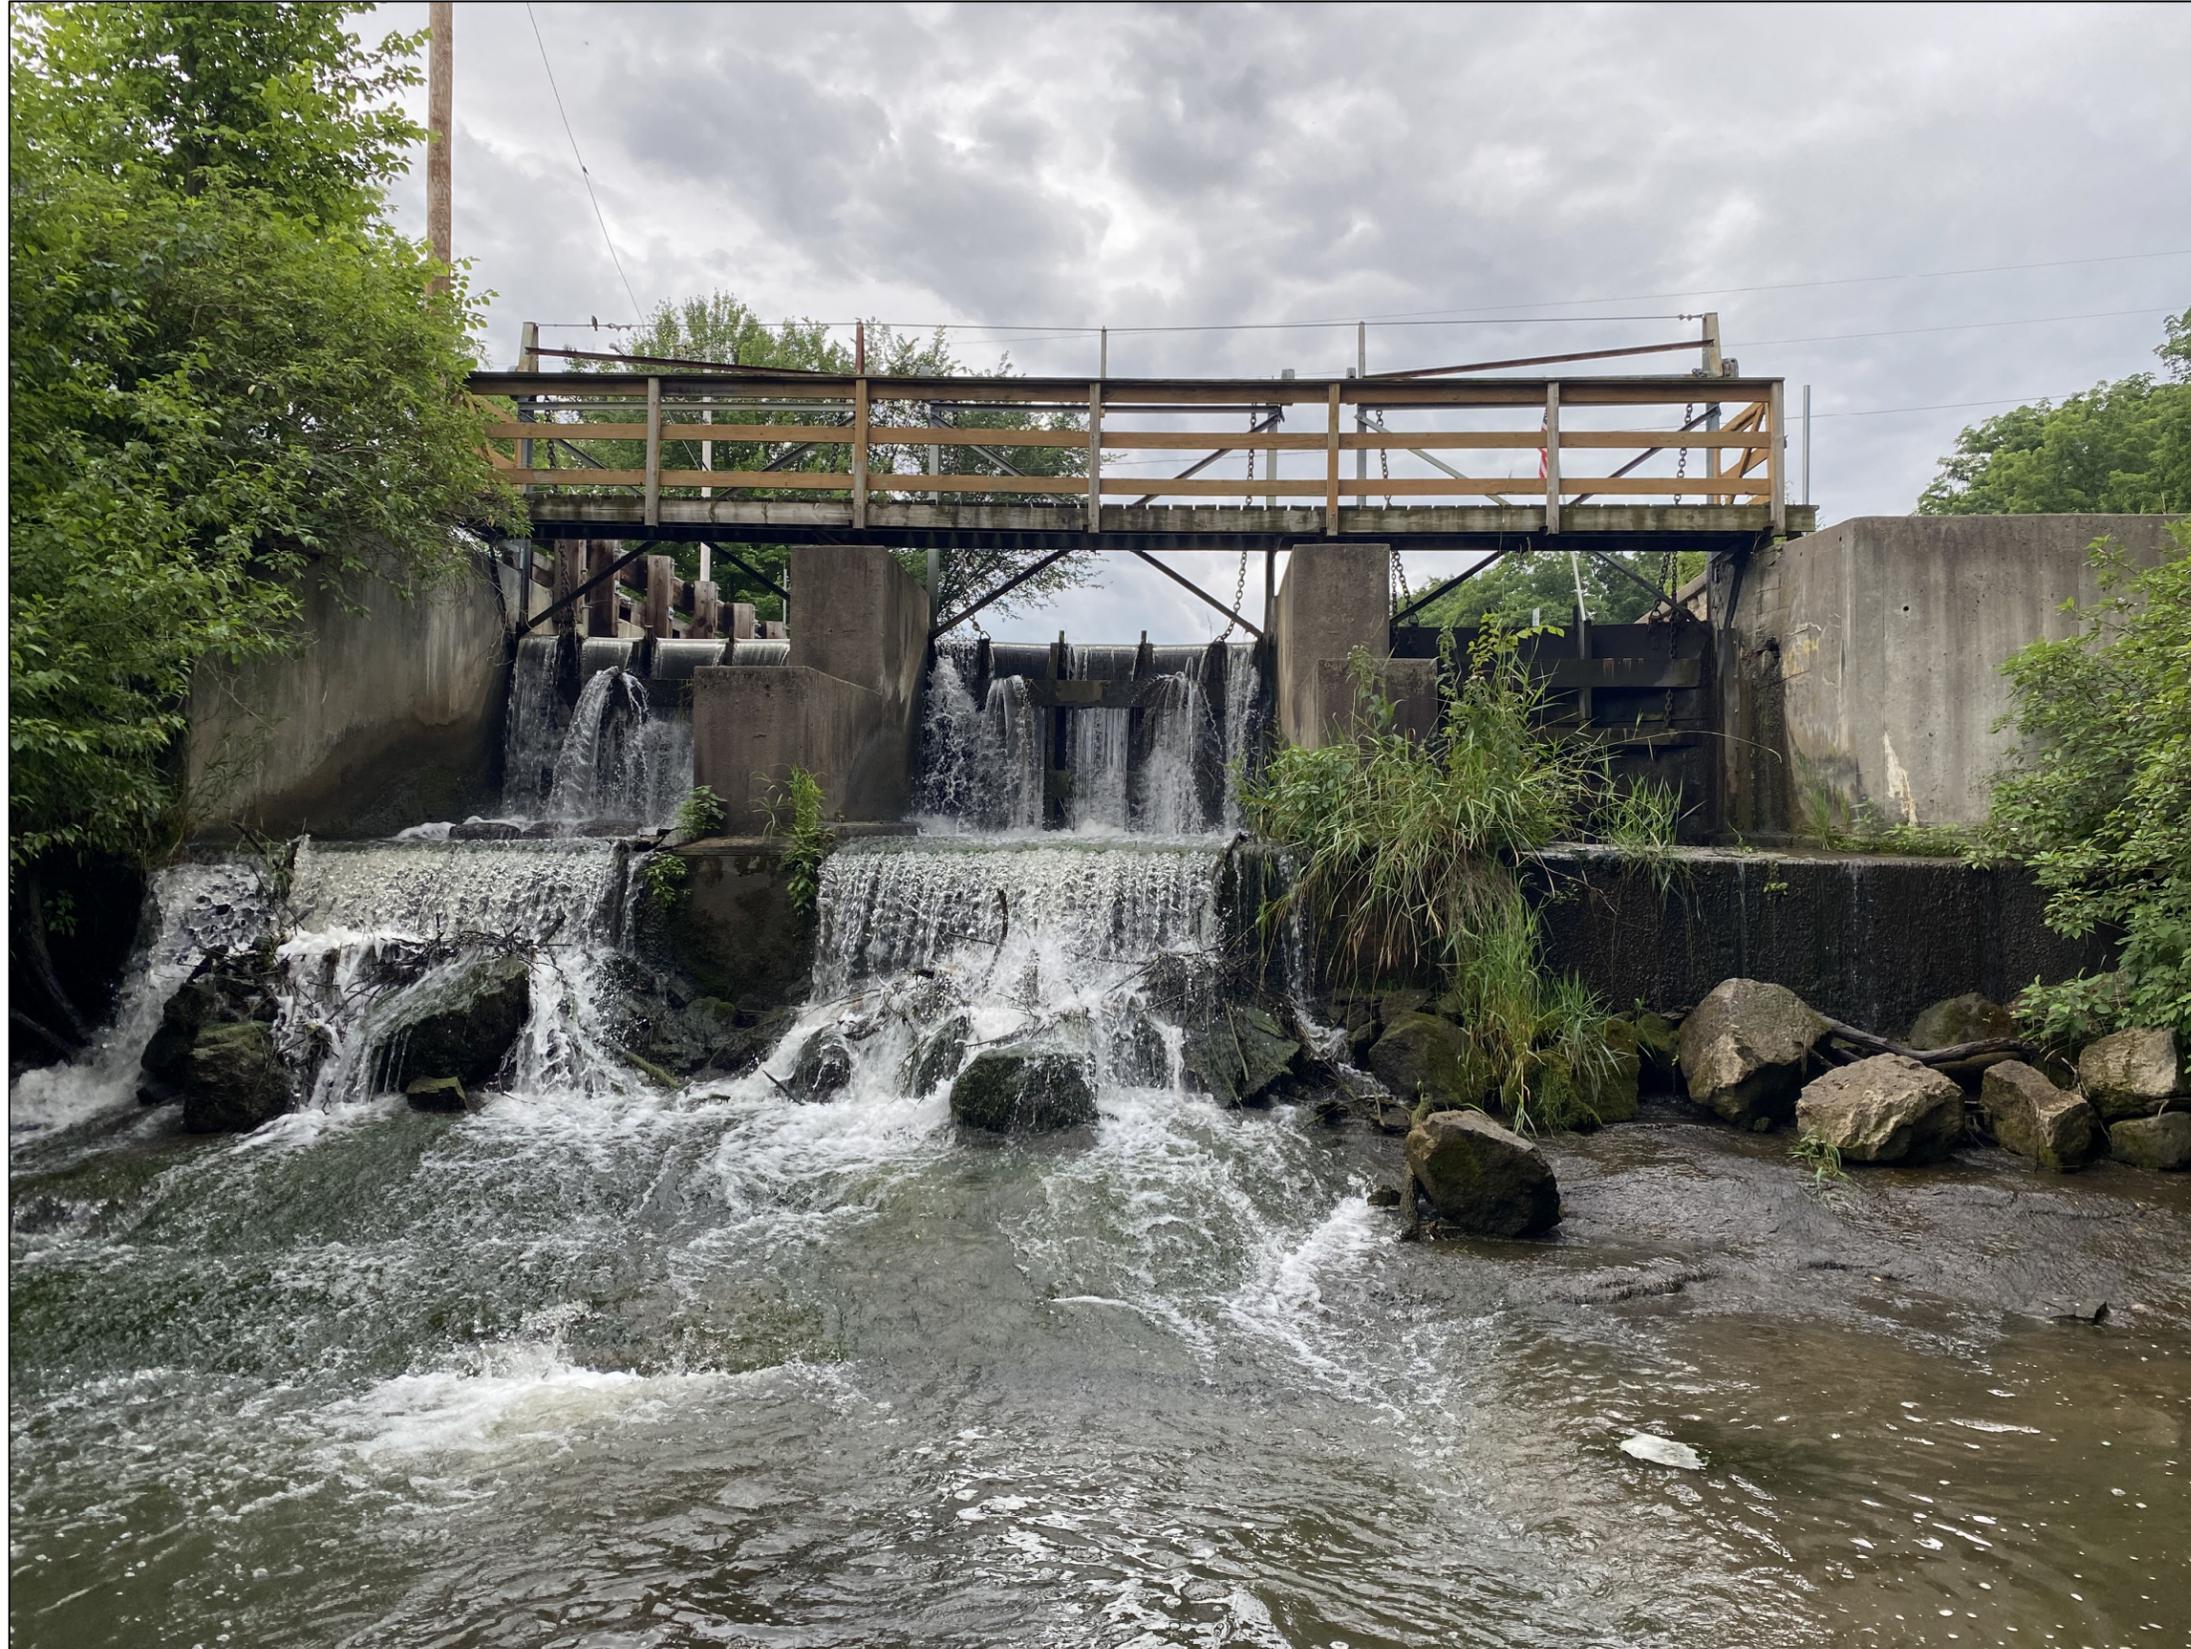
### Photo 6

Area lying northerly of concrete spillway. Area to be supplemented with riprap. View facing southerly from middle of creek
