**2017 Capital Investment Request
Minnesota Veterans Home - Hastings**

Minnesota Veterans Homes – Hastings Facility Summary

Asset Preservation Requested Item Summary – Hastings

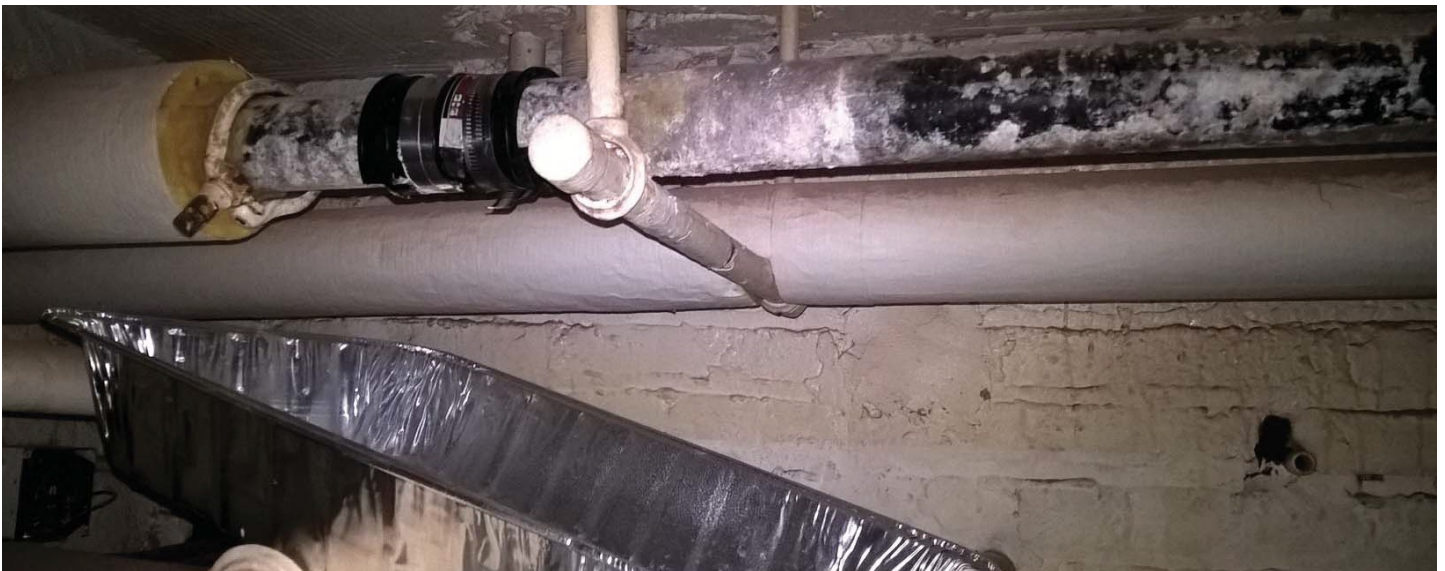
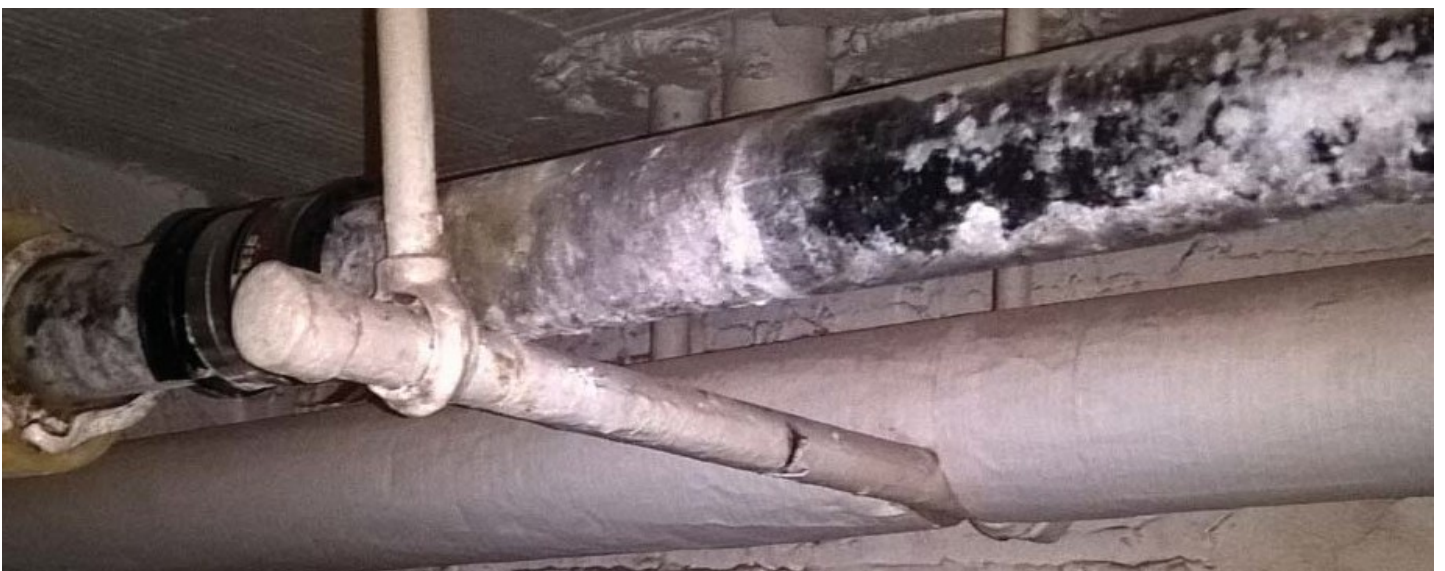
1. Domestic Cold Water Line Replacement - Building 23

Facility Condition Assessment Rating: **2 - Poor**

Replacement of domestic cold water line in Building 23 and C1 tunnel. The galvanized water line has had a number of pin-hole leaks in the past. The water line is located in the ceiling and leaks will cause a serious safety concerns over electrical equipment, along with other related building damage. Copper, PVC, - Systems have been installed and modified for more than 60 years. Some original waste piping still is in use. Some domestic water piping has been replaced. Majority of the pipe and fixtures are original and need replacement due to age and condition.

Domestic cold water line leaks and is causing corrosion and wear on the piping and surrounding areas.

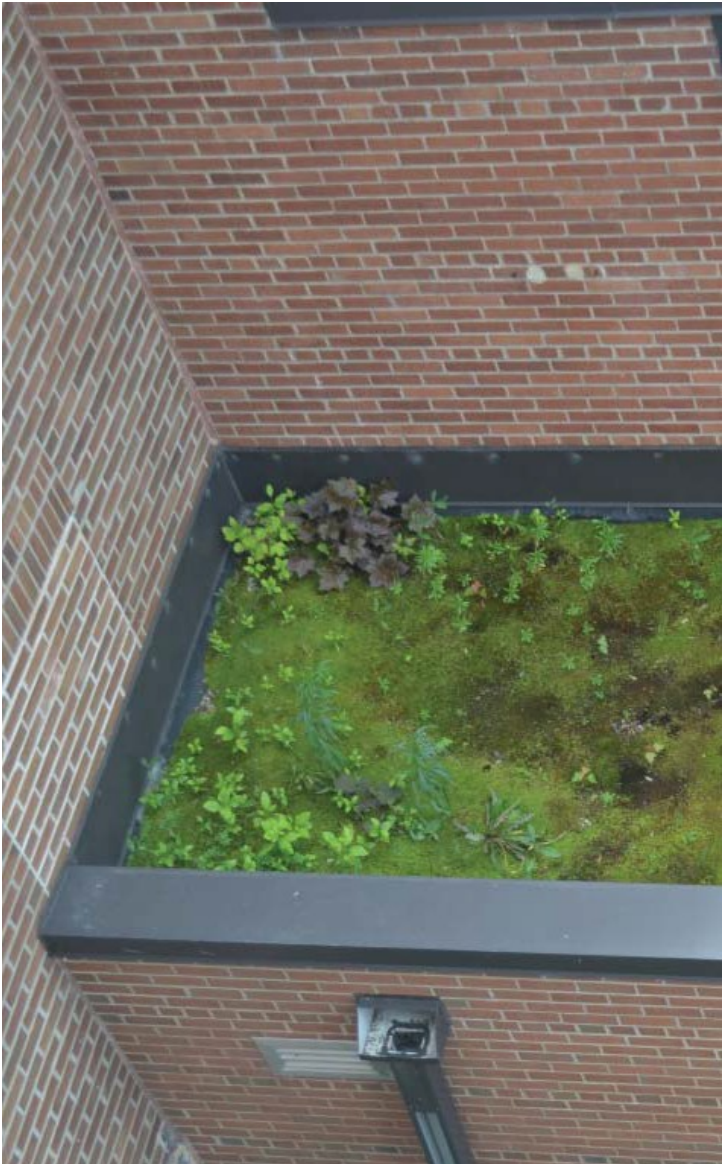
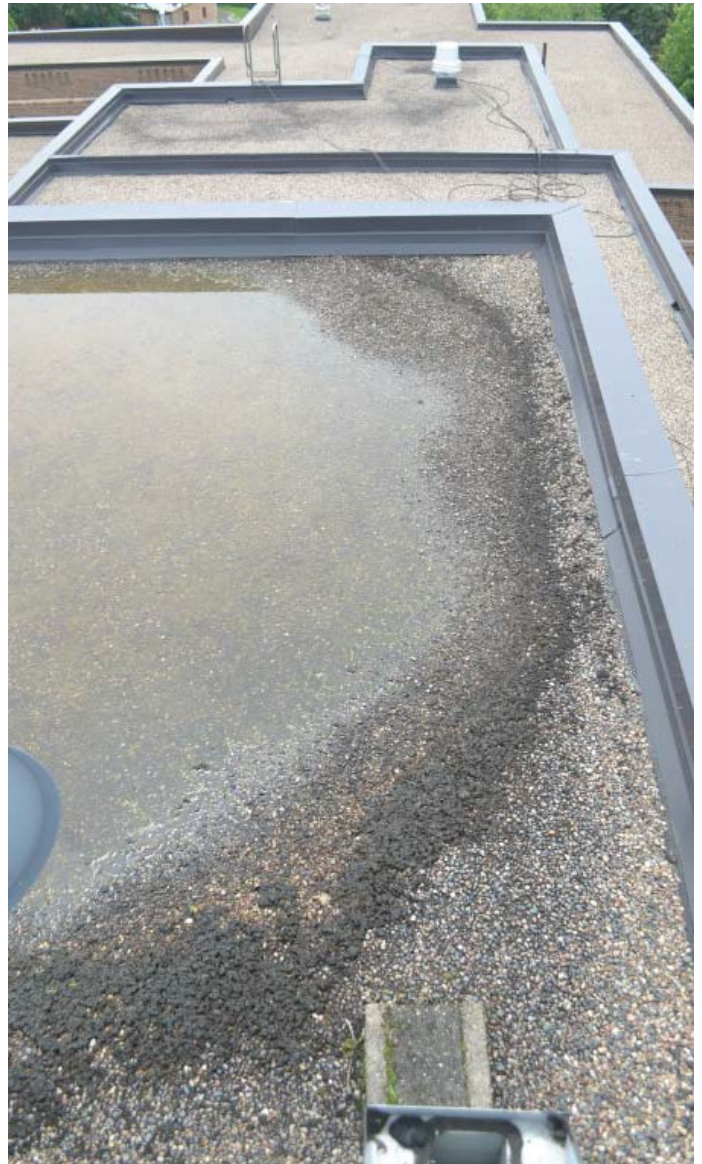
2. Roof Replacement - Building 23

Facility Condition Assessment Rating: 3 - Fair

Major System: Ballasted built-up roof - The system is in fair condition. Replacement of sections were completed in 2003 and 2008. Western portion of roof is still in good condition. The majority of roof is in need of replacement (3/4 of 33,143 total roof area)

- pea gravel does not cover completely
- vinyl liner is separating from tar on edges
- moisture is holding on roof and allowing plants to grow

Roof is not sloped correctly in places. Moisture is collecting on the roof and allowing plants to grow. Replacement is needed for all but the western portion.

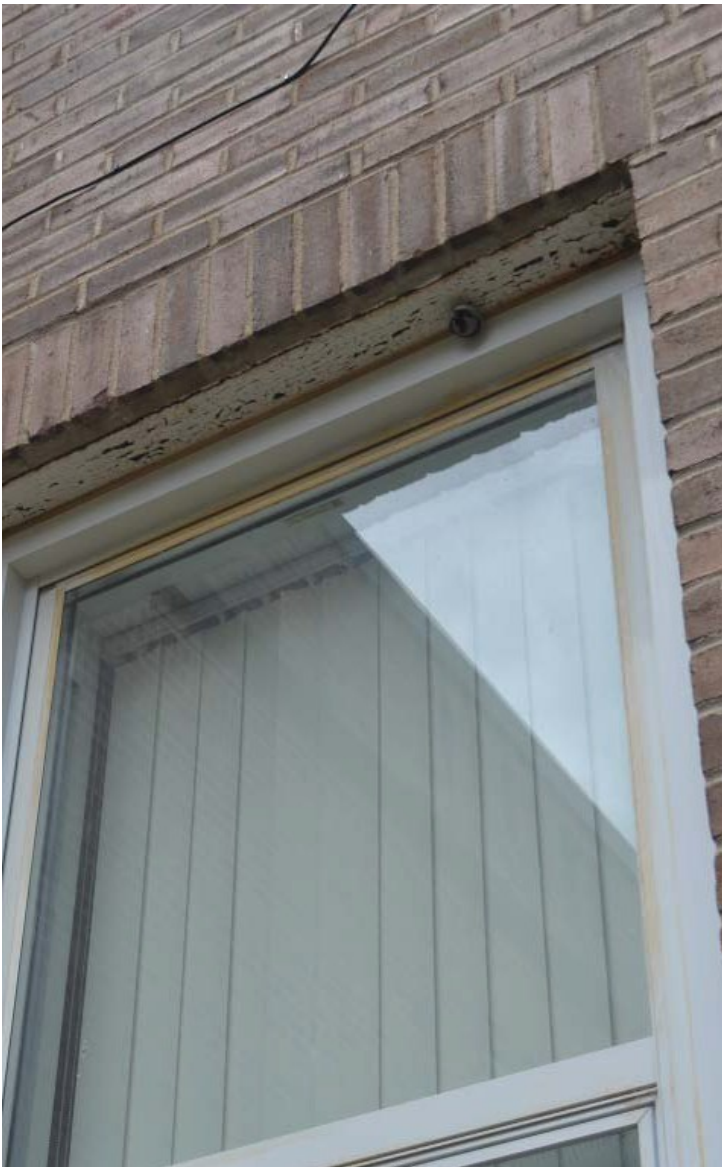
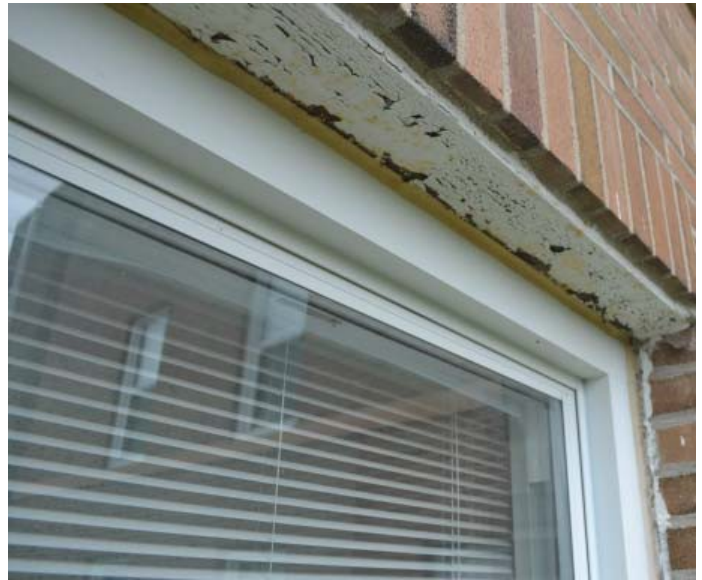
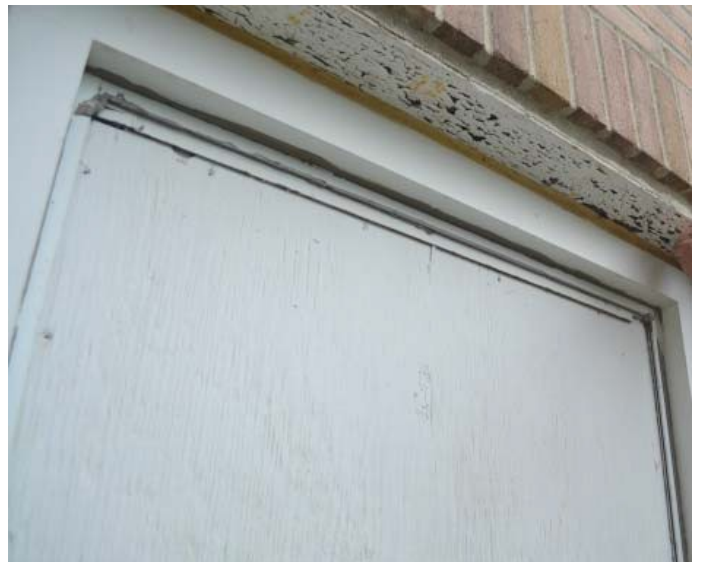
3. Window Replacement - Building 23

Facility Condition Assessment Rating: 2 - Poor

Building 23 FCA Individual window system is rated as poor. They are a challenge to operate and maintain and have less than 3 years remaining.

The exterior windows for Building 23 are worn and difficult to operate. Many of the windows are unable to be opened and closed.

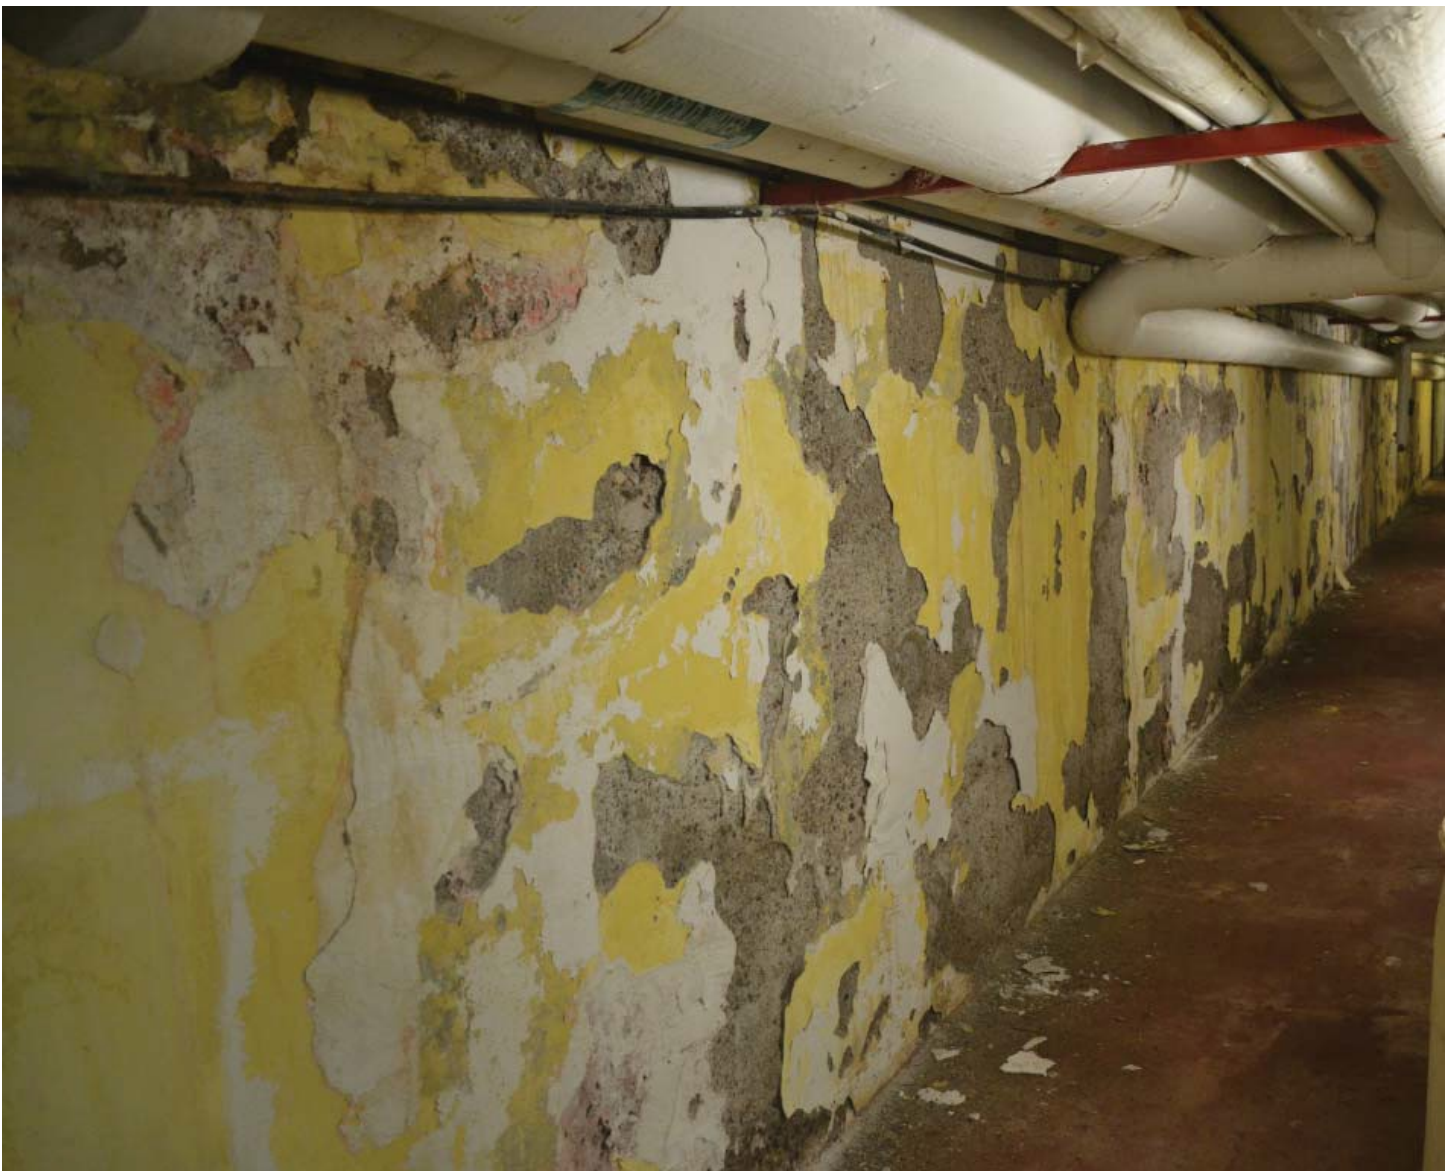
4. Tunnel Wall Repair - Tunnel E

Facility Condition Assessment Rating: 2 - Poor

FCA Tunnel E concrete basement walls are rated in poor condition. The walls are spalling in numerous locations due to water infiltration. The walls should be sealed and re-poured in order to prevent further damage. Approximately 40% of the walls need to be addressed.

The tunnel walls are cracking and falling apart due to water damage. Walls should be repaired and resealed in order to prevent further damage.

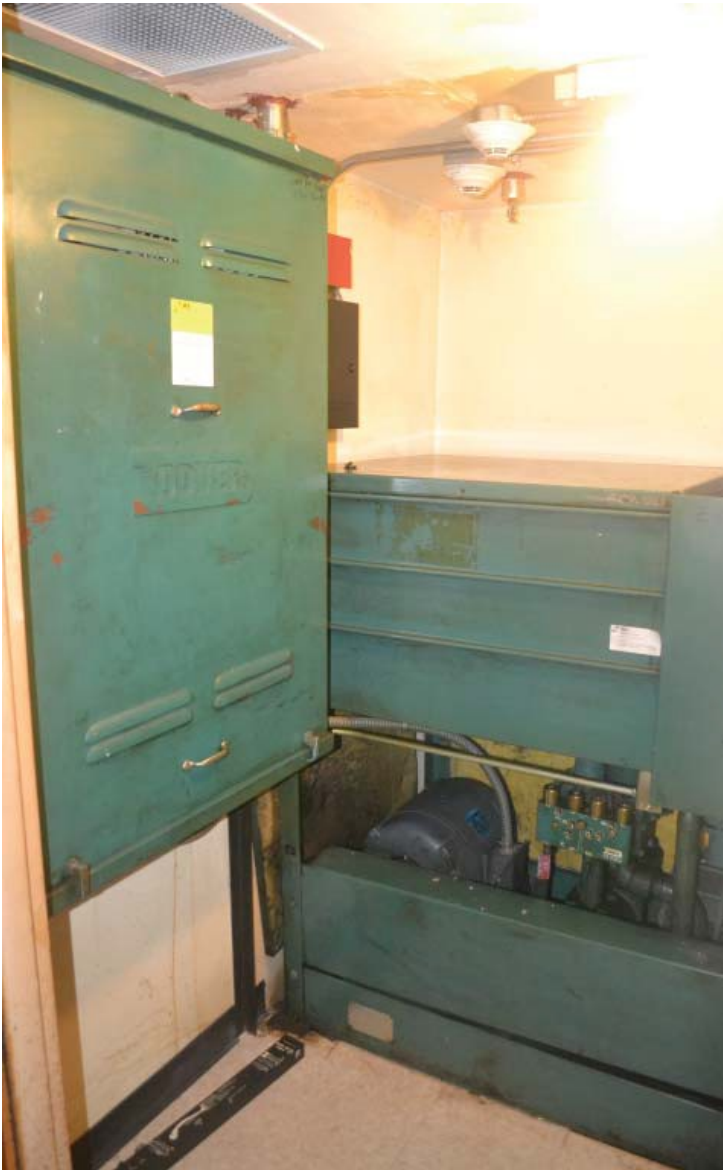
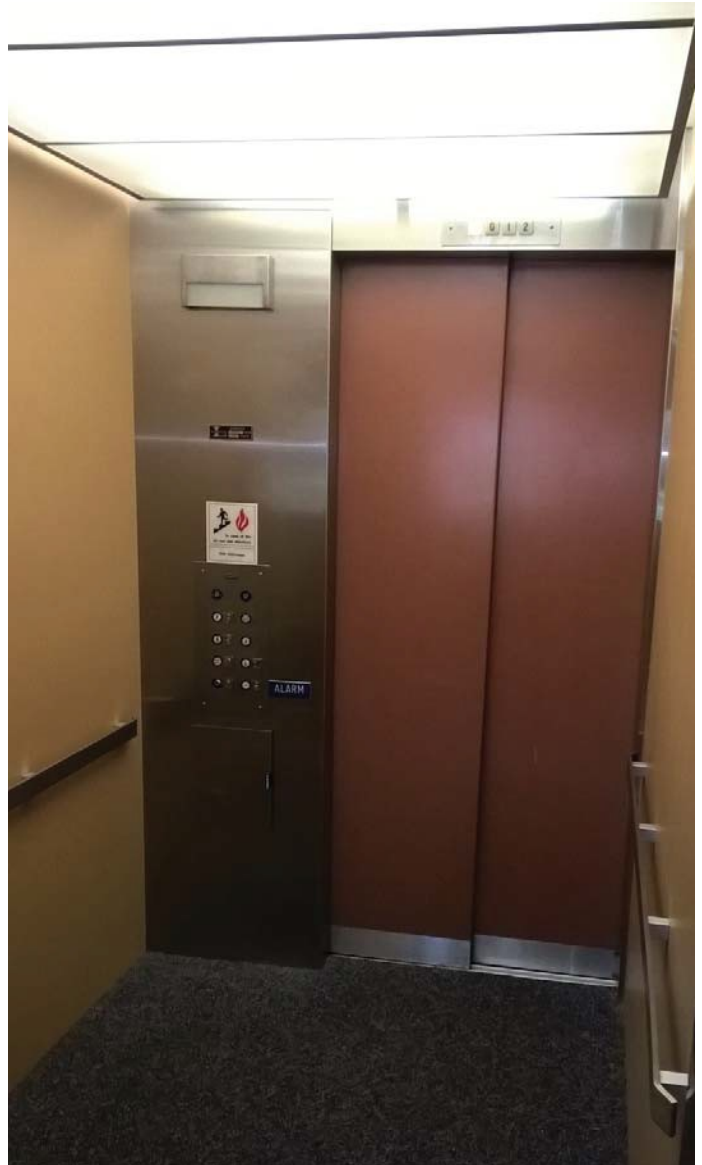
5. Elevator Replacement - Building 25

Facility Condition Assessment Rating: 2 - Poor

Building 25 FCA elevators are rated as poor. The hydraulic elevator was installed in 1980 and is in poor condition based on age. Less than 3 years remaining.

Elevator hydraulics are aged and obsolete. Rated as Poor based on age and condition and should be replaced.

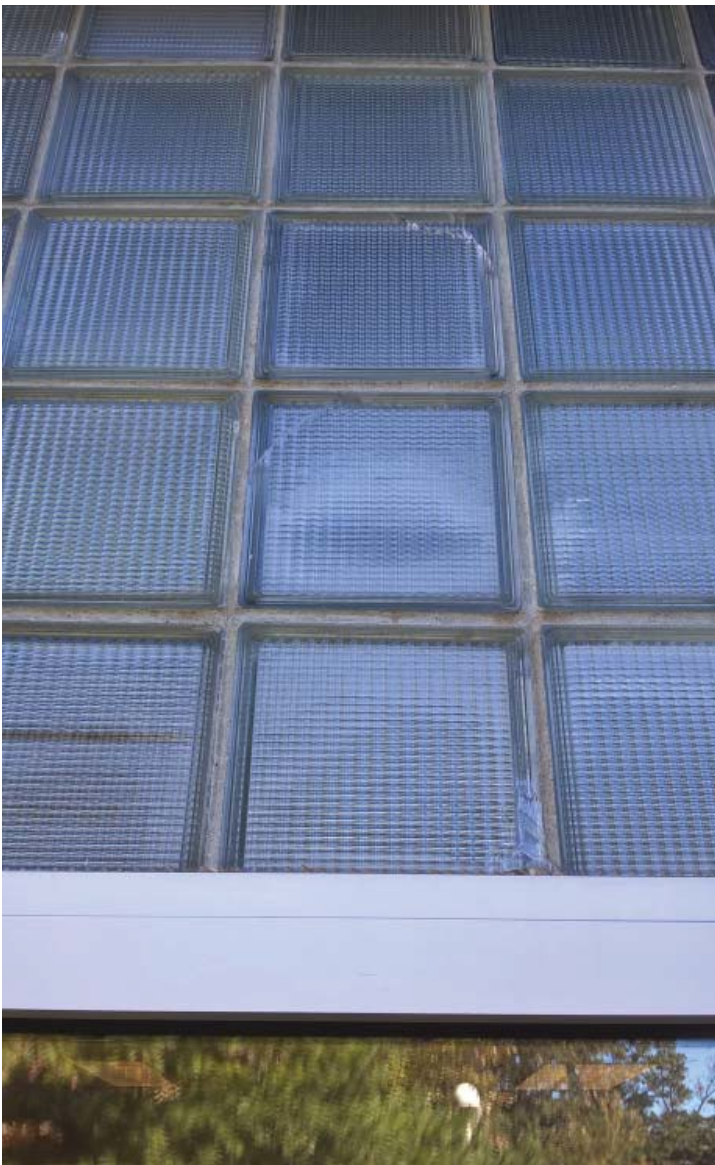
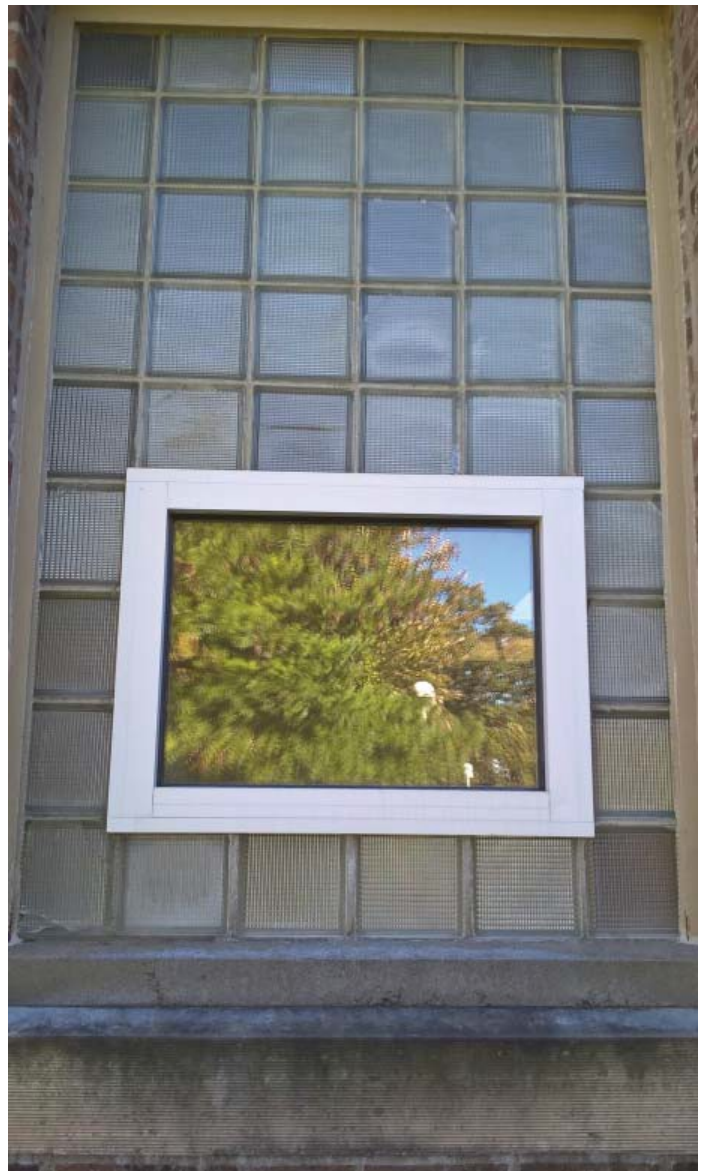
6. Window Replacement - Building 20

Facility Condition Assessment Rating: **2 - Poor**

Building 20 FCA Exterior window system is fair overall due to some being replaced in 2006. The remaining windows are glass block that is original to the structure. Approximately 20% of the glass block is damaged and in need of replacement. One section has a broken seal allowing water to infiltrate the structure

Glass block is cracked in many areas and is in need of replacement. Some of the windows are leaking to the interior.
