Duluth Aerial Lift Bridge No. L6116- Funding Statement

Duluth Aerial Lift Bridge- Bridge No. L6116

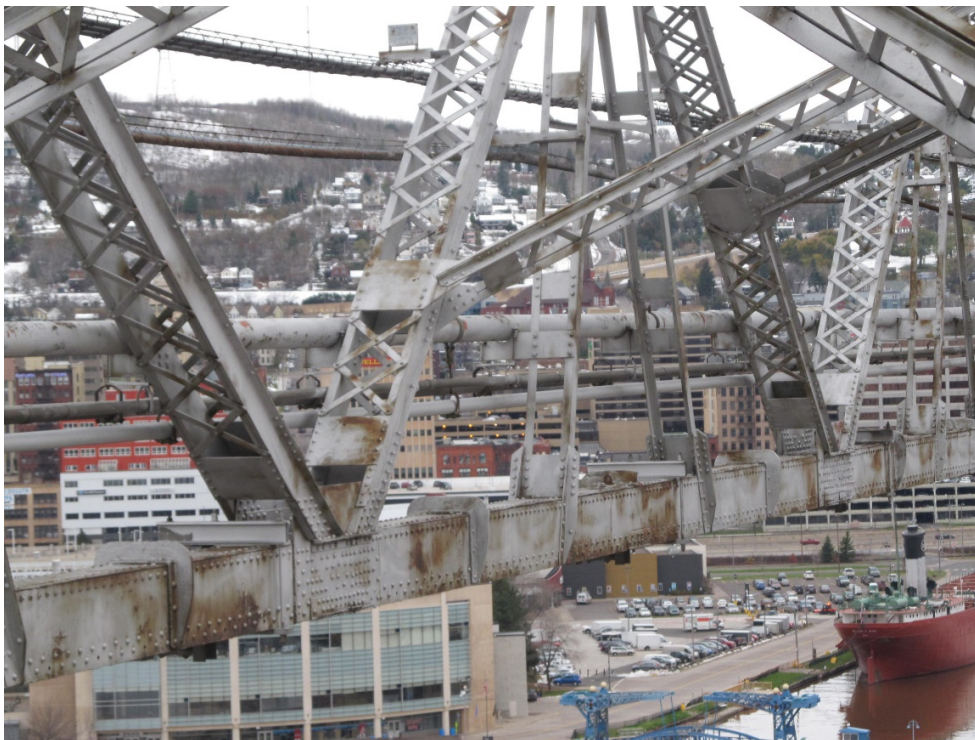
- The bridge's iconic overhead truss is experiencing significant areas of rust, corrosion, and loss of steel section, and requires structural steel repairs and replacement of the failed corrosion protection paint coating. The overhead truss spans nearly 400 feet at a height over 160 feet from water. Because the lift span truss nests into the overhead truss to provide a full height lift for shipping traffic, most of this work must be performed during the winter when shipping traffic under the bridge is suspended. In addition to needing to perform much of the work during the more costly winter season, the failed corrosion protection paint system contains lead which imposes further containment, regulatory and cost requirements upon the work.

Corrosion, Steel Section Loss and the need for Repairs and New Protective Paint Coating System to the Overhead Truss

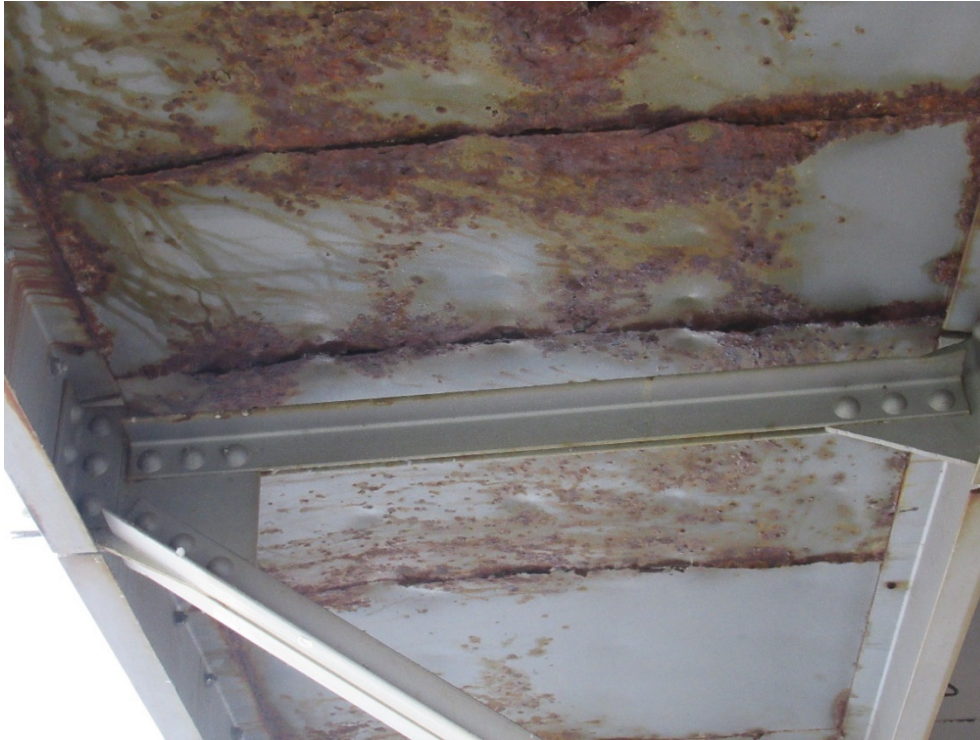
- The pedestrian sidewalks suspended off each side of the bridge's lift span truss require substantial reconstruction work. The sidewalk structural steel support system and concrete filled steel sidewalk grating is heavily deteriorated resulting in ongoing repairs to maintain safe pedestrian travel. To affect a proper repair, the sidewalk grating and much of its underlying steel support system requires replacement.

Steel Section Loss and Corrosion to Underside of Supported sidewalk on Lift Span

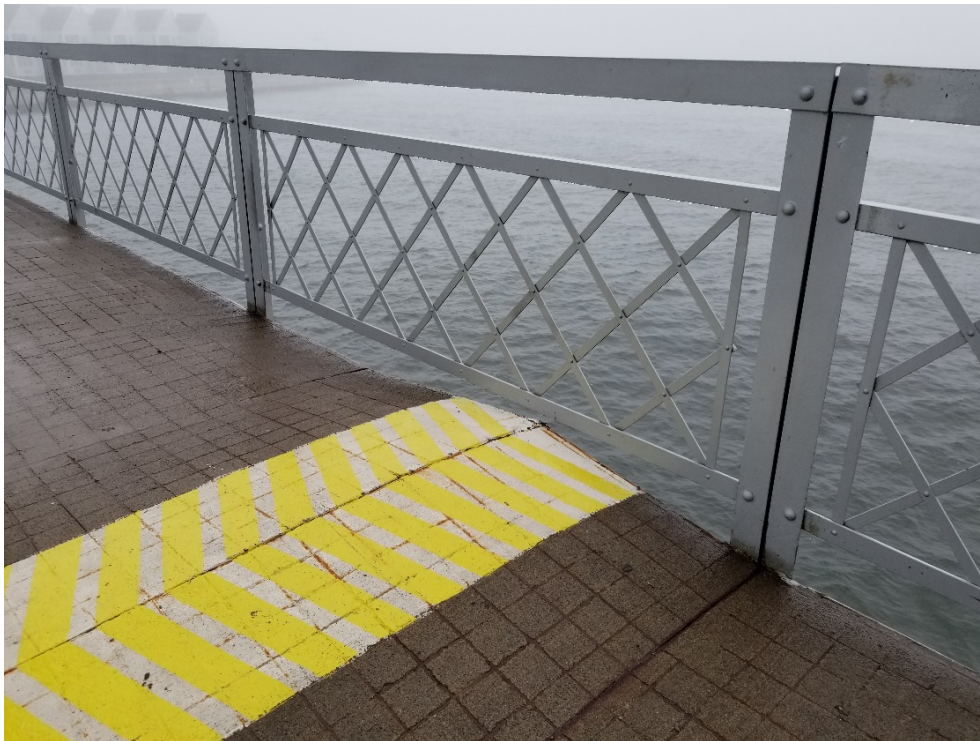
Trip Hazards from Deteriorating, Heaving Sidewalk Panels on the Lift Span are Prevalent

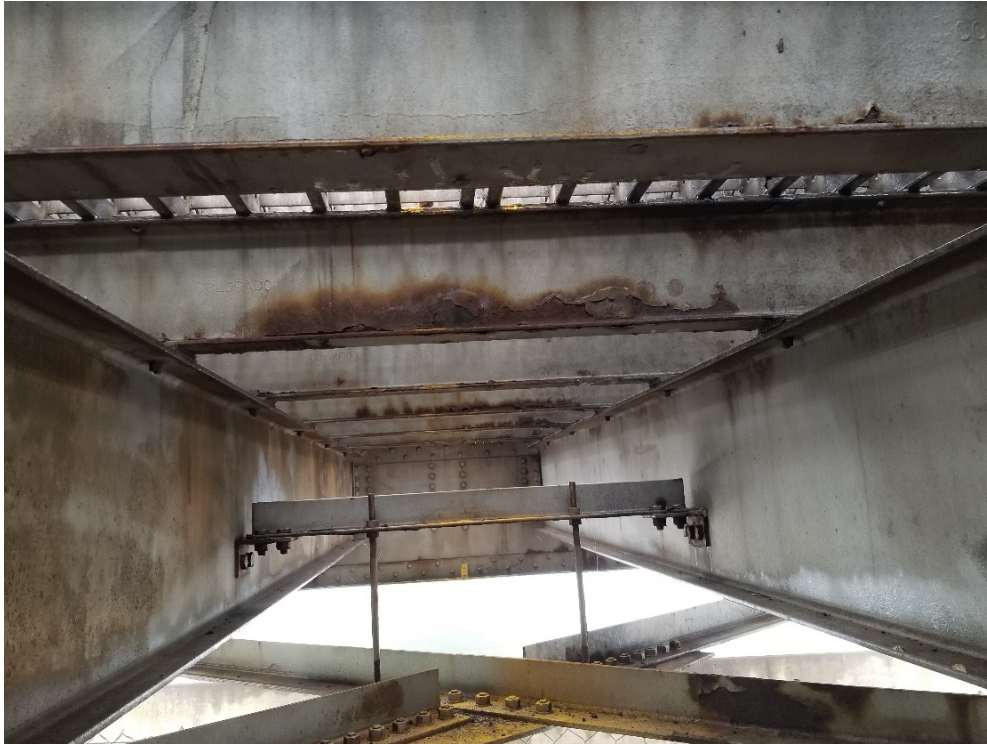
- The lower region of the lift span truss (region exposed to roadway salts) was last repainted in 2001. The protective paint system is nearing the end of its life, allowing corrosion of steel elements to occur. To avoid costlier repairs to the steel elements, and mitigate present steel section loss, structural steel repairs and replacement of the corrosion protection paint system is necessary in the near term.

Rust and Corrosion from Road Salts is Necessitating Steel Repairs and New Protective Paint System to the Lower Regions of the Bridges Lift Span Truss

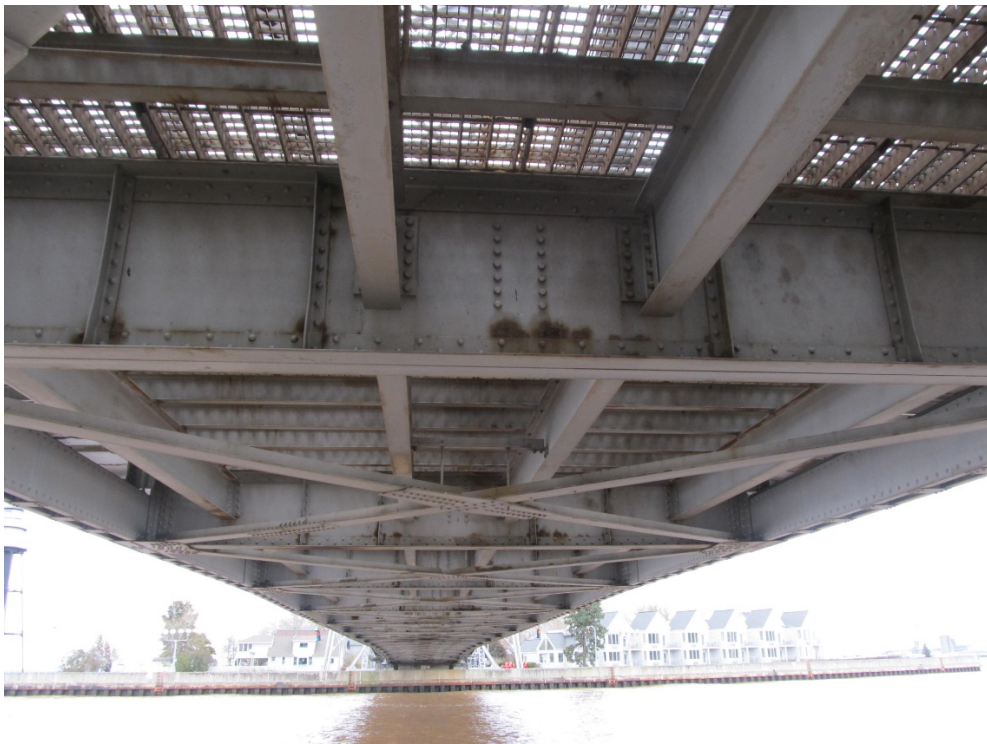
Additional View- Underside Lift Span Truss Protective Paint System Failure

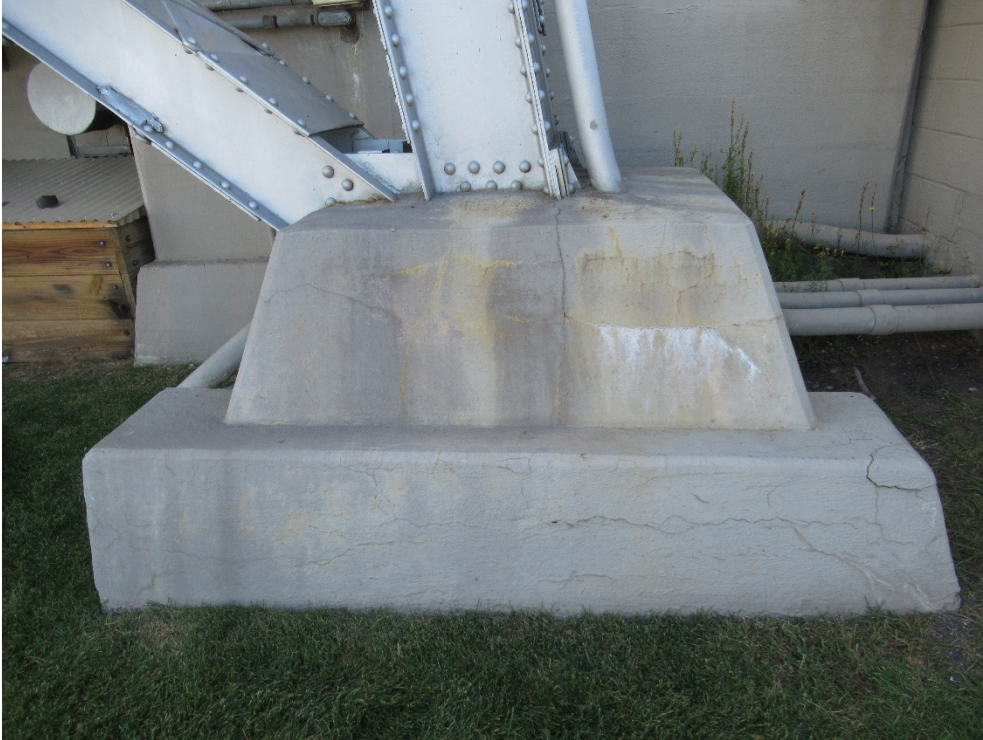
- Spalling of the concrete surfaces of the abutment wingwalls and tower base pedestals has begun to accelerate. Repair of these locations will preserve structural soundness and mitigate exponentially increasing costs from additional deterioration expounded by freeze-thaw cycles.

Cracking and Delaminations in Southwest Corner Tower Leg Concrete Footing

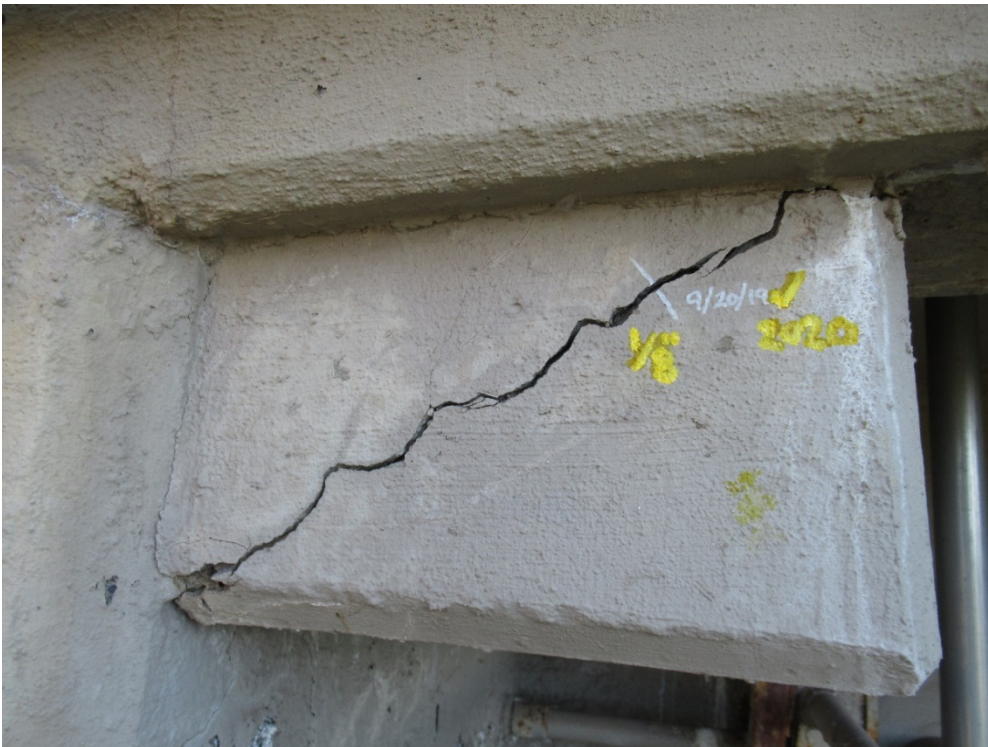
Cracking in Northwest Corner Concrete Sidewalk Support Beam
