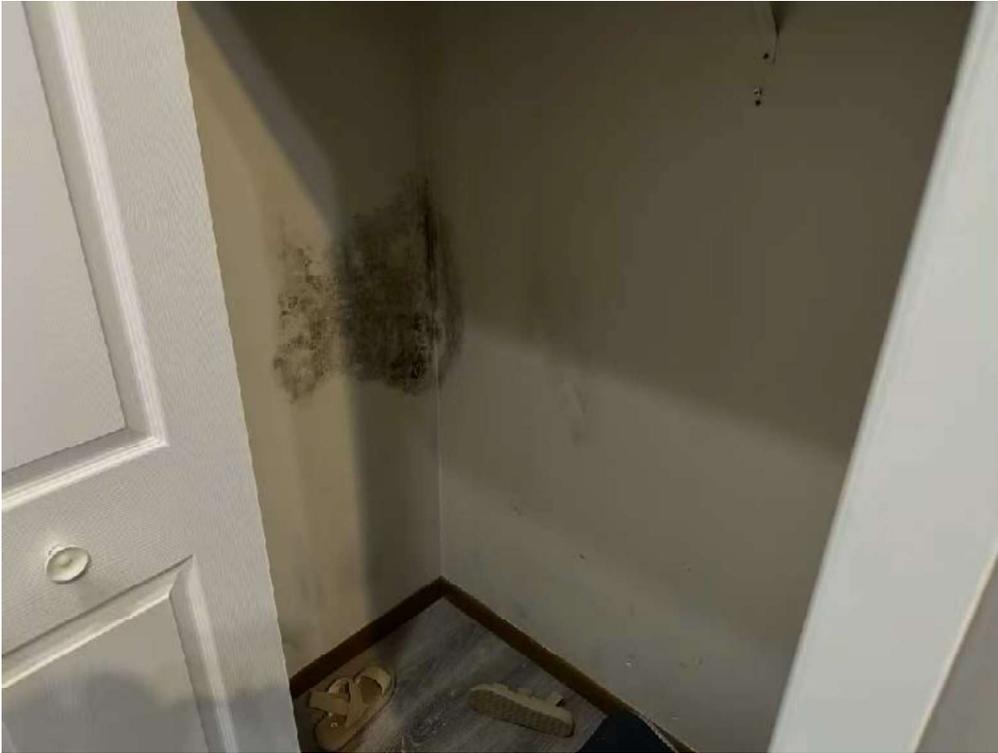
A-15: NORTHWEST CORNER IN ENTRY CLOSET

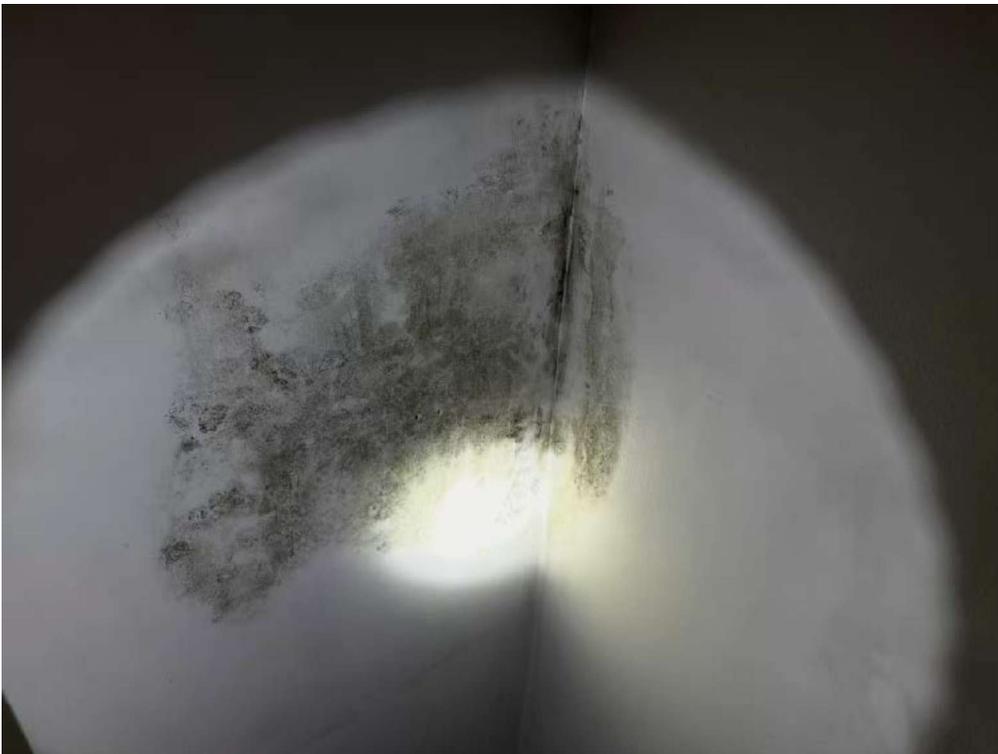
A-16: VIEW OF AREA OF DISCOLORATION ON WALL AT CORNER

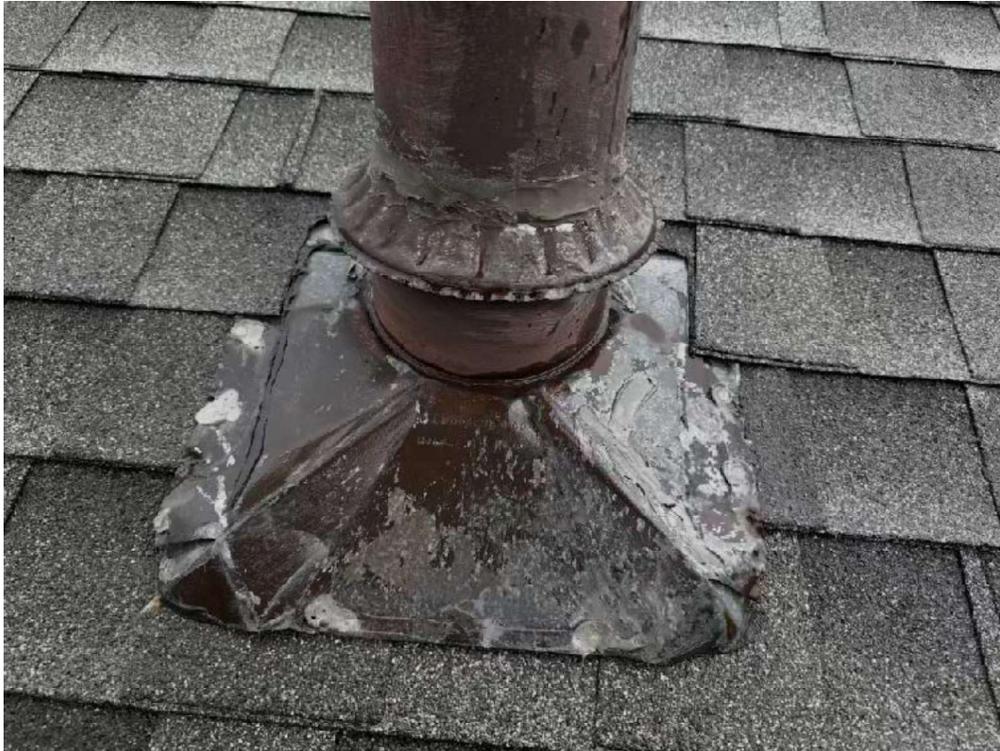
A-27: BASE OF FURNACE VENT, AGED AND DAMAGED METAL

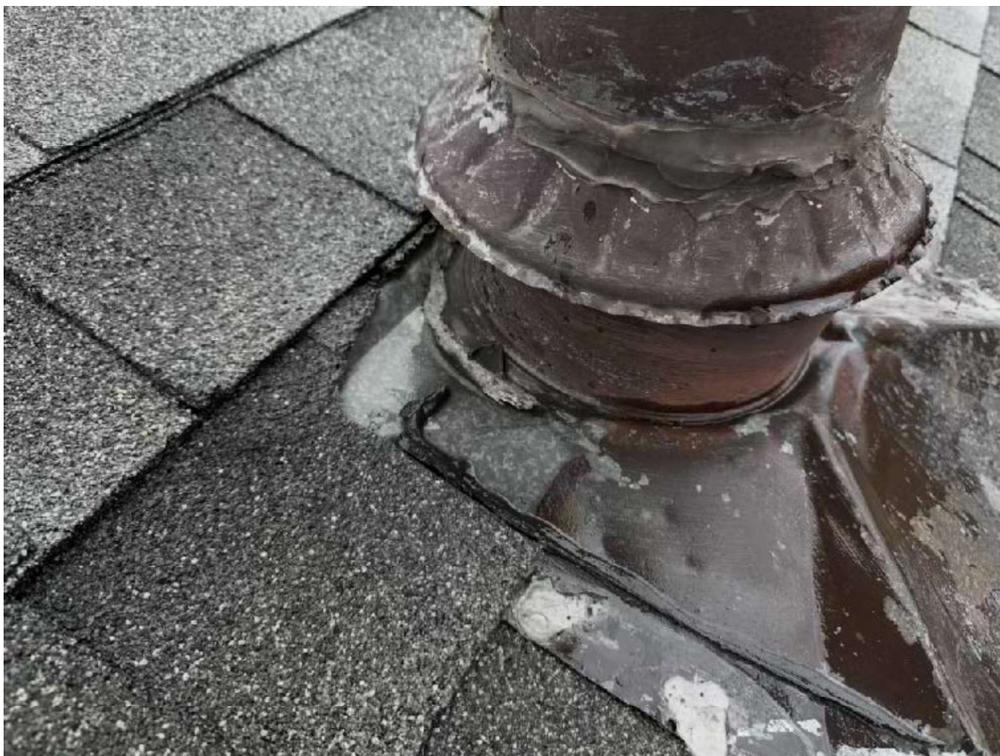
A-28: UPPER CORNER OF FURNACE VENT AND EXISTING FLASHING

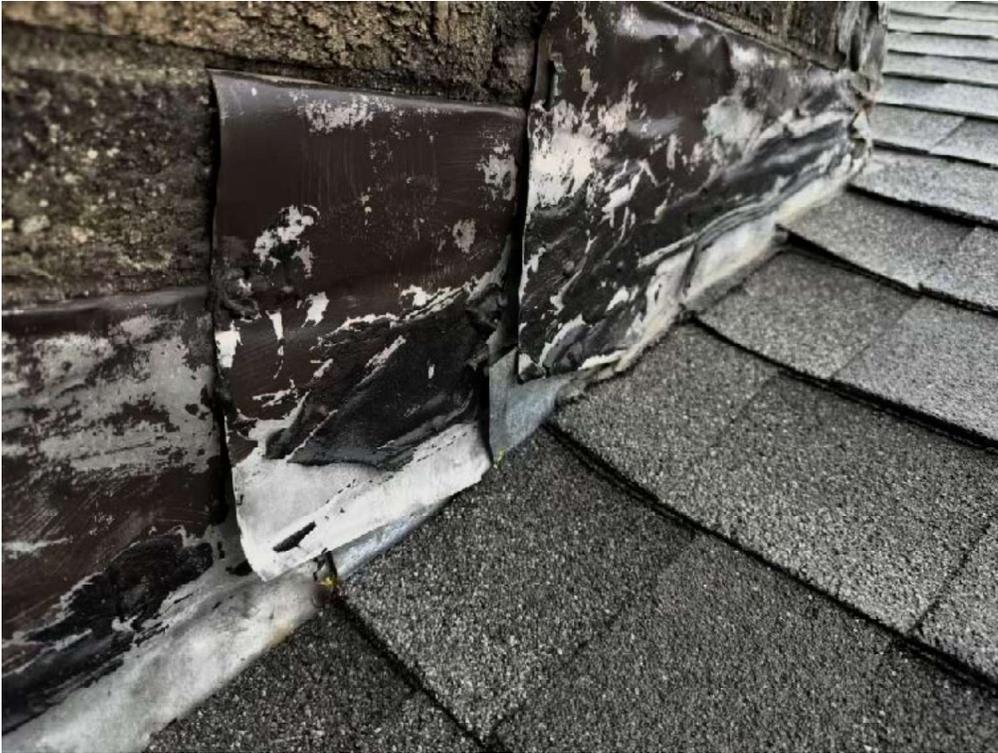
A-37: VIEW OF FLASHING ALONG EAST SIDE OF CHIMMNEY

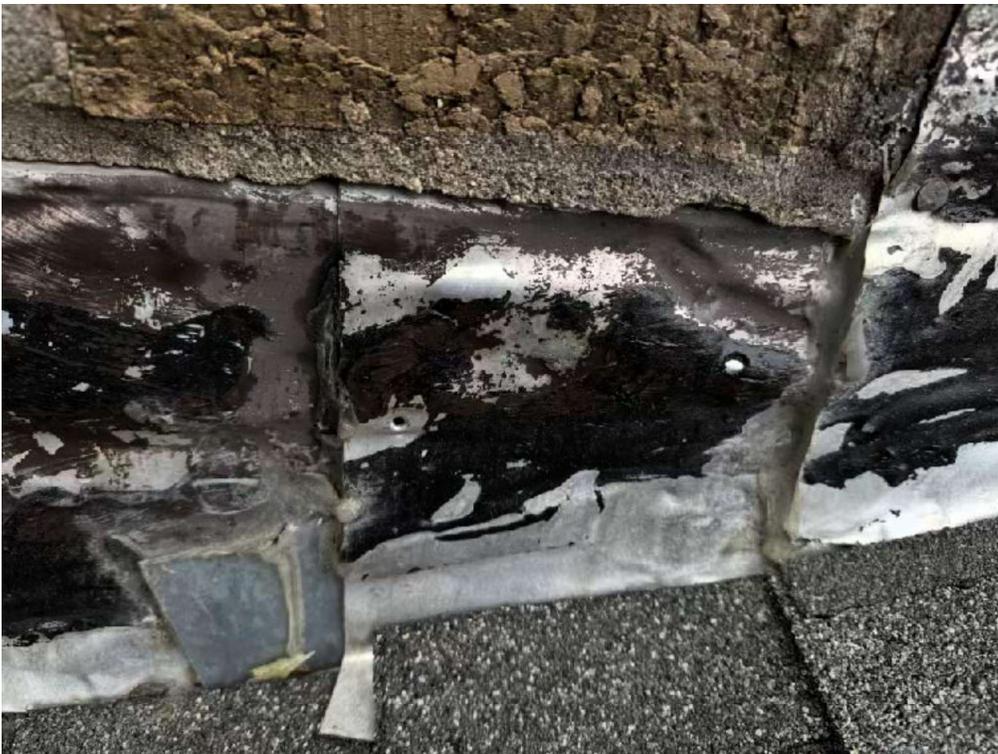
A-38: OLDER DAMAGED FLASHING ALONG SIDE OF CHIMNEY

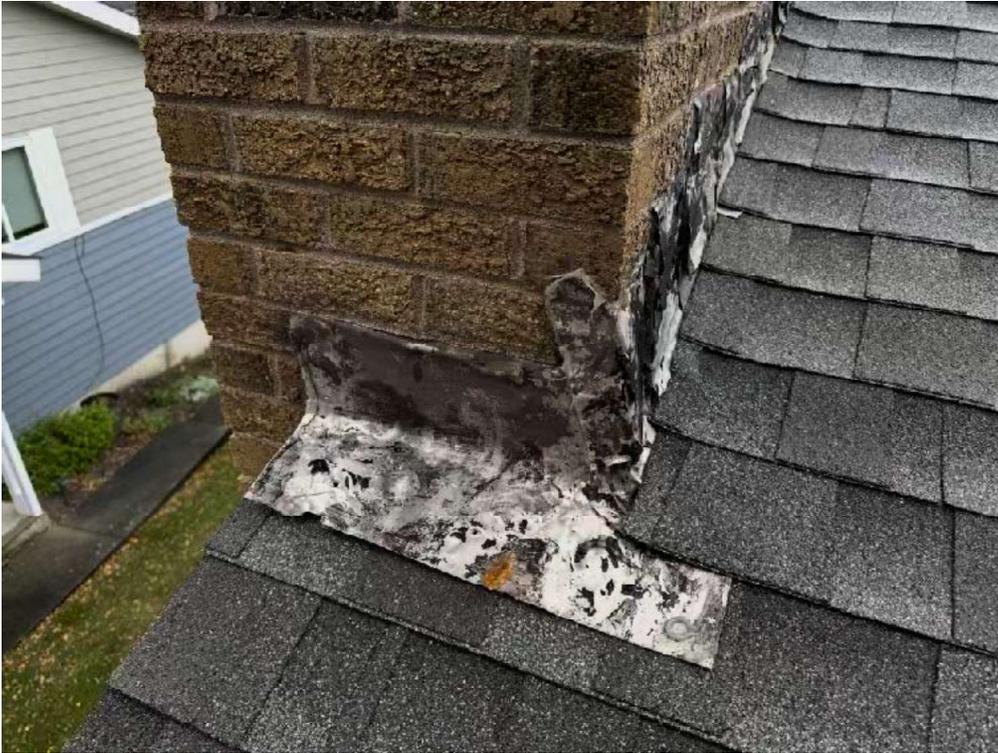
A-39: SOUTH SIDE OF CHIMNEY AT ROOF

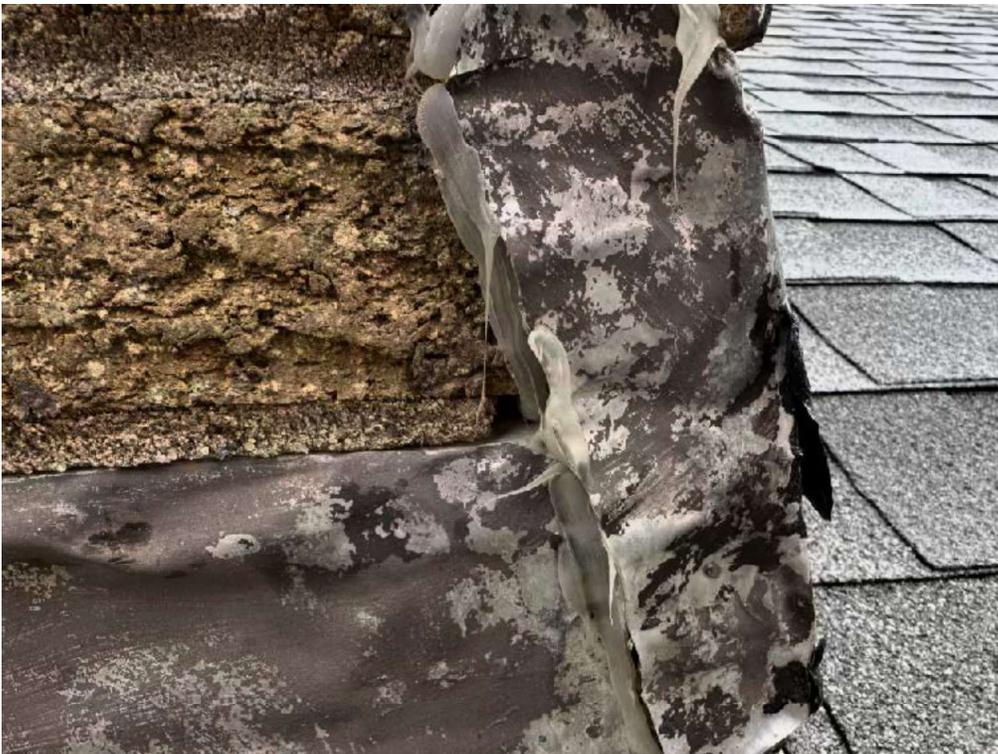
A-40: GAP AT INTERSECTING FLASHING PIECES AT SOUTHEAST CORNER

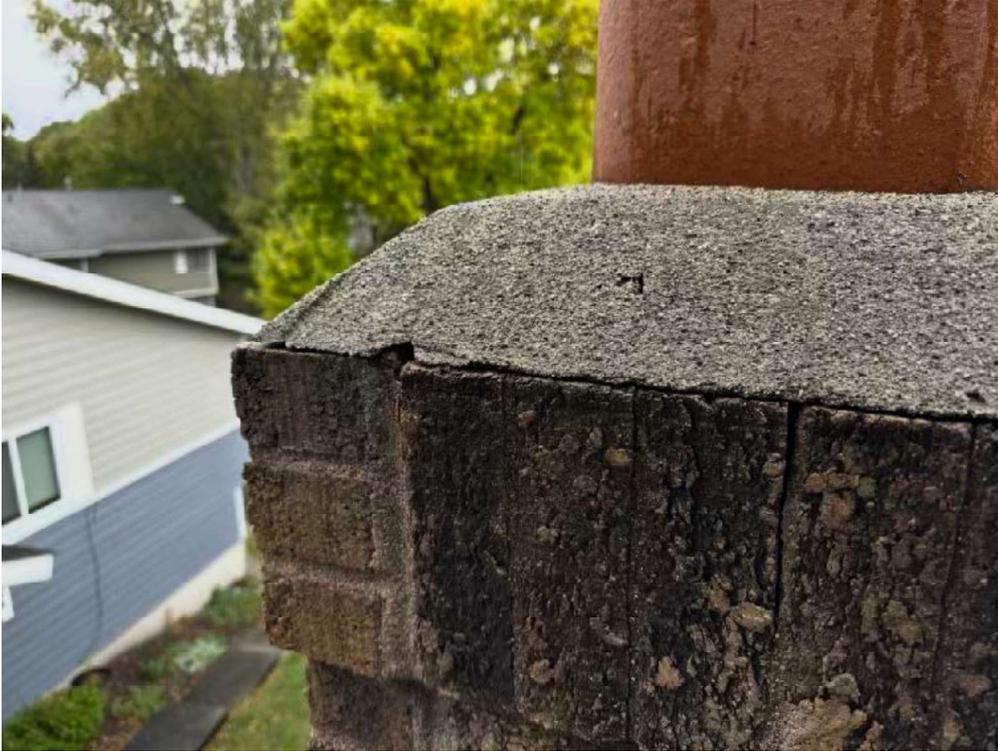
A-43: SOUTHWEST CORNER, GAP BETWEEN CAP AND BRICK

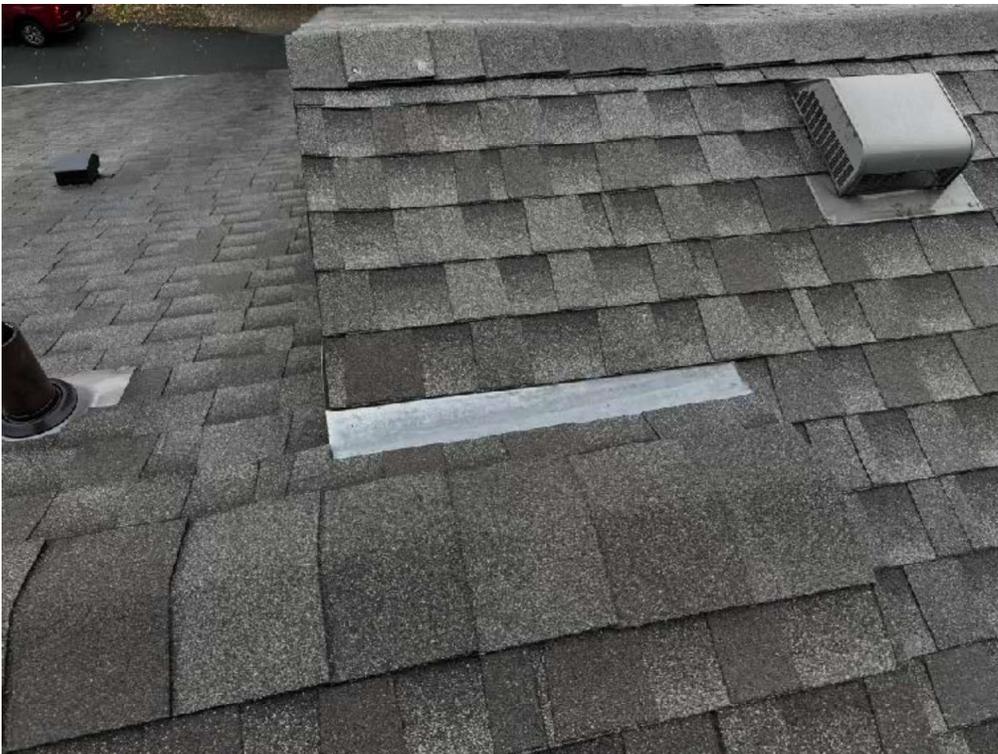
A-44: VIEW OF TRANSITION AT ROOF FIELDS BETWEEN UNITS

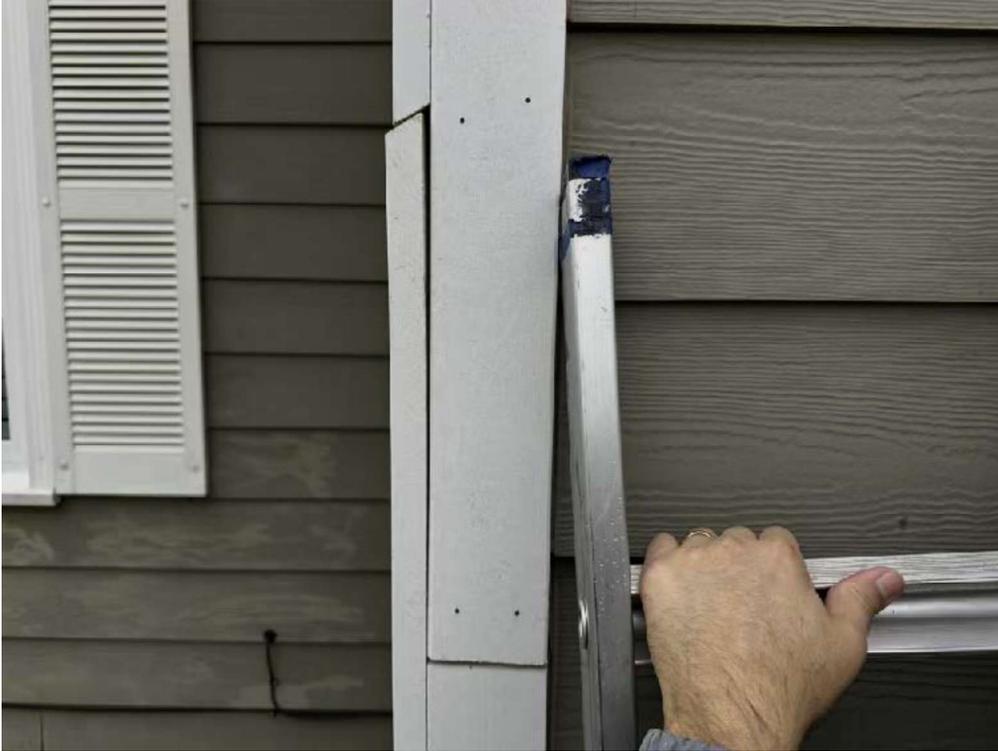
A-61: GAPS AT INTERSECTING JOINTS IN TRIM BOARDS, NORTHWEST CORNER

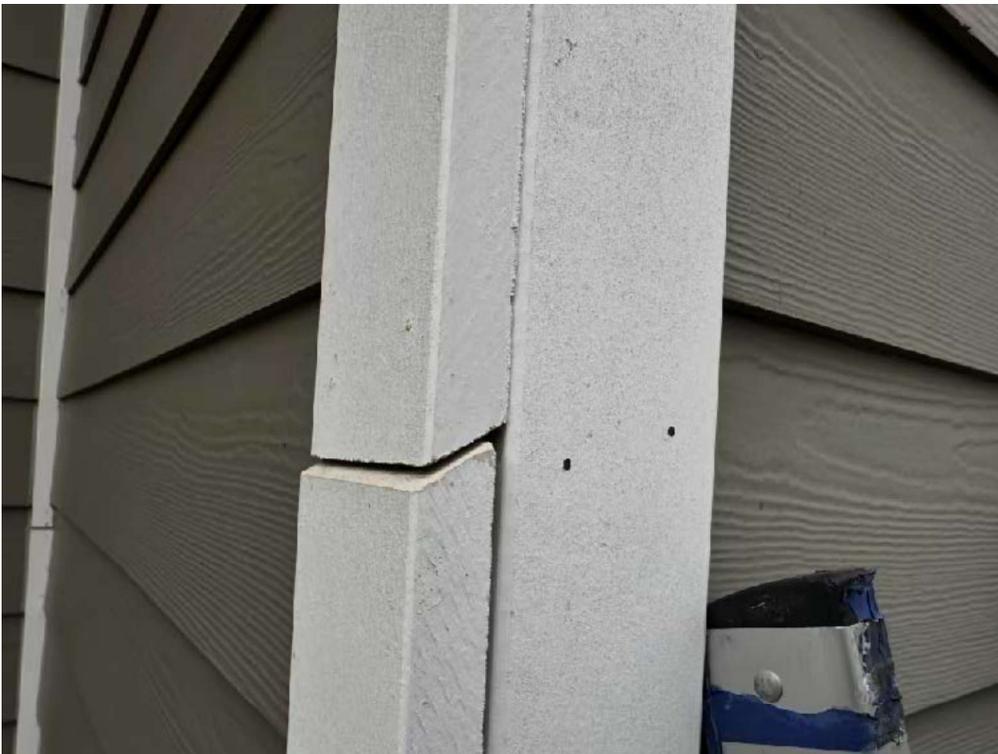
A-62: VIEW OF GAPS AND SHRINKAGE OF TRIM BOARDS
