A Minnesota Department of Public Safety
State Fire Marshal Division Report

LESSONS LEARNED: The November 2019 Minneapolis High-Rise Fire

Narrative Report

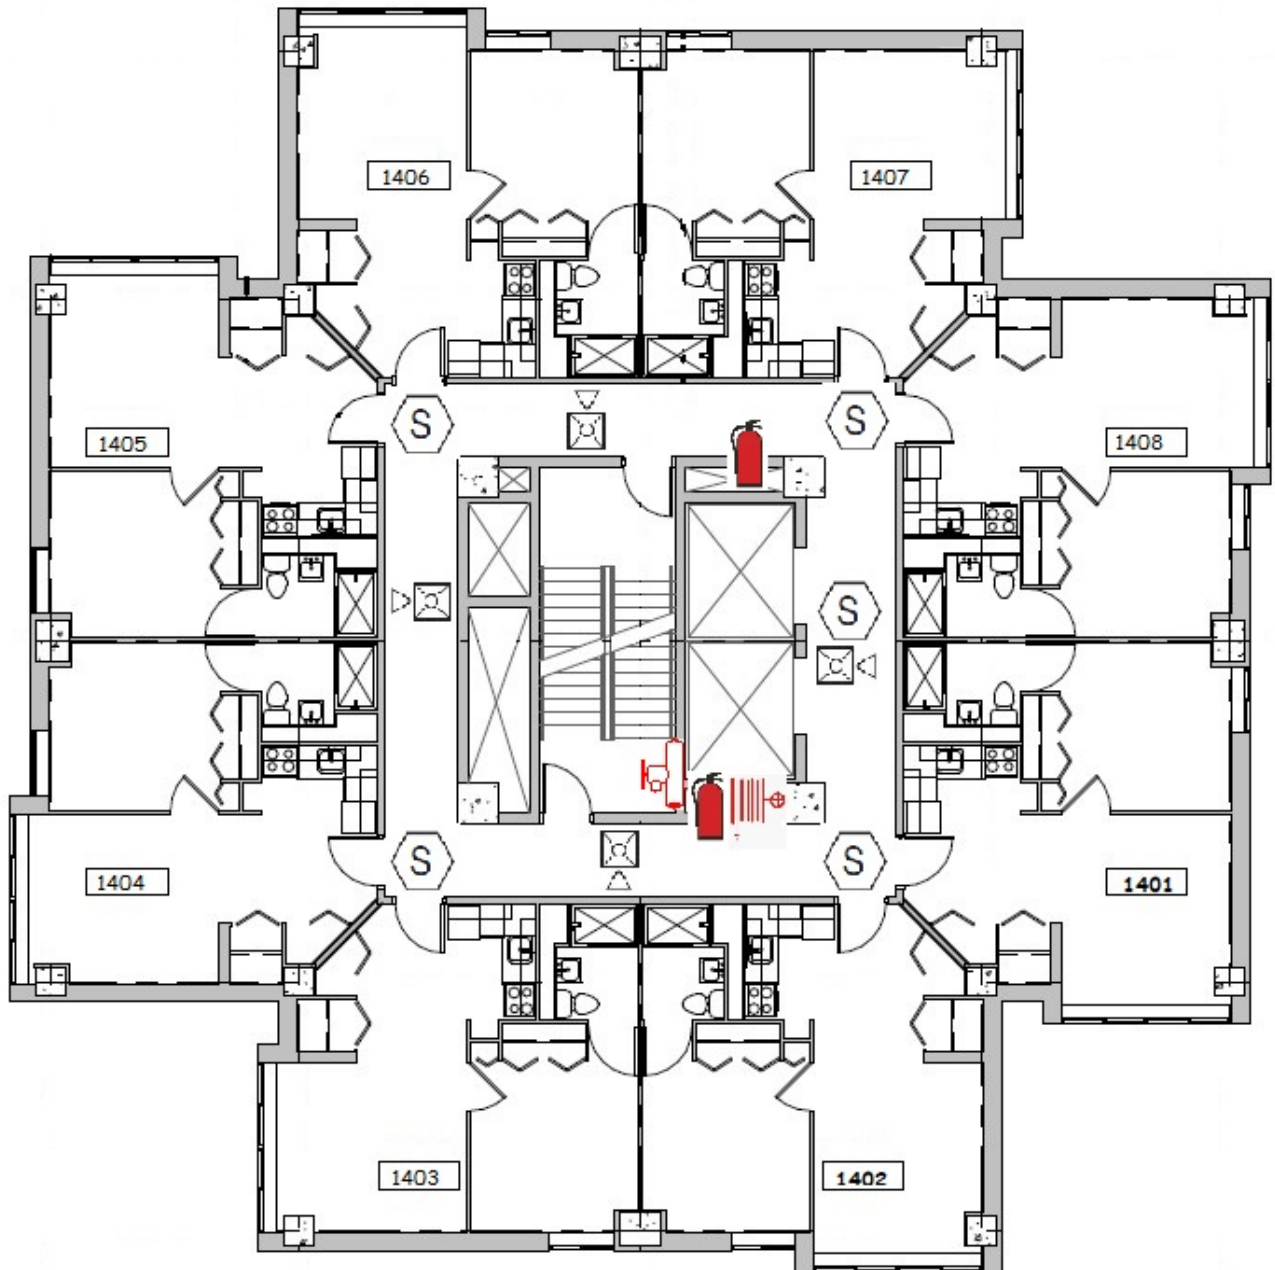
Figure 3: 14th story - Location of fire protection equipment and devices (approximate / not to scale)

Figure 3 shows the approximate location of the fire protection features on the 14th story.

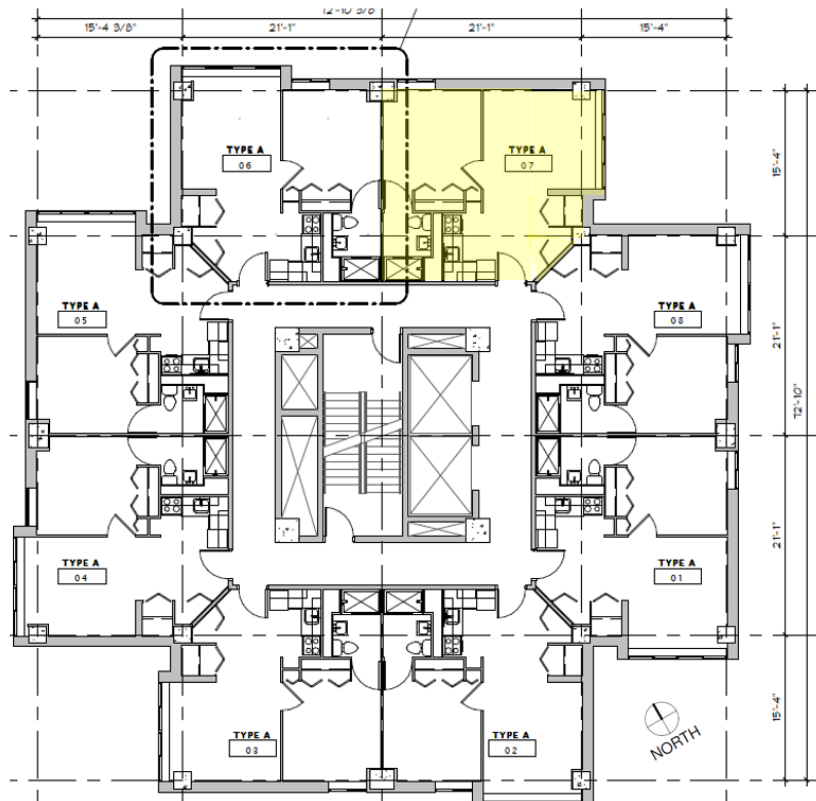
Figure 4 shows the layout of the 14th story (story of fire origin).

The fire started in apartment 1407, located near the east corner of the northeast wall (highlighted in yellow in Figure 4). State and local fire investigators determined that the fire's origin was in the bedroom of apartment 1407.

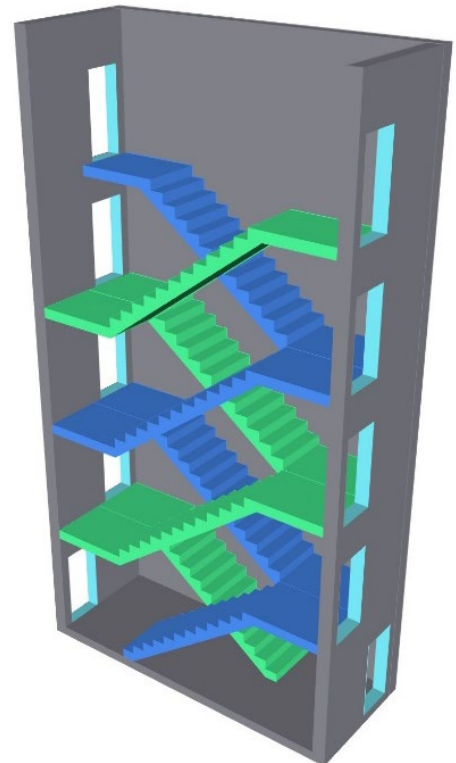
Figure 6: Example of a scissor stair
(drawing courtesy of SFMD)

The two stairways were arranged in a "scissor stair" configuration, where both stairways are located within the same enclosure. This was a design practice from decades ago – especially in high-rise buildings – to save space and the cost of building a second enclosure. Unfortunately, this practice was incongruent with the safe egress concept of having two ways out in an emergency. See Figure 6 for an example of a scissor stair.

Since both stairways are located within the same enclosure, or "shaft," a single open door can quickly compromise both stairs, which are the only paths of egress from the upper stories of the building. Doors get opened as occupants use the stairway(s) to egress or as firefighting operations take place from within the stair enclosure.

Modern building, fire, and life safety codes have not allowed scissor stairs for new buildings for several years. Since the majority of the heat released in a fire is convective heat, which tends to travel upwards or vertically, the use of scissor stairs is a significant fire and life safety risk to the building's occupants in a multi-story building.

The presence of scissor stairs in non-sprinkler-protected buildings is a significant life safety threat. The practice of building scissor stairs should be discontinued. Scissor stairs should be fire-separated into independent stair enclosures to provide distinct egress paths for occupants and to be congruent with the egress concept of having two separate ways out of a building in a fire emergency. If it is not feasible or possible to fire-separate the stair enclosures, the building should be sprinkler-protected throughout.

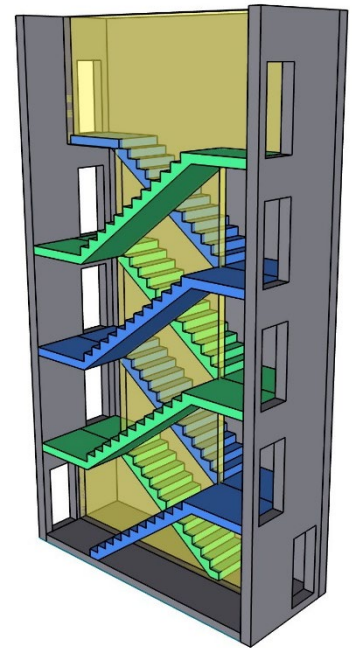
Figure 7: Scissor stairs with fire separation (drawing courtesy of SFMD)

The fire separation wall (shown in yellow) needs to separate the two stairs (shown as blue and green in Figure 7) on each story and completely separate the landings on the lowest and uppermost story to create separate compartments.

To correct the fire and life safety risks of having scissor stairs and both paths of egress in the same enclosure, a fire separation wall can be constructed to divide the space into separate compartments. Adding this fire separation wall divides the stair enclosure into two separate environments and provides a protected egress path if the other path should become contaminated with smoke or heat. Figure 7 shows one way this could be accomplished. The fire separation wall needs to be one-hour fire-rated in existing buildings (see MSFC 1103.4).

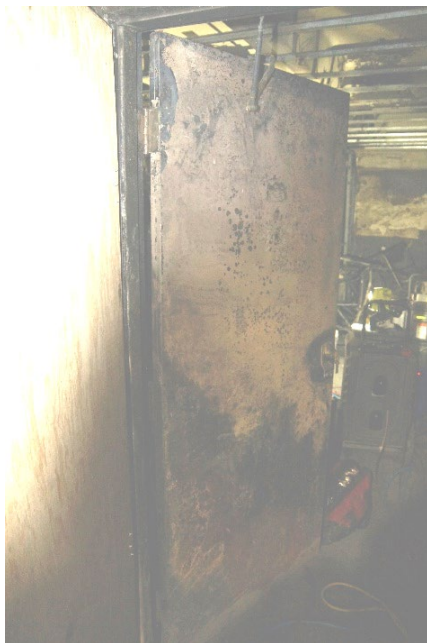
Figure 8: Door to apartment 1407

Steel doors with self-closing devices separated the apartments from the corridors. Although no listing tags were found on the doors, they likely would have satisfied the requirements of MSFC Section 1104.17.2.1 for fire-rated doors in existing buildings (20-minute fire-rated, 1-3/4 inch thick solid wood doors, or 1-3/8 inch insulated steel doors are allowed by the MSFC). Figure 8 is a photo of the door separating Apartment 1407 from the corridor.

The heaviest burn pattern on the door is shown in the lighter color moving upward from the latch side of the door to the hinge side of the door. This indicates that the door was in the open position and heat traveled from Apartment 1407 into the corridor. Had the door been closed, the smoke and heat spread from the apartment into the corridor and ultimately into the scissor stair enclosure would have been limited.

- Discontinue the practice of propping fire doors open or placing objects in the path of the door that prevent it from closing in a fire. Not only are these practices violations of the MSFC, they pose life safety risks to occupants using the corridor, which is the only means of egress from the building.
- Install fire sprinklers throughout the building if existing doors to resident rooms from corridors must be held open or prevented from closing.
- Provide fire separations for existing scissor stairs to form independent stair enclosures to provide at least two distinct paths of egress.

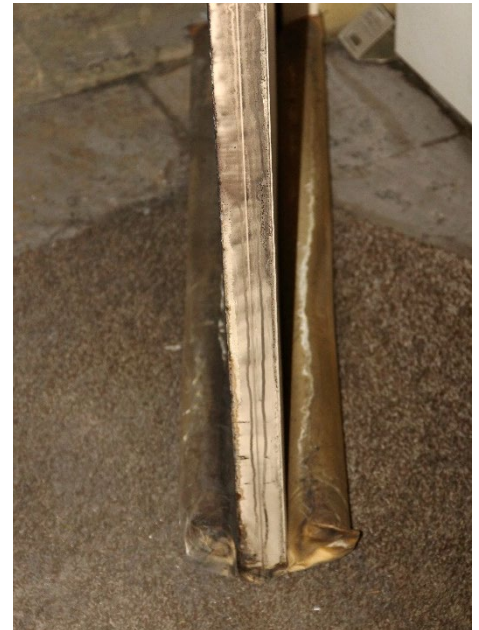
Figure 9: Seal under door of adjacent apartment

Although the corridor/apartment separation doors were equipped with self-closing devices, the closing feature was rendered ineffective by the placement of seals at the bottom of the doors that prevented the doors from closing. Although the exact reason for the seals is unknown, it is presumed that they were to prevent infestation spread or to prevent loss of heat from the individual apartment (see Figure 9). Other apartment doors on the 14th story were examined; the door bottom seal created friction against rugs or carpeting and prevented the door from closing.

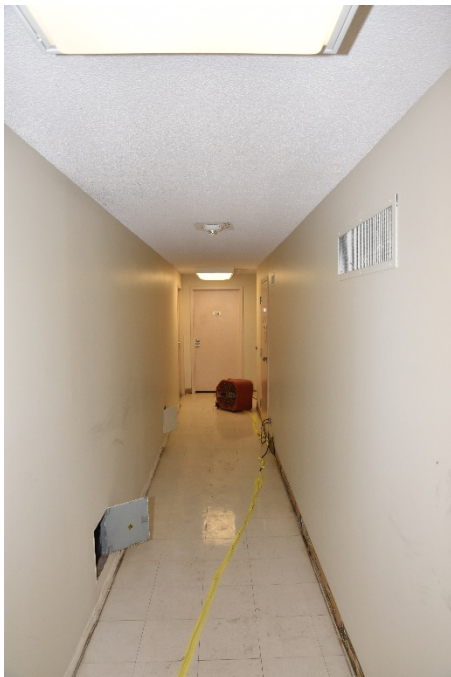
Figure 11: Typical corridor

Figure 10 shows the damage to the corridor on the 14th story. Figure 11 shows a typical corridor from another story.

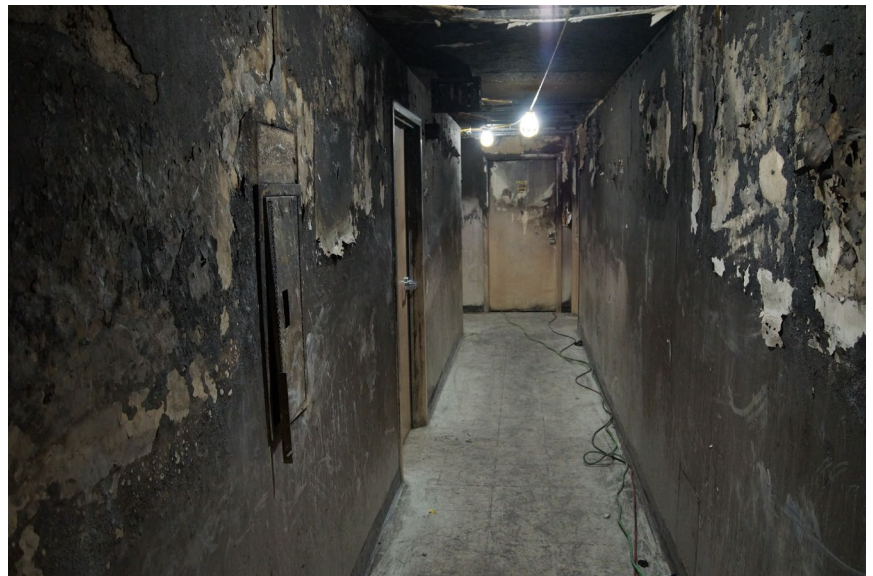
Figure 10: 14th story corridor (looking west from Apartment 1407)

The story of origin experienced significant heat and smoke damage; four of the fire's victims were found on this story. Within the first few moments of the fire, conditions were likely untenable. The 14th story corridor system was exposed to extreme heat and smoke conditions once the fire left the apartment of origin. Building occupants on the 14th story trying to use the stairway doors to exit that story would likely have had little time to do so.

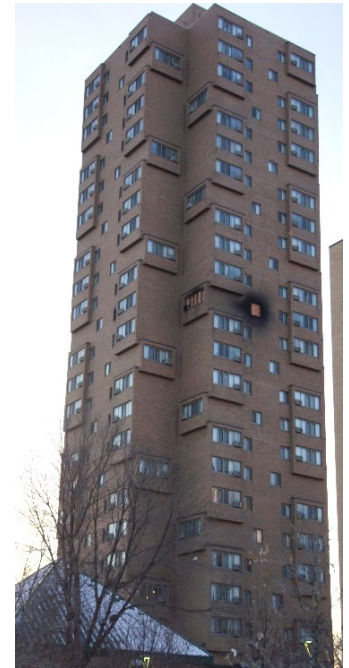
Figure 12: Exterior view from east side

Apartment 1407 was located on the northeast side of the building. At some point in the incident, the windows in the bedroom of Apartment 1407 failed (likely due to the heat of the fire) and the strong winds from the north created a “wind-driven fire.” This wind-driven fire, together with the apartment-to-corridor door being unable to close, contributed to the spread of fire throughout the 14th story. The living room windows were ventilated during fire department suppression activities.

Figure 12 is a view of the building from the east side showing the missing windows from the bedroom and living room of Apartment 1407.
