Fire Station 1 Background

415 Jackson Avenue, Elk River, Minnesota

Information from April 2026

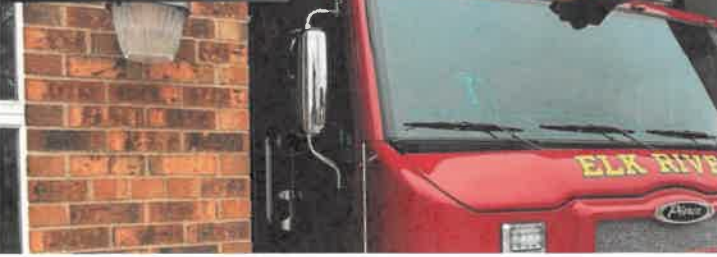
EXTERIOR

- Brick veneer and painted concrete in poor condition with damaged mortar joints.
- Window frames in poor condition.
- Exterior doors have deteriorating hardware.
- Entire building lacks energy efficiency.
- Roof has several leaks and needs replacing.
- Exterior concrete and asphalt need replacing.

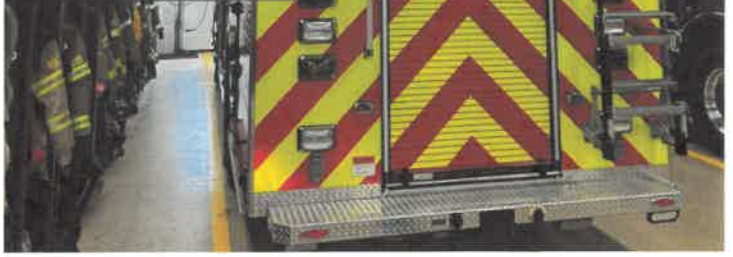
GARAGE & BAY

- Garage doors need replacing.
- Bays are too narrow, with the apparatus too close to the walls.
- Bays are disjointed due to previous additions.
- Ceiling clearance is too short for modern apparatus.
- Bays are not drive-through, which creates a safety issue when backing up from a busy street.

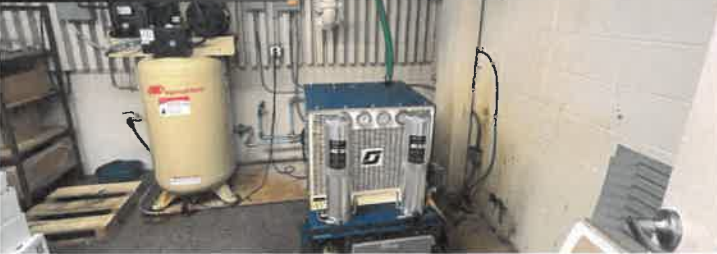
MECHANICAL

- Electrical panels are obsolete, and wiring is beyond its expected life.
- Electrical service and distribution systems are a combination of original and renewed components, making electrical a high priority for replacement.
- Plumbing needs to be updated and replaced due to cast-iron piping beyond its expected life.
- Significant remodeling would need to be done just to access underground pipes for repair or replacement.

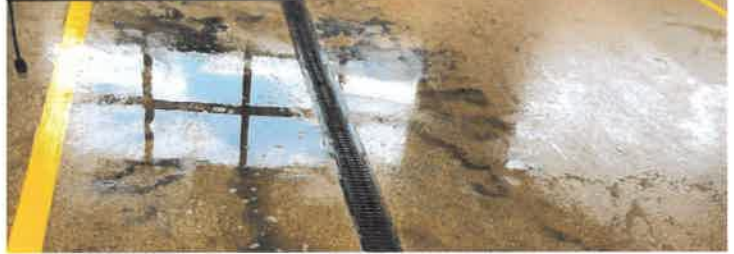
OPERATIONAL

- Garage flooring lacks appropriate drainage.
- SCBA (oxygen tank) filling, equipment decontamination, and workshop are currently housed in one place.
- Training areas, dayrooms, and workrooms are significantly undersized and do not accommodate the department's growth.
- Existing station has used over 90% of the property, allowing no further expansion space.

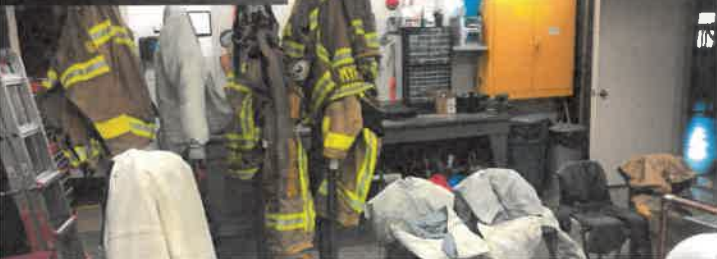
SAFETY

- Turnout gear is currently left exposed within the apparatus bays.
- Outdated electrical systems are becoming hazardous.
- Building lacks appropriate ventilation systems.
- SCBA (oxygen tank) filling, equipment decontamination, and workshop are currently housed in one place.
- Lack of security within station.

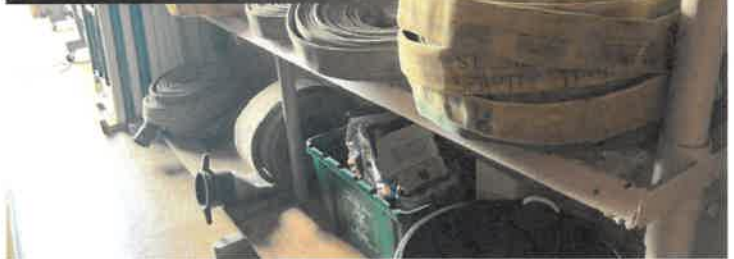
EQUIPMENT STORAGE

- No appropriate place for turnout gear and PPE to be stored safely and effectively for operations.
- General lack of storage space for a variety of equipment.
- Narrow hallways throughout station.
