10-Year Capital Asset Need: *Taking care of what we have.*

February 2023

Minnesota Department of Natural Resources (DNR)

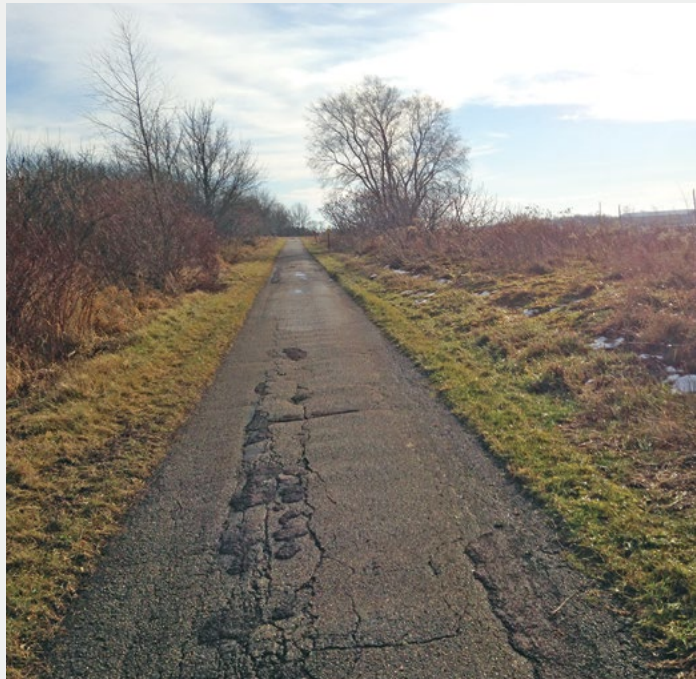
Before: Sakatah Singing Hills State Trail. The segment between Elysian and Waterville, a portion of which is shown in the photo, was aged and had begun to fail, requiring major reconstruction.

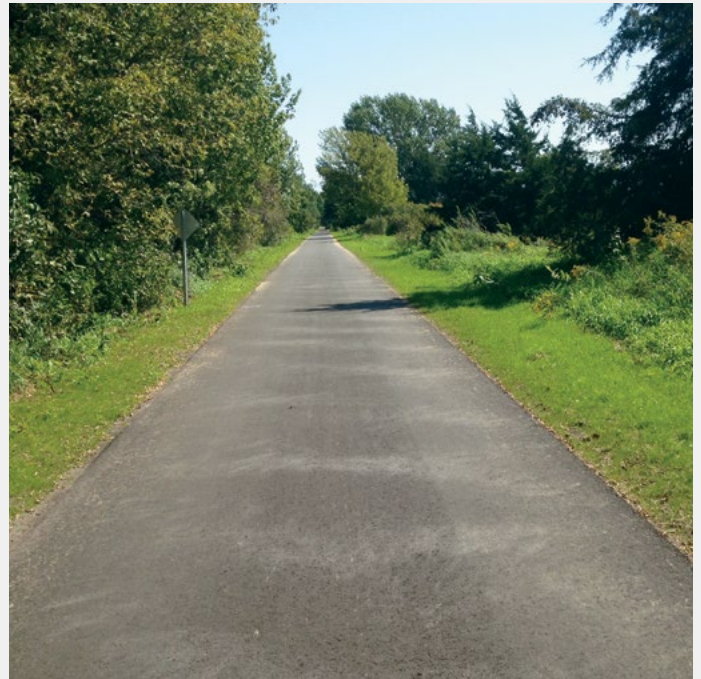
After: As can be seen in this photo of part of the trail following repair, the wider structure, improved drainage, and new pavement provide a better experience for trail hikers and bikers for years to come.

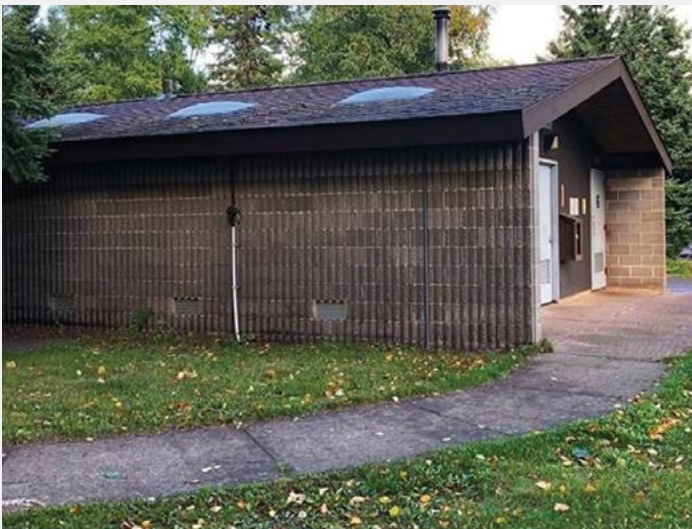
Before: Temperance River State Park old campground shower building. In addition to its poor physical condition, the building was not accessible or compliant with modern user needs.

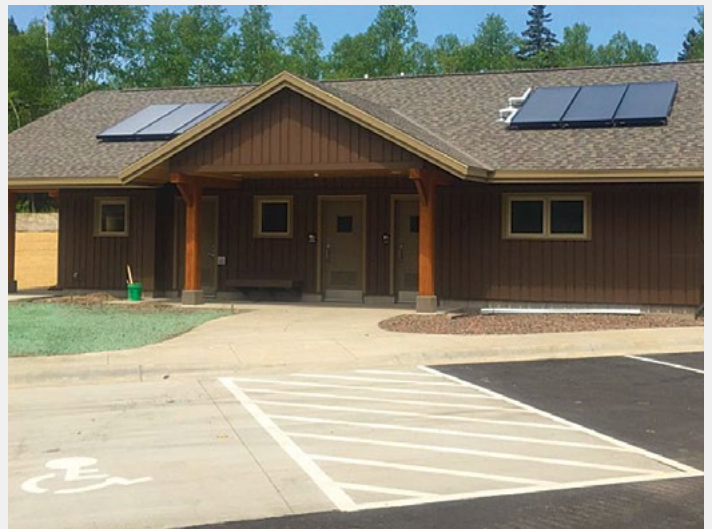
After: Temperance River State Park new shower building. The replacement building consumes less water and energy, is fully accessible, and provides for modern camper needs such as family rooms and a dish washing station.

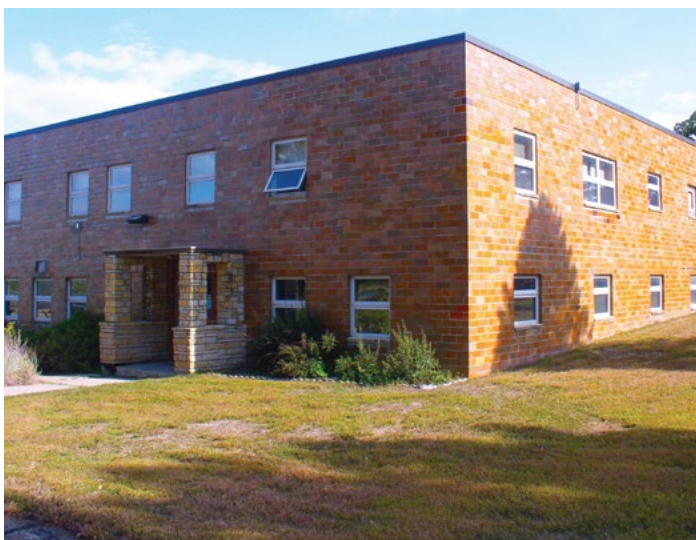
Main entrance of the Waterville Hatchery office. The entrance, and the 1950s-era facility as a whole, are not accessible.

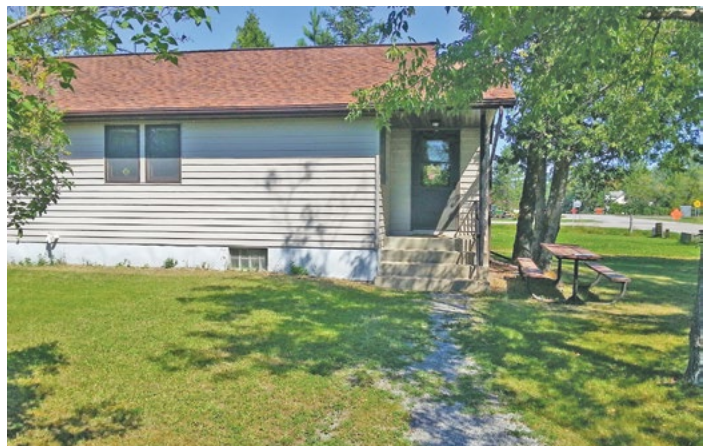
Public entrance of Williams Forestry office. Sidewalk and stairs do not meet ADA requirements.

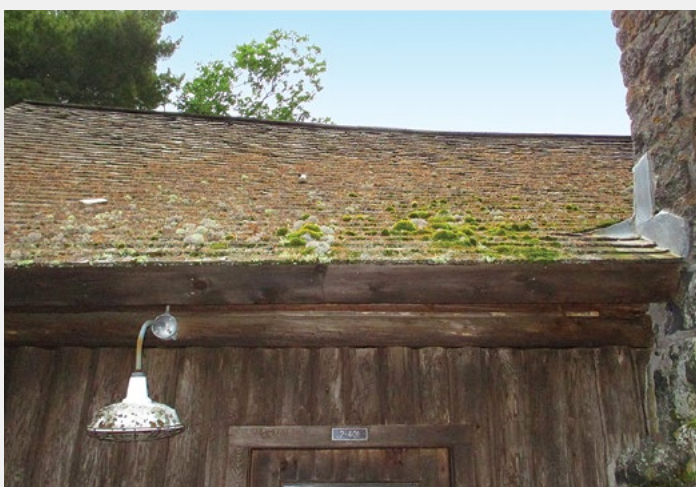
Tettegouche State Park historic camp lodge roof in crisis condition.

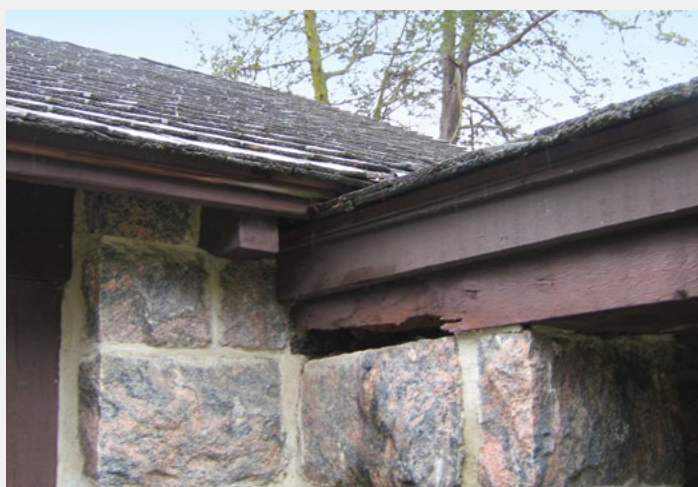
Fort Ridgely State Park campground picnic shelter with rotting supporting timbers.

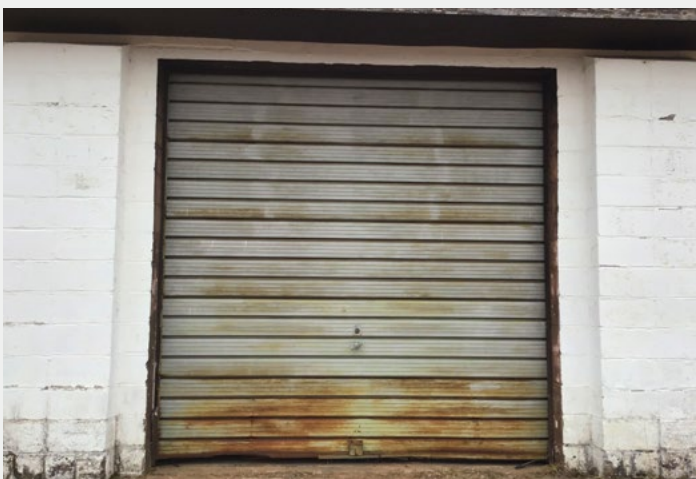
General Andrews Forestry area office garage. The metal overhead door is severely corroded and must be replaced.

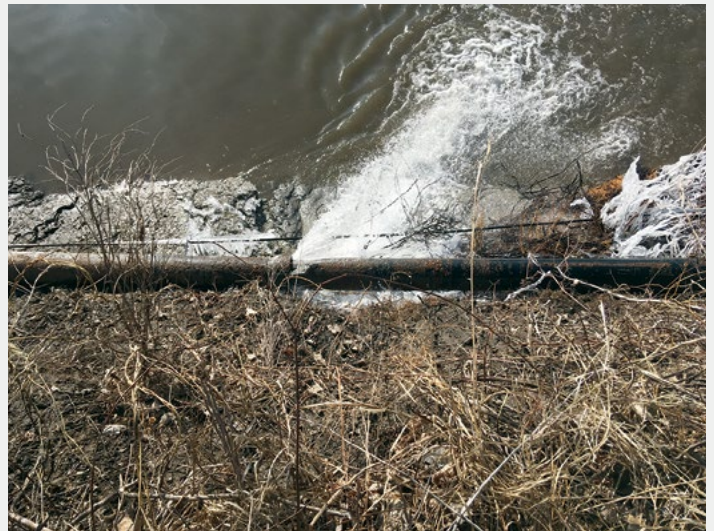
A recent water main break in Fort Snelling State Park. This is an all-too-often occurrence in many of our state parks due to aging infrastructure.

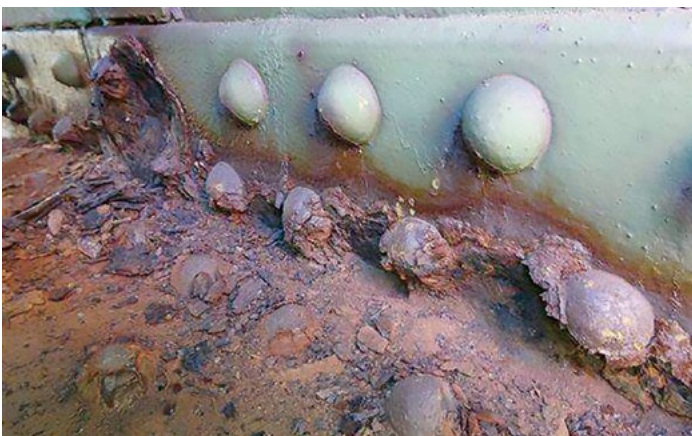
In the past few years, DNR has experienced significant issues with a number of aging bridges, resulting in mandatory closures to traffic or the imposition of weight restrictions. In particular, the High Falls Bridge at Tettegouche State Park must be replaced as soon as possible due to age and corrosion of the suspension cables. In 2019, the vehicle bridge at Tettegouche State Park connecting the visitor center to the campground required an emergency repair after a bent gusset plate was discovered during a routine inspection. This bridge is 98 years old and has a fracture-critical structure. While the emergency repair allowed for continued use of the bridge for a short while, a long-term solution is needed. DNR is currently evaluating options for the future of this bridge.

Photo at left: Extremely corroded structural steel on the bridge at Tettegouche State Park.

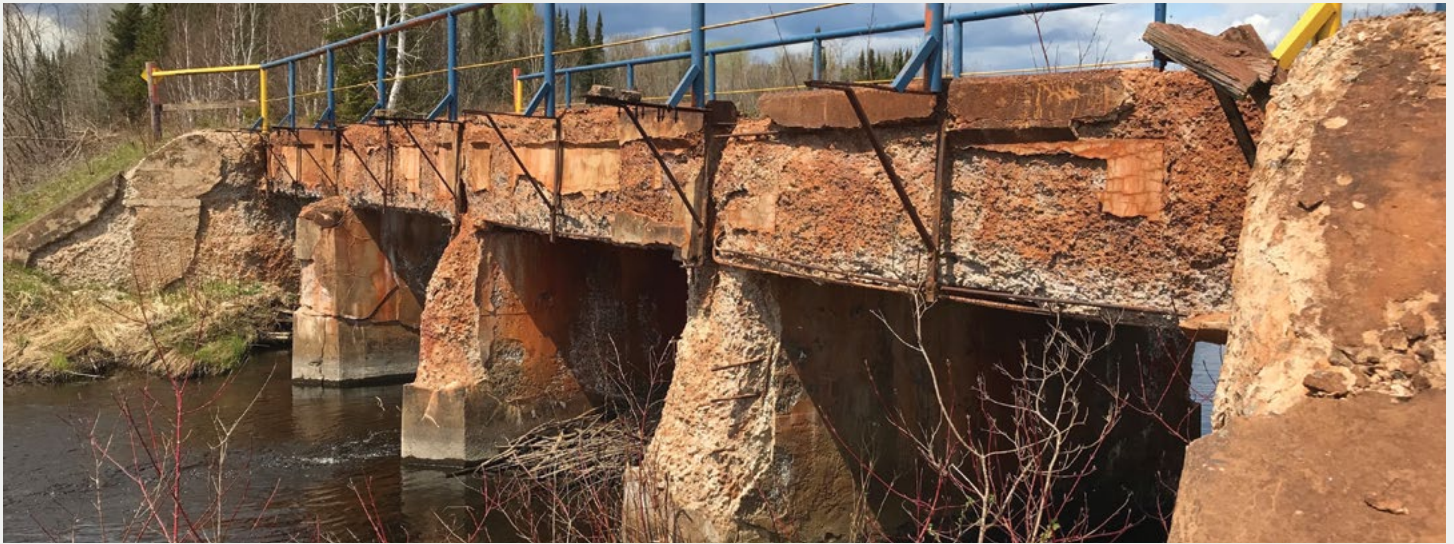
Above: Alborn-Pengilly Trail. This old railroad bridge shows complete failure of the concrete surfaces, exposing structural reinforcing steel to corrosion. This bridge must be completely replaced; it is not repairable.

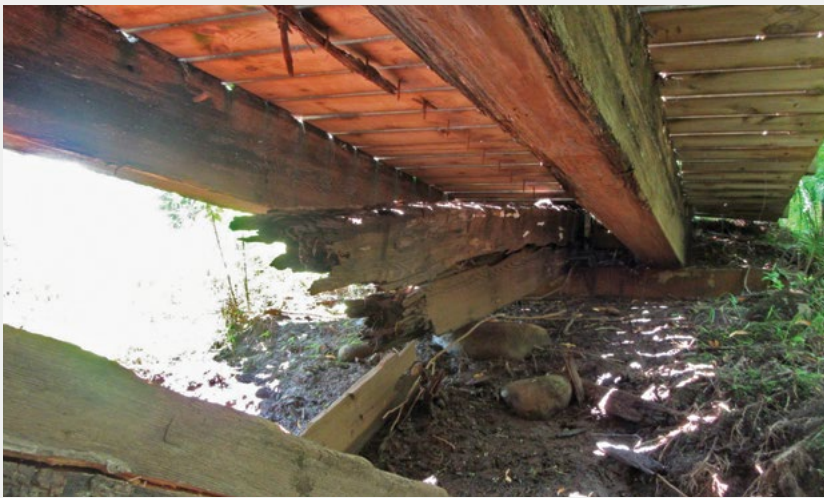
Center: Banning State Park. This bridge is closed to vehicle traffic due to the fractured support beam seen in the photo.

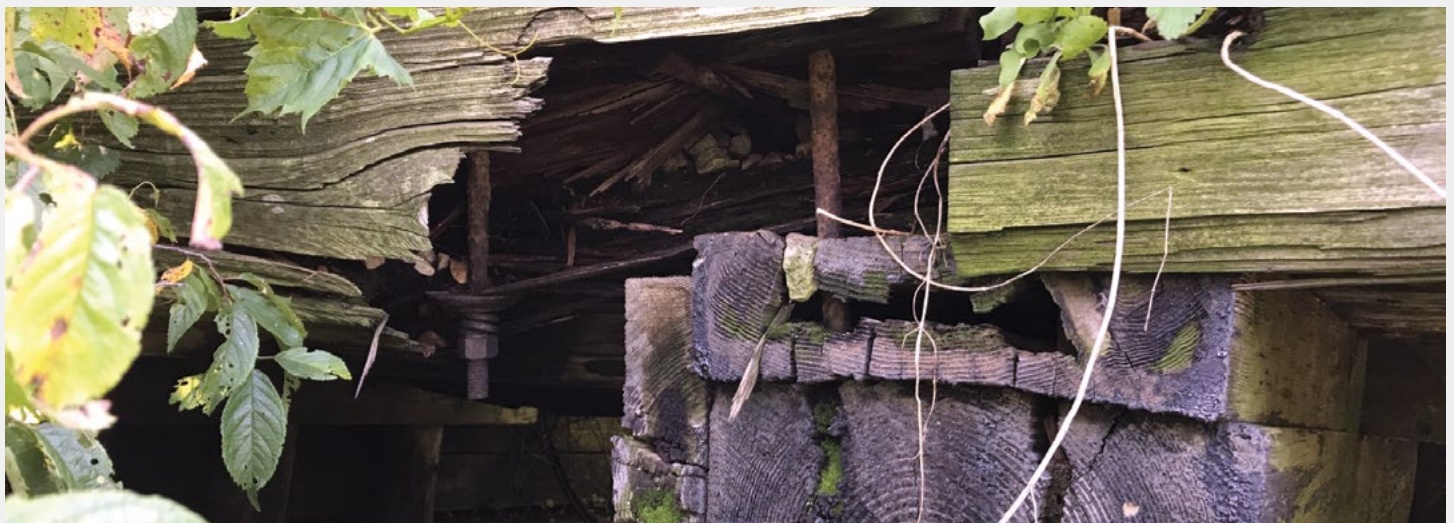
Below: Wild Indigo Prairie SNA. This trail bridge is in imminent danger of collapse due to rotting structural timbers. This bridge must be completely replaced; it is not repairable.

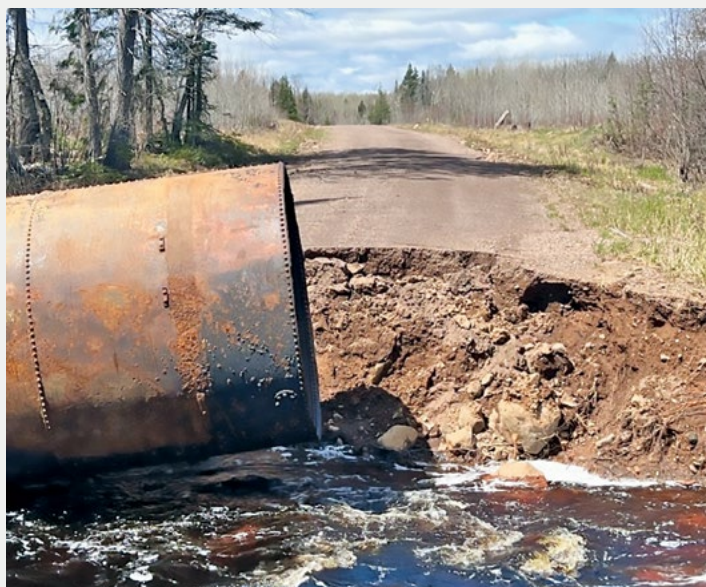
This very large culvert on a forest system road in Finland State Forest was washed out by a storm in 2022. Storm events are steadily increasing in intensity, overwhelming old road infrastructure that was not designed for today’s climate.

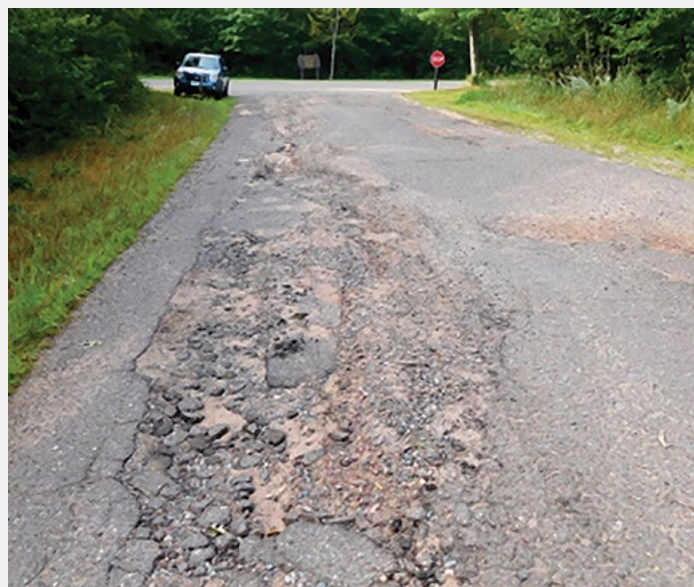
Wild River State Park. This asphalt road has failed and requires full reconstruction.

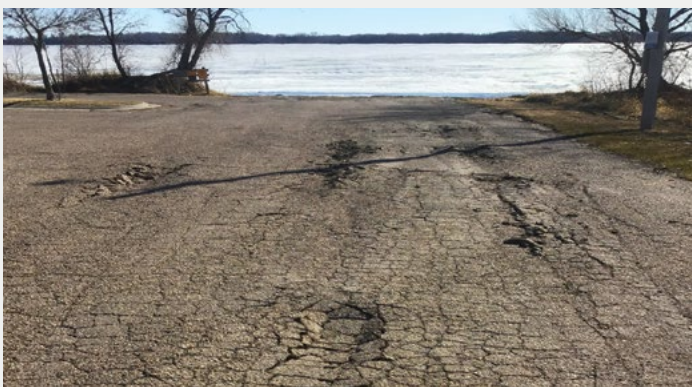
German Lake PWA showing failure of the asphalt pavement. This pavement must be completely replaced.

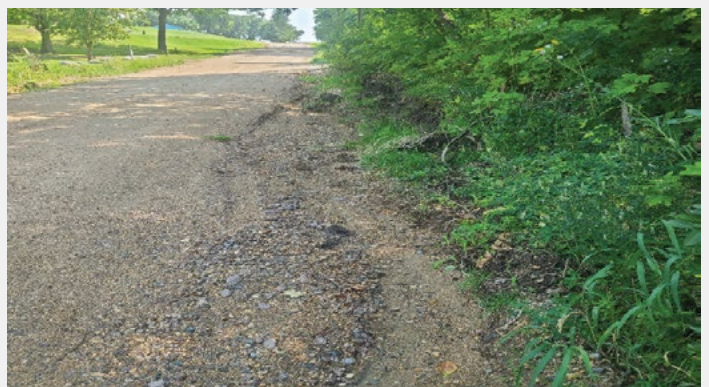
Lake Rachel PWA gravel road showing ongoing storm water erosion. This area must be repaired or erosion will get worse.

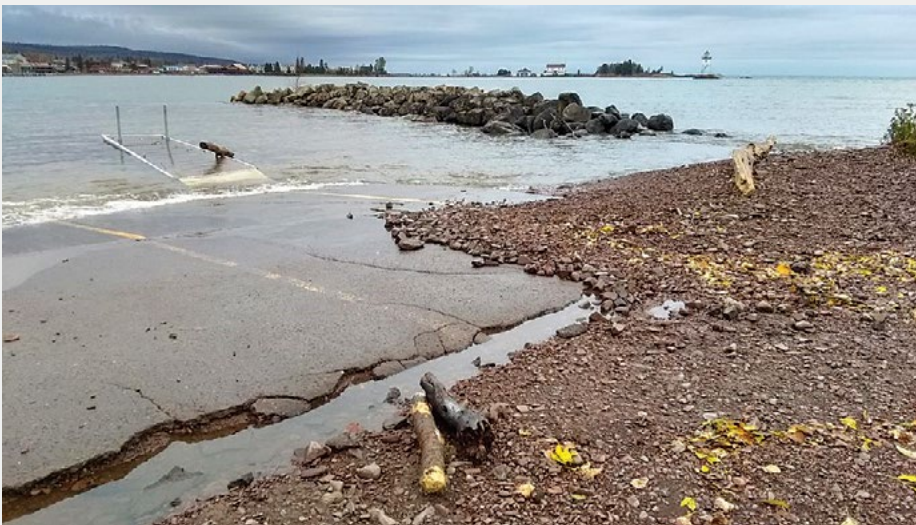
Left: The Grand Marais water access and breakwater in failed condition.

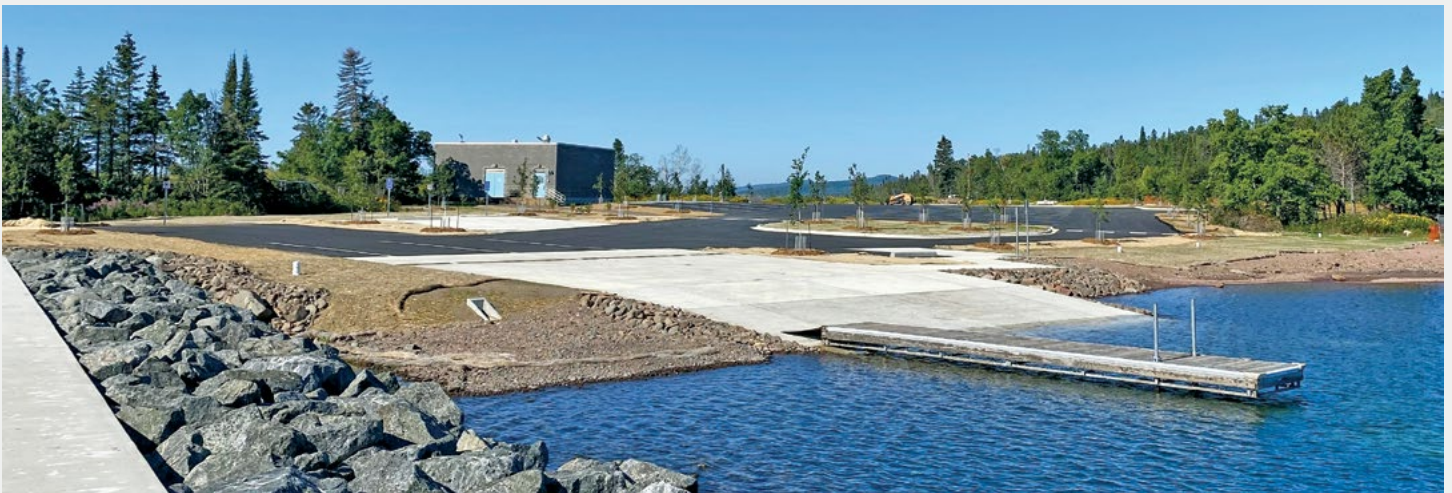
Below: The same water access after reconstruction in August 2022. The new breakwater is substantially stronger and designed to require less maintenance.

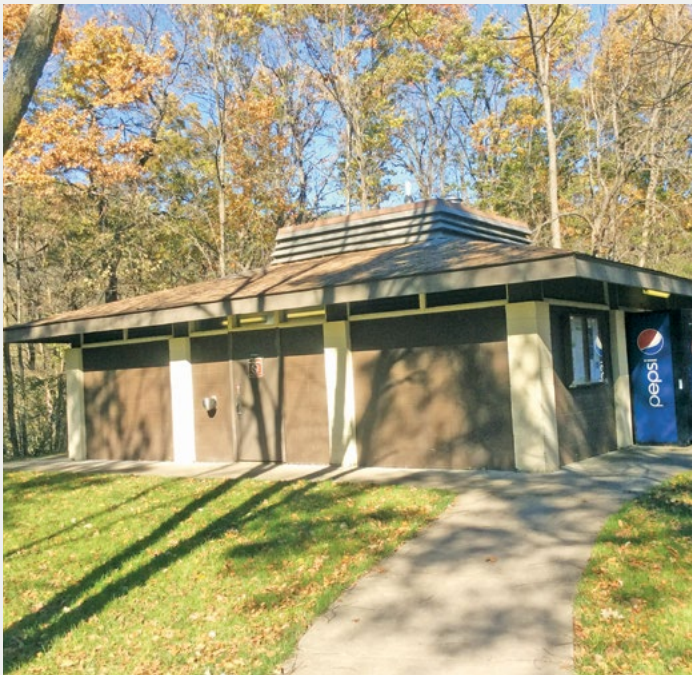
The old Cedar Hill Campground shower building at Whitewater State Park. This building was in poor condition, undersized, energy inefficient, and did not meet the needs of today's campers.

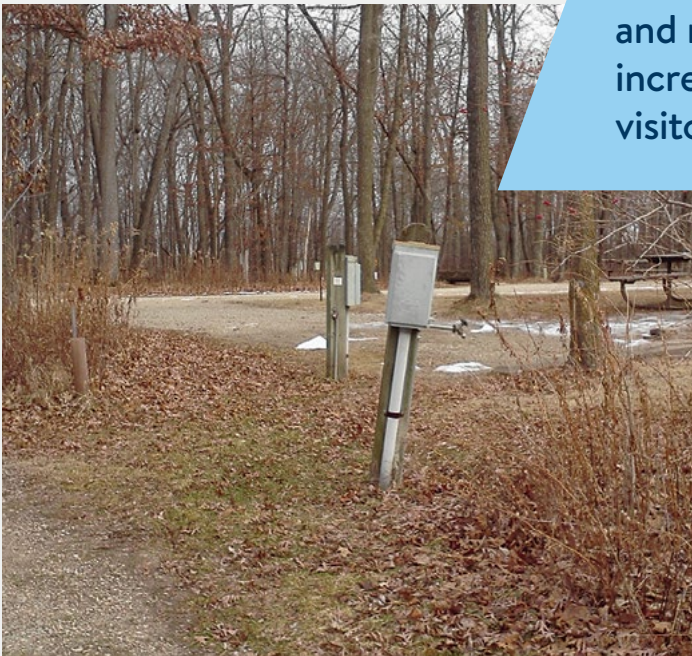
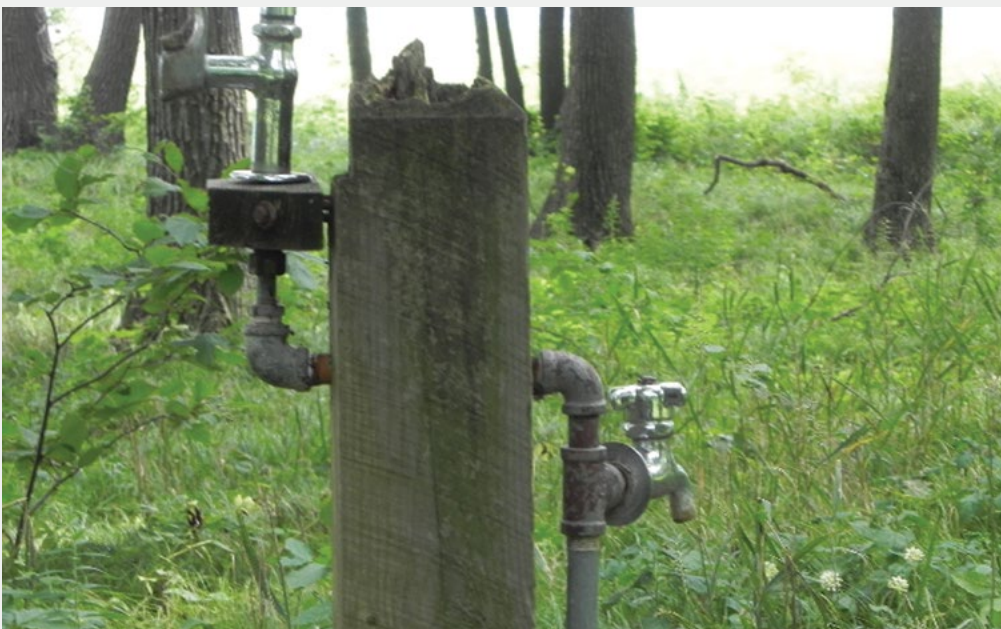
These examples of inadequate and aging electrical infrastructure (left) and campground water delivery (below) illustrate system-wide needs.

Campgrounds across the system can no longer support the electrical demands of today's campers. Old and failing electrical and drinking water infrastructure must be replaced with larger systems that meet current and future capacity needs.

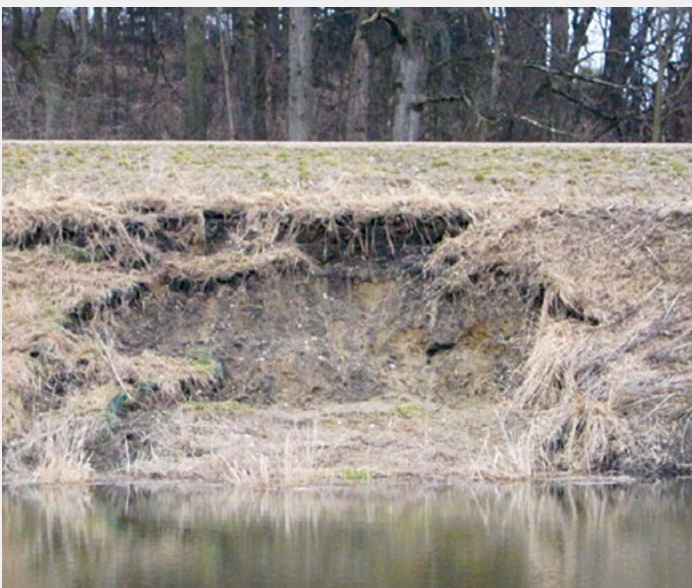
Failing pond dike at Waterville Hatchery.

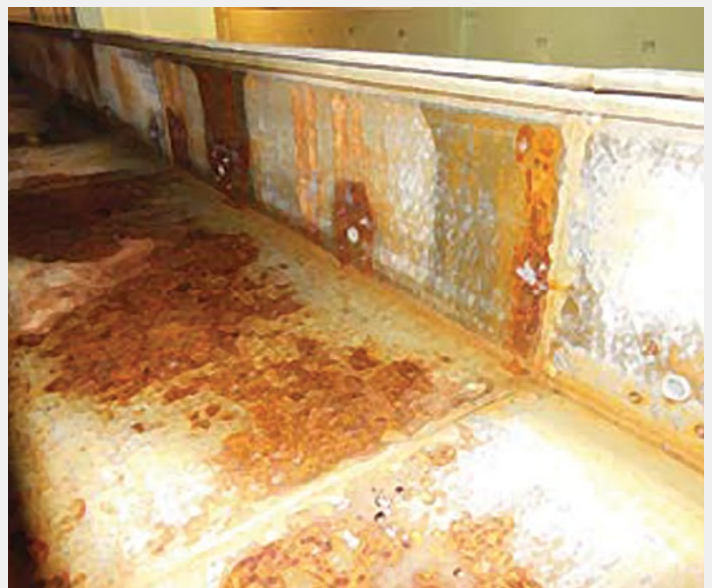
Waterville Hatchery fry tank in poor condition.

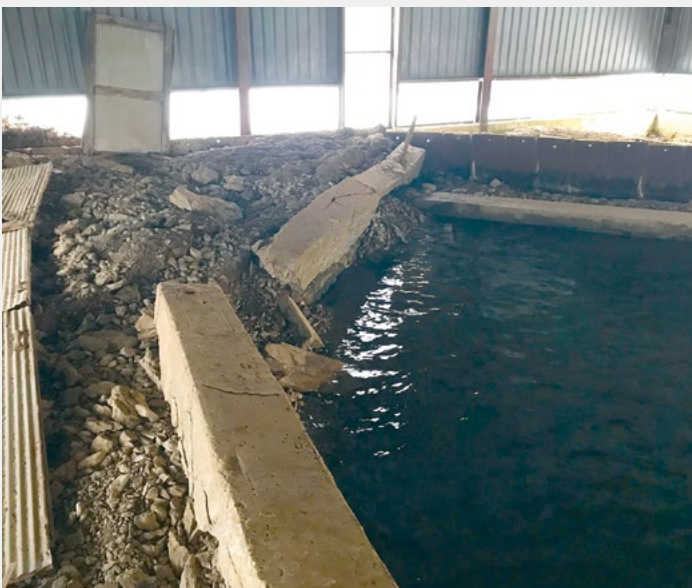
Lanesboro Hatchery dilapidated spring pool wall.

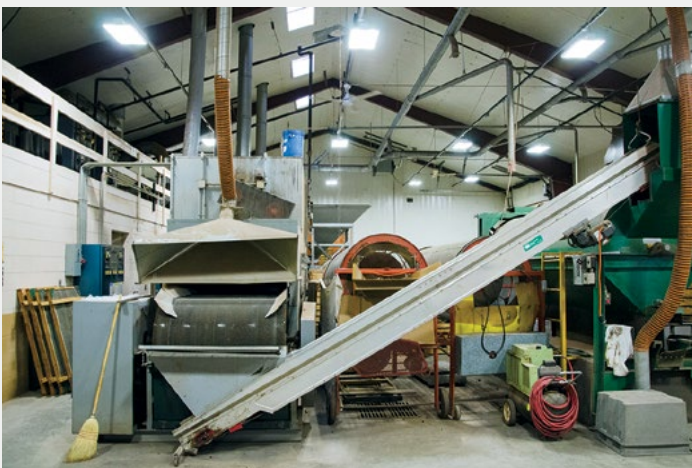
The pine cone seed extractor. The equipment in the seed extractor is old, no longer maintainable, and must be replaced with modern, efficient equipment. The facility’s HVAC and dust controls also require replacement.

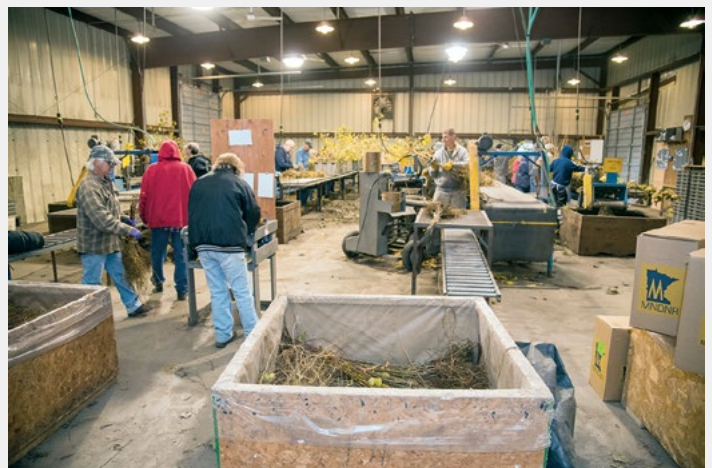
Seedling packing, sorting and grading. This facility is too small and does not provide forklift access to the coolers for refrigerated storage of seedlings. These problems limit the DNR’s ability to pack and ship tree seedlings across the state. This entire facility requires replacement.

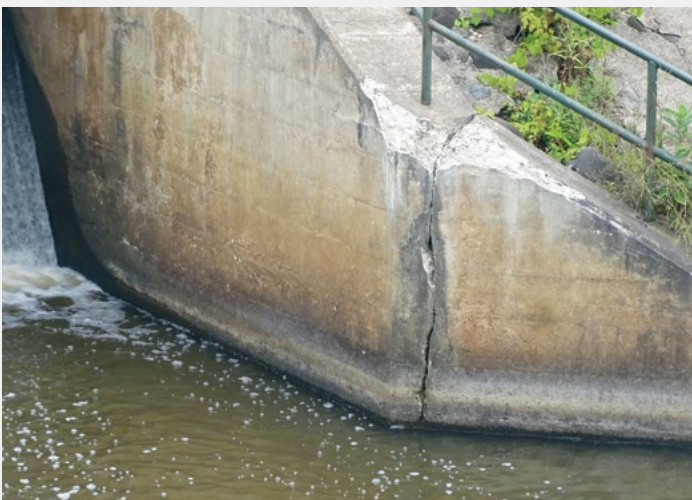
A wing wall of the Grindstone Dam spillway. The concrete is cracked completely through, increasing the likelihood of collapse and subsequent failure of the dam.

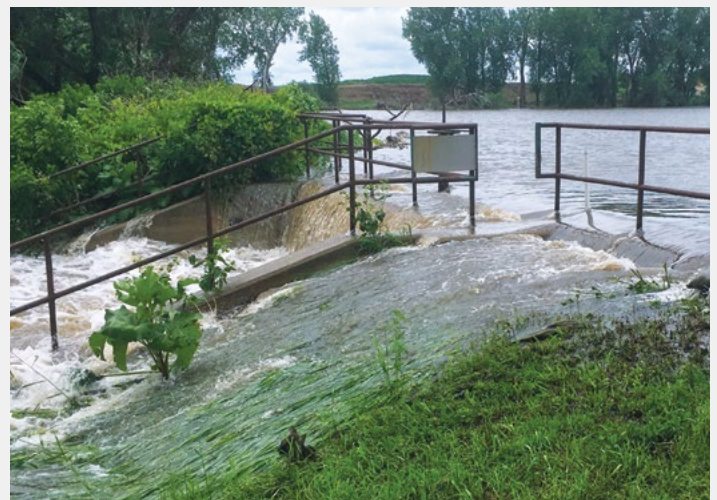
Warren Lake dam failure caused by overtopping. The spillway is undersized to safely pass incoming floodwaters.

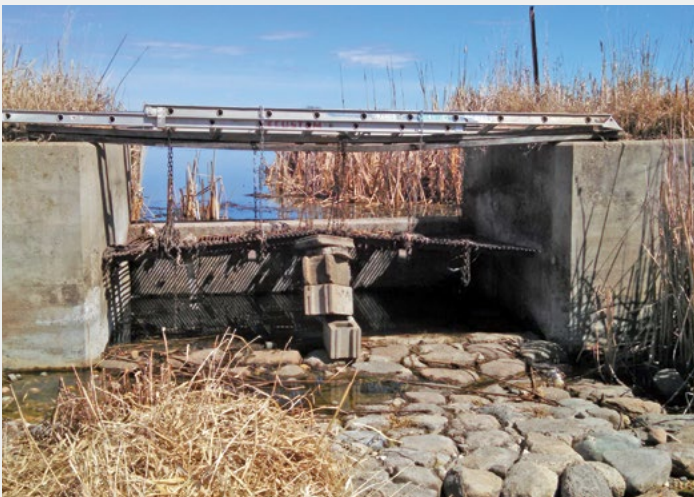
Silver Lake (Sibley County) water control structure in crisis condition. Note the control gate is held up by a stack of cinder blocks. A replacement for this structure is currently in design.

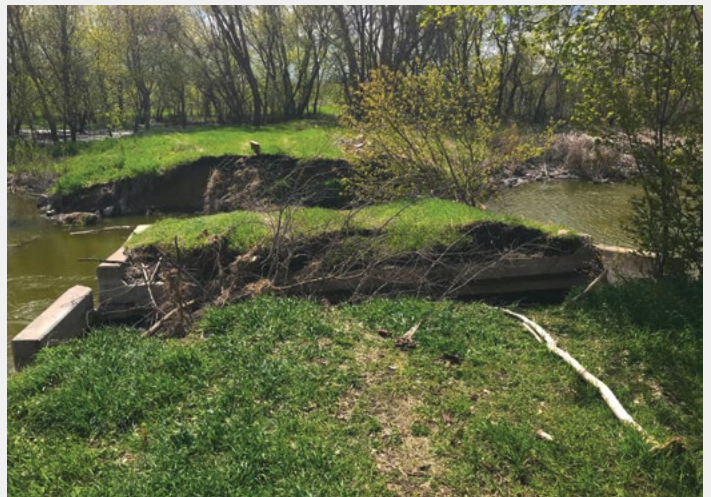
Perkins Lake water control structure failure. The earth embankment washed out and lake levels can no longer be managed.

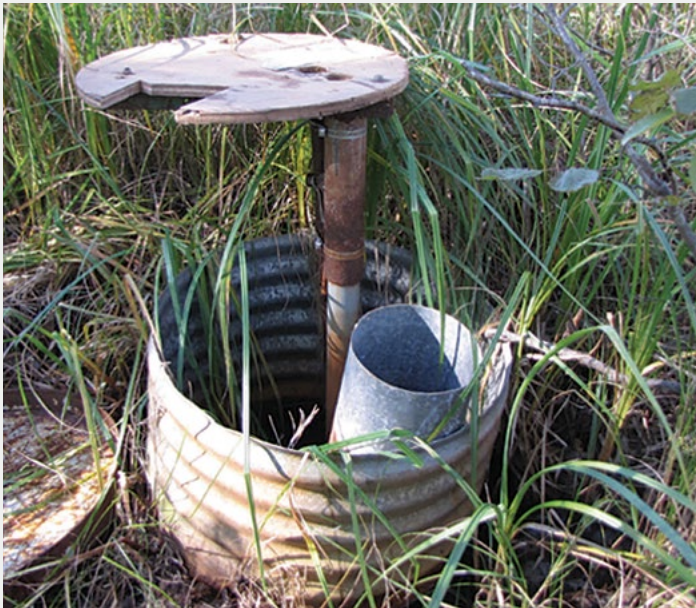
Monitoring well on state forest land in Aitkin County in poor condition.

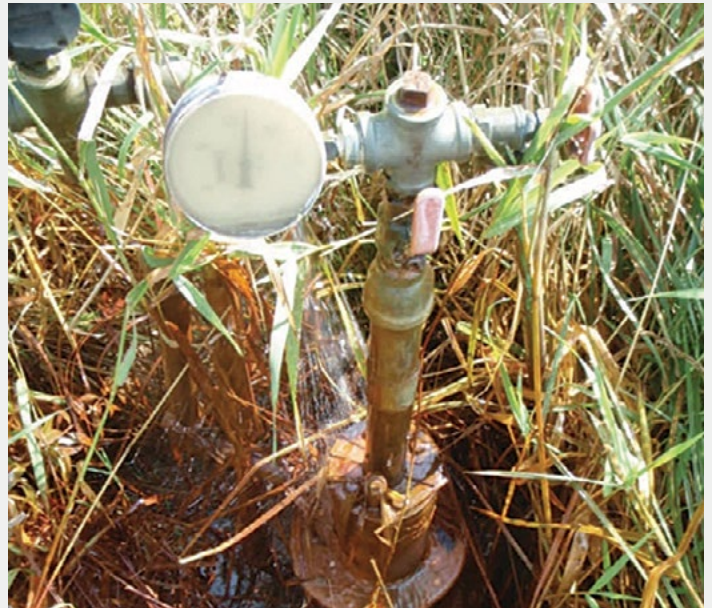
Monitoring well in need of replacement.
