January 31, 2022

Re: Updated Cost Estimate for Granite Falls Hydroelectric Powerhouse Repairs

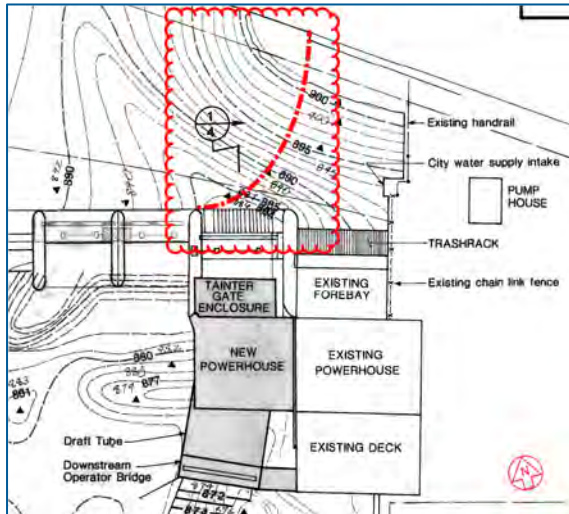
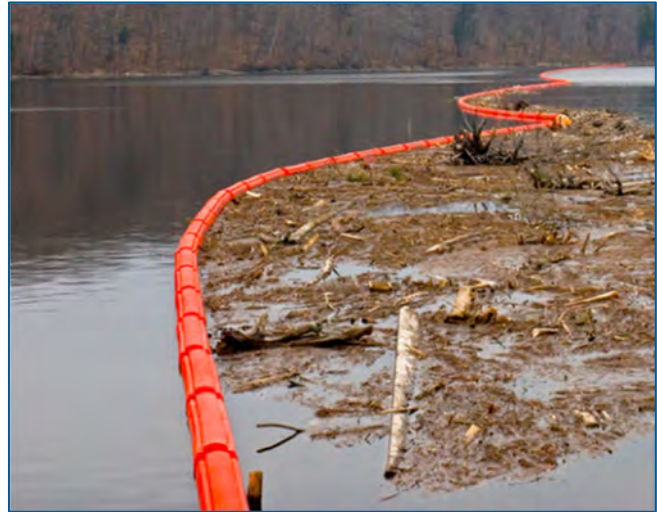
3. Debris Boom

Debris such as tree branches collects in front of the powerhouse intake area and causes the intakes to plug and the generators to trip offline. To help mitigate this operational problem, a debris boom is to be installed upstream of the powerhouse. The debris boom would span between the upstream riverbank on the left (east) side of the river and the right side of the intake for unit #3. Installation of the boom would

result in less powerplant down-time and maintenance while also improving public safety. The photograph below is an example from a different site.
