A Minnesota Department of Public Safety
State Fire Marshal Division Report

LESSONS LEARNED: The November 2019 Minneapolis High-Rise Fire

Narrative Report

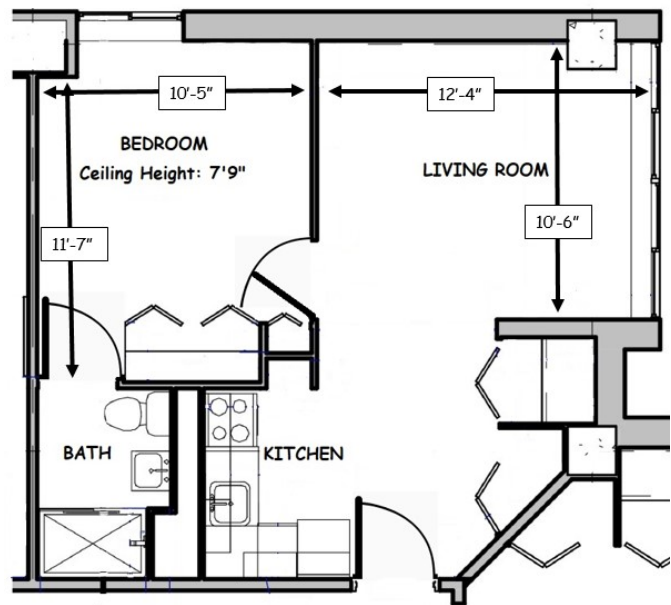
Figure 5: Typical apartment layout (apartment 1407 resembled this)

All apartments appeared to be similar in size and shape. Some were mirror images of the others, depending on their location around the building's perimeter. Every fourth story had slightly different configurations than the previous three (the 14th story was one of those). On these stories, the windows were located in slightly different locations due to outcroppings or cantilevered areas on the building's exterior walls. Apartment 1407's configuration was similar to Figure 5. All dimensions are approximate.
